**Attachment 4 –**  
**SEWPBPD Biennial WPDES Report – March 31, 2021 to March 31, 2023 (except where noted)**

**Quarterly Stormwater Pond Inspection Reports and Documents**

PROJECT:  
2022 WPDES  
PERMIT  
COMPLIANCE

LOCATION:  
MILLER PARK

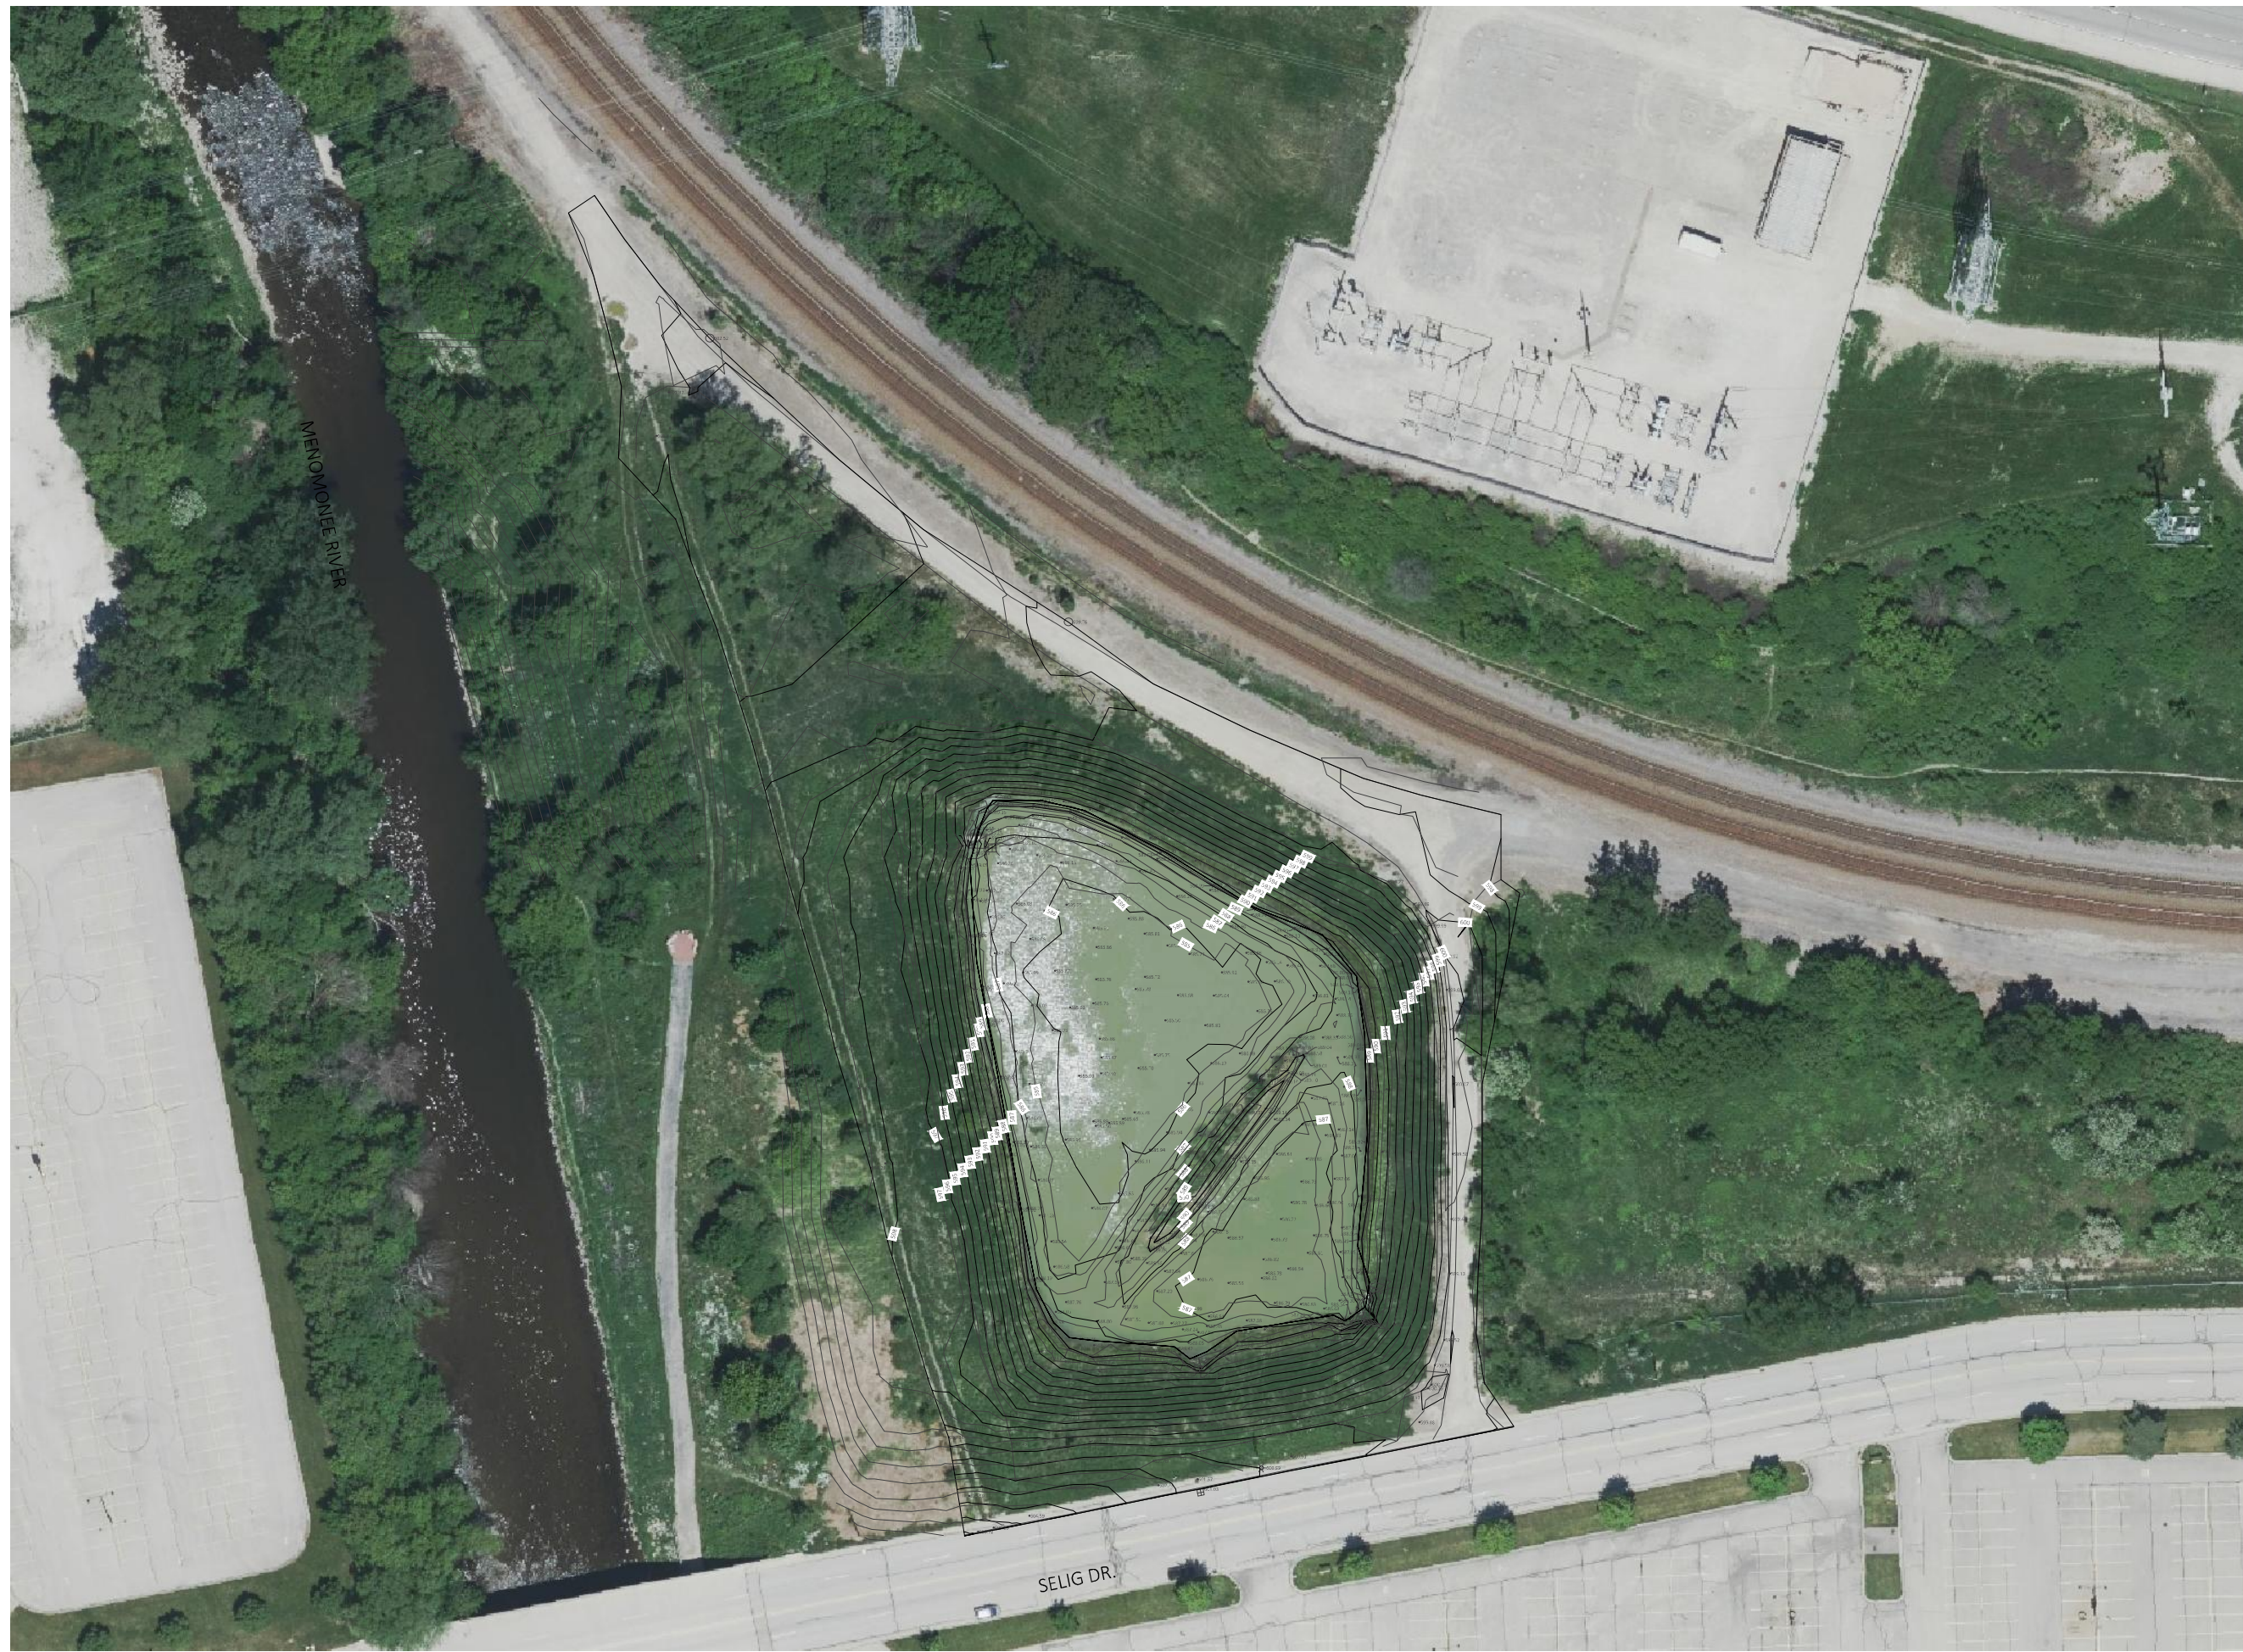
SHEET:  
POND ELEVATIONS

Person Conducting Inspection:	Jason Herther, RLS	Date: 6/4/2014	Date: 7/15/22	Date: 7/15/22
	North Basin (Pond)	South Basin (Forebay)	North Basin (Pond)	South Basin (Forebay)
Water Elevation	589.8	589.8	589.8	589.8
Average Sediment Elevation	584.6	585.5	585.86	586.77
Pond Depth	5.3	4.5	3.94	3.03
As-Built/Plan Elevation	585	585	585	585
Sediment Buildup (ft)	-0.4	0.5	0.86	1.77
Sediment Buildup (CY)	N/A	117.00	504.44	413.00
