SUBJECT: Case Closure with Continuing Obligations
Menomonee River Stadium Proj, GW&Free Pro, BRRTS #: 02-41-001187, FID # 241615110
WI DH&SS Stadium Proj Areas B&C Contam Fill, BRRTS #: 02-41-001189, FID #: 241838190
500 S. 44th Street, Milwaukee, WI

CAP MAINTENANCE PLAN SOUTHEAST WISCONSIN PROFESSIONAL BASEBALL PARK DISTRICT – RIVER EAST

CAP PHOTOGRAPHS SOUTHEAST WISCONSIN PROFESSIONAL BASEBALL PARK DISTRICT RIVER EAST—BRRTS #02-41-001187 & #02-41-001189 MILWAUKEE, WISCONSIN	PHOTO
		Page 4

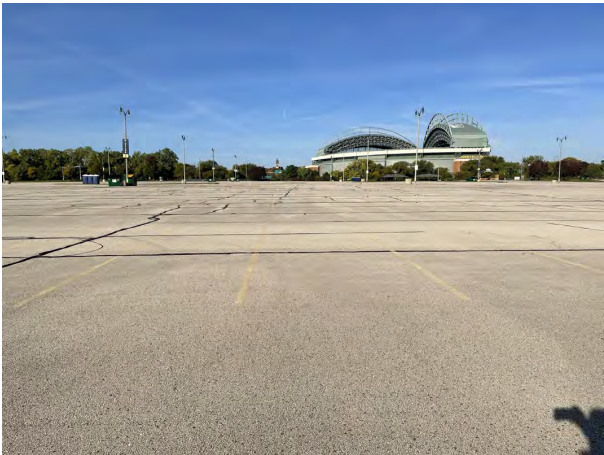
Photo 4: Yount Lot: Asphalt cap over Yount Lot: 4-inch asphalt pavement overlying 8-inches of crushed aggregate base course. Photo depicts current conditions for comparison during future inspections.
Photo taken facing west on October 4, 2022.

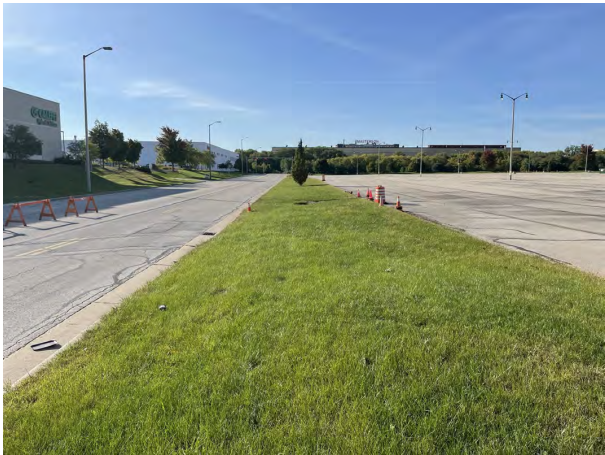
Photo 1: Yount Lot: Greenspace cap along parking lot median: 12-inches of low permeability non-impacted soil covered with 4-inches of vegetated (grass as shown) topsoil. Asphalt capped Selig Drive shown on left side of photo. Asphalt capped Yount Lot shown on right side of photo.
Photo taken facing south on October 4, 2022.

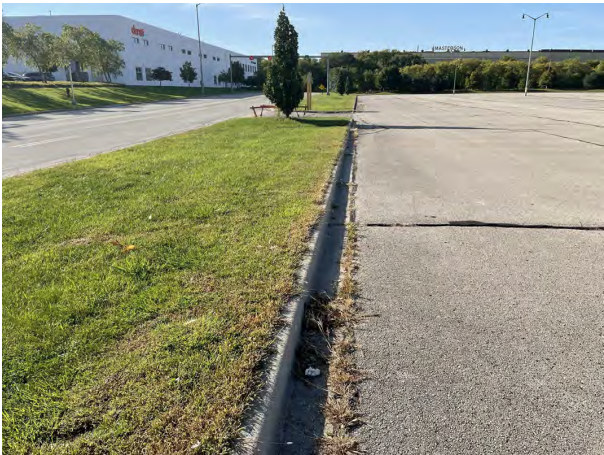
Photo 3: Yount Lot: Asphalt cap over Yount Lot (right side of photo): 4-inch asphalt pavement overlying 8-inches of crushed aggregate base course. Greenspace cap over parking lot median: 12-inches of low-permeability non-impacted soil covered with 4-inches of vegetated topsoil. Concrete curb and gutter along median perimeter and edge of asphalt pavement.
Photo taken facing south on October 4, 2022.

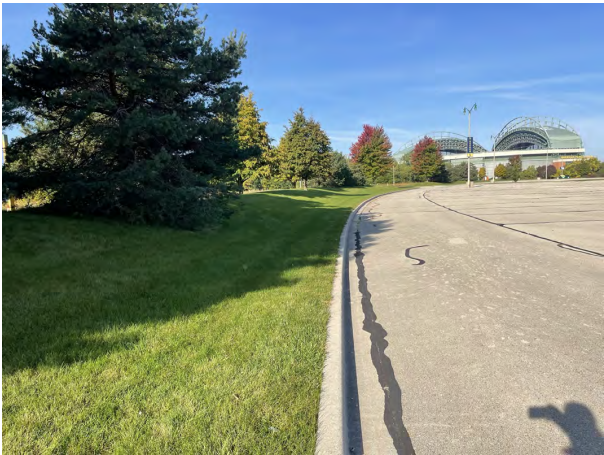
Photo 8: Uecker Lot: Asphalt cap over Uecker Lot (right side of photo): 4-inch asphalt pavement overlying 8-inches of crushed aggregate base course. Greenspace cap over parking lot median along Frederick Miller Way on south side of Uecker Lot: 12-inches of low-permeability non-impacted soil covered with 4-inches of vegetated topsoil. Concrete curb and gutter along median perimeter and edge of asphalt pavement.
Photo taken facing west-northwest on October 4, 2022.

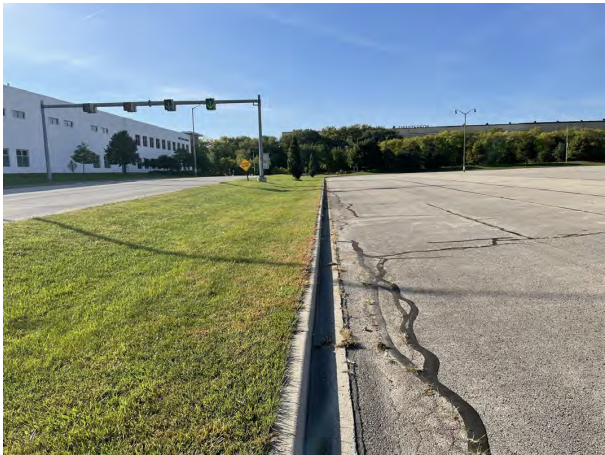
Photo 5: Uecker Lot: Asphalt cap over Uecker Lot (right side of photo): 4-inch asphalt pavement overlying 8-inches of crushed aggregate base course. Greenspace cap over parking lot median: 12-inches of low-permeability non-impacted soil covered with 4-inches of vegetated topsoil. Concrete curb and gutter along median perimeter and edge of asphalt pavement.
Photo taken facing south on October 4, 2022.

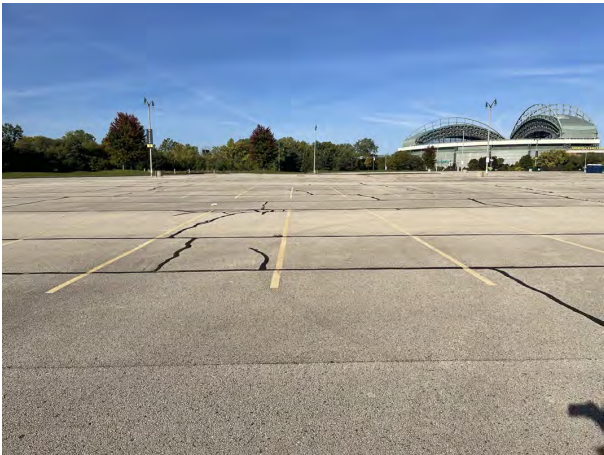
Photo 7: Uecker Lot: Asphalt cap over Uecker Lot: 4-inch asphalt pavement overlying 8-inches of crushed aggregate base course.
Photo taken facing west on October 4, 2022.

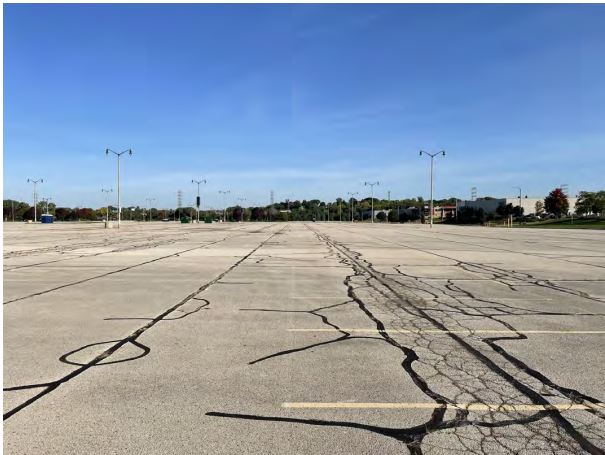
Photo 10: Uecker Lot: Asphalt cap over Uecker Lot: 4-inch asphalt pavement overlying 8-inches of crushed aggregate base course.
Photo taken facing north on October 4, 2022.

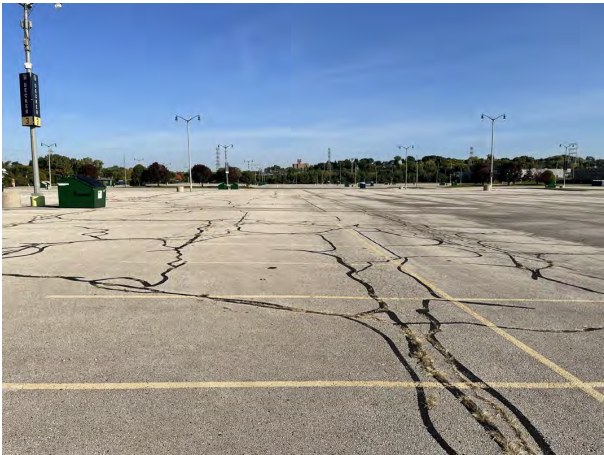
Photo 12: Uecker Lot: Asphalt cap over Uecker Lot: 4-inch asphalt pavement overlying 8-inches of crushed aggregate base course.
Photo taken facing north on October 4, 2022.

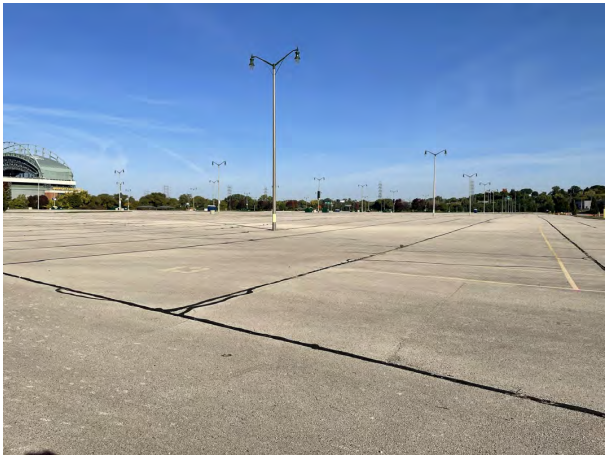
Photo 9: Uecker Lot: Asphalt cap over Uecker Lot: 4-inch asphalt pavement overlying 8-inches of crushed aggregate base course.
Photo taken facing northwest on October 4, 2022.

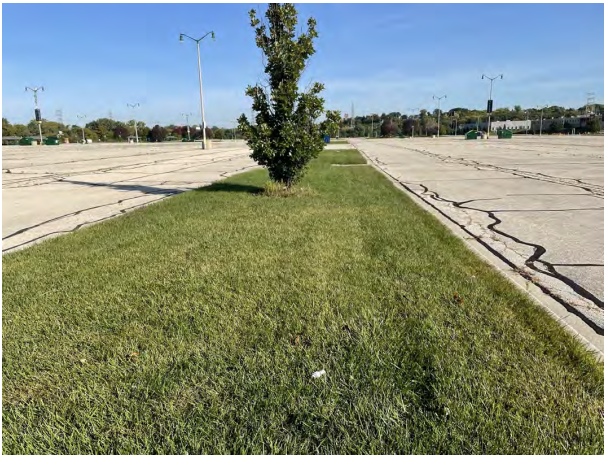
Photo 11: Uecker Lot: Greenspace cap over Uecker Lot island: 12-inches low permeability soil covered with 4-inches of vegetated topsoil.
Photo taken facing north on October 4, 2022.

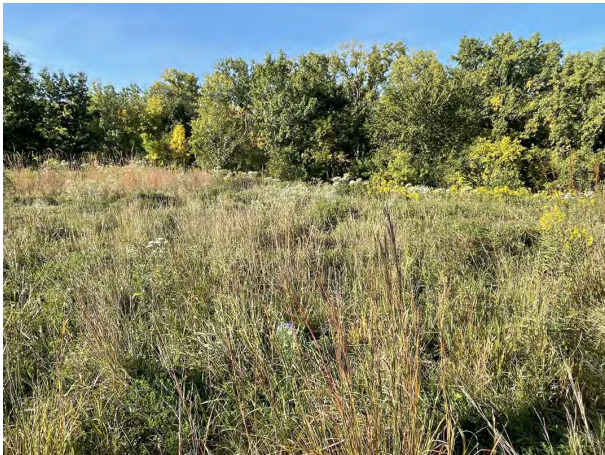
Photo 14: South of Uecker Lot: Greenspace cap and native plantings overgrowth south of Uecker Lot and Frederick Miller Way.
Photo taken facing south on October 4, 2022.

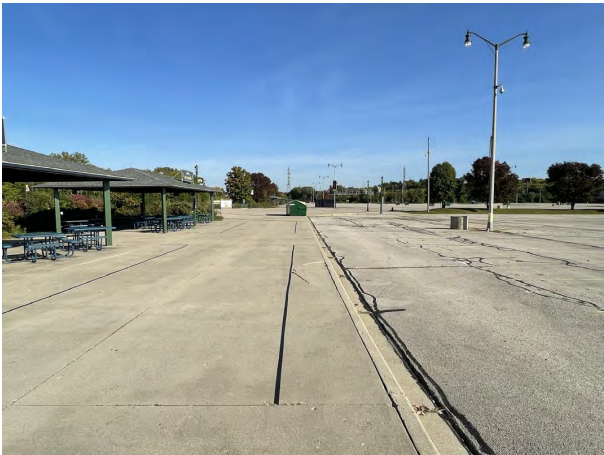
Photo 16: Uecker Lot: Concrete paved plaza and pedestrian path along west side of Uecker Lot (shown on left side of photo): 6-inch concrete pavement overlying 8-inches crushed aggregate. Asphalt paved Uecker Lot (shown on right side of photo): 4-inch asphalt pavement overlying 8-inches crushed aggregate.
Photo taken facing north on October 4, 2022.

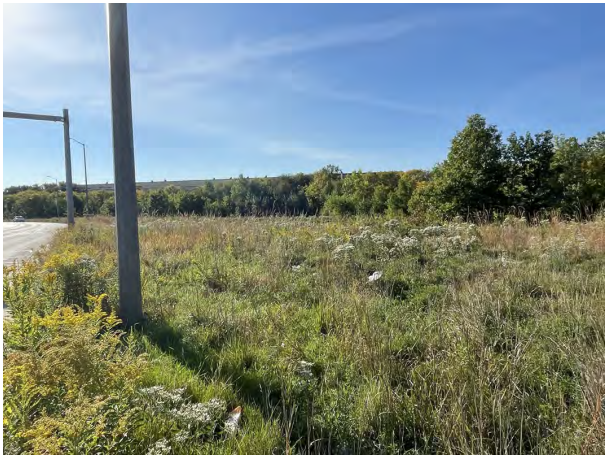
Photo 13: South of Uecker Lot: Greenspace cap and native plantings overgrowth south of Uecker Lot and Frederick Miller Way.
Photo taken facing southeast on October 4, 2022.

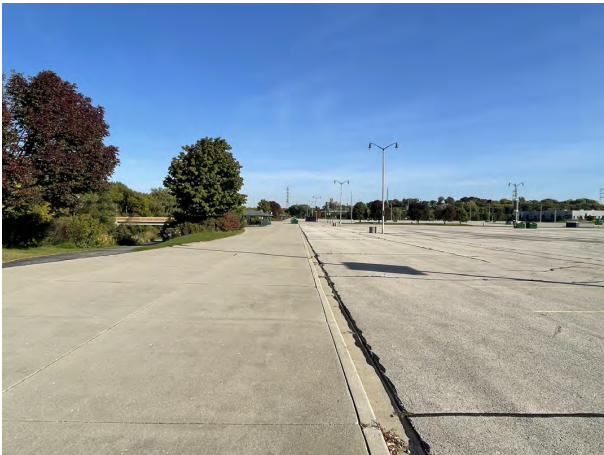
Photo 15: Uecker Lot: Concrete paved plaza and pedestrian path along west side of Uecker Lot (shown on left side of photo): 6-inch concrete pavement overlying 8-inches crushed aggregate. Asphalt paved Uecker Lot (shown on right side of photo): 4-inch asphalt pavement overlying 8-inches crushed aggregate.
Photo taken facing north on October 4, 2022.

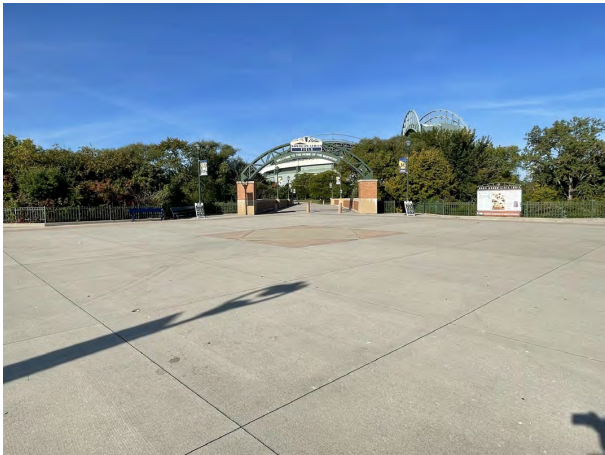
Photo 18: Uecker/Yount Lot: Concrete paved plaza and pedestrian path along west side of Uecker and Yount Lots: 6-inch concrete pavement overlying 8-inches crushed aggregate.
Photo taken facing west on October 4, 2022.

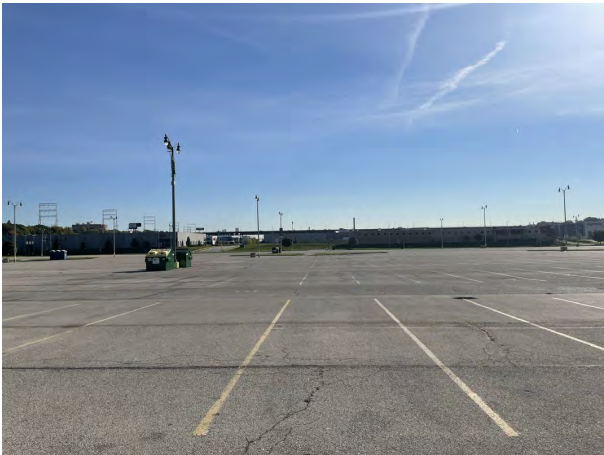
Photo 20: Yount Lot: Asphalt cap over Yount Lot: 4-inch asphalt pavement overlying 8-inches of crushed aggregate base course.
Photo taken facing east on October 4, 2022.

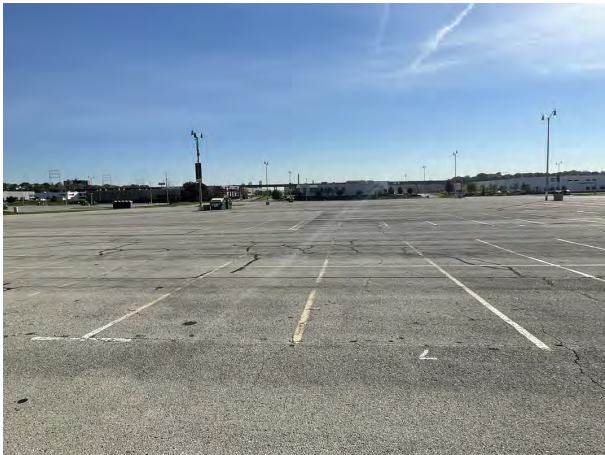
Photo 17: Uecker Lot: Asphalt cap over Uecker Lot: 4-inch asphalt pavement overlying 8-inches of crushed aggregate base course.
Photo taken facing east on October 4, 2022.

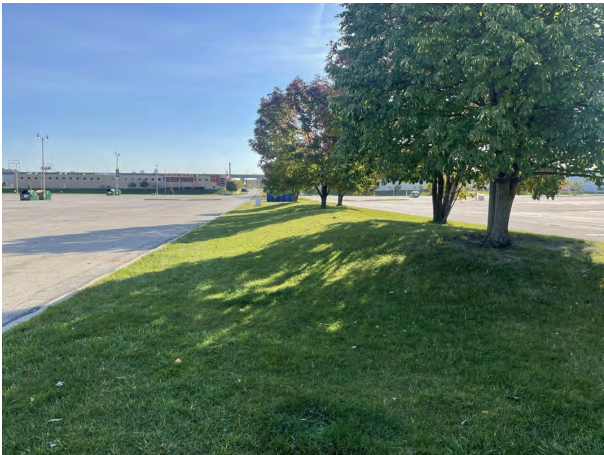
Photo 19: Uecker/Yount Lot: Greenspace cap parking lot island/median between Yount and Uecker Lots on west side of site: 12-inches of low permeability non-impacted soil covered with 4-inches of vegetated topsoil (grass) as well as various landscape plantings.
Photo taken facing east on October 4, 2022.

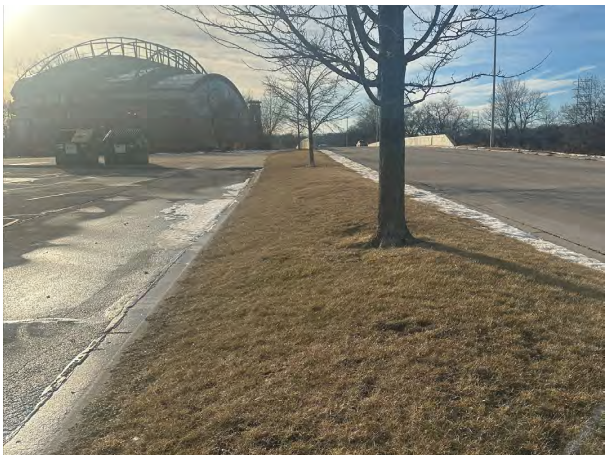
Photo 22: Yount Lot: Greenspace cap over parking lot median on north side of Yount Lot, along the south side of Selig Drive. Photo taken facing west on February 8, 2022.

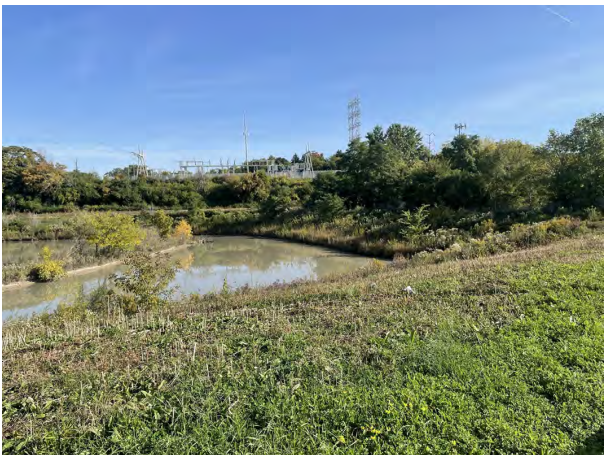
Photo 24: Yount Lot: Storm water pond with clay liner and geomembrane liner, north of Yount Lot and Selig Drive. Landscaping around the pond consists of vegetated topsoil with native plantings. Photo taken facing north on October 4, 2022.

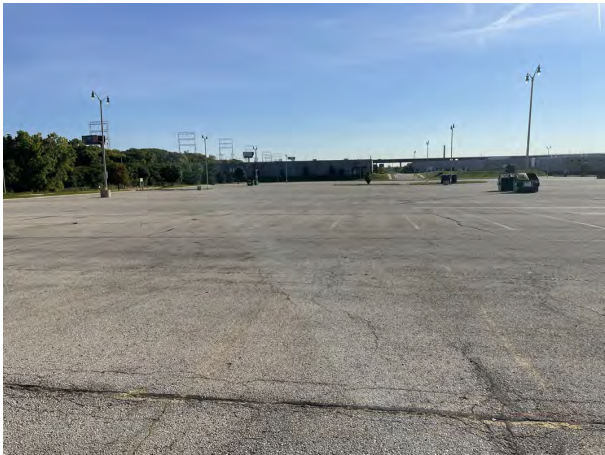
Photo 21: Yount Lot: Asphalt cap over Yount Lot: 4-inch asphalt pavement overlying 8-inches of crushed aggregate base course. Photo taken facing east on October 4, 2022.

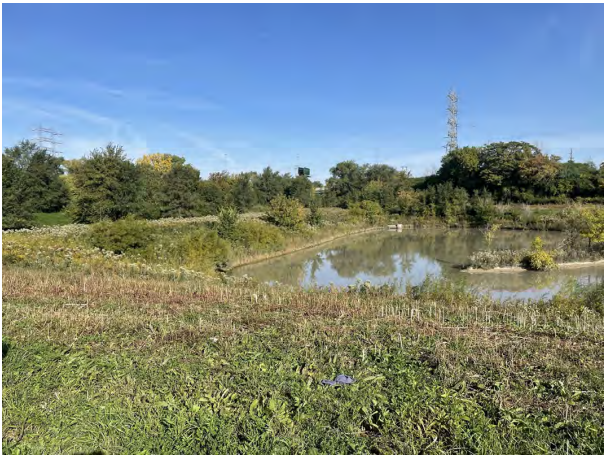
Photo 23: Yount Lot: Storm water pond with clay liner and geomembrane liner, north of Yount Lot and Selig Drive. Landscaping around the pond consists of vegetated topsoil with native plantings. Photo taken facing north on October 4, 2022.

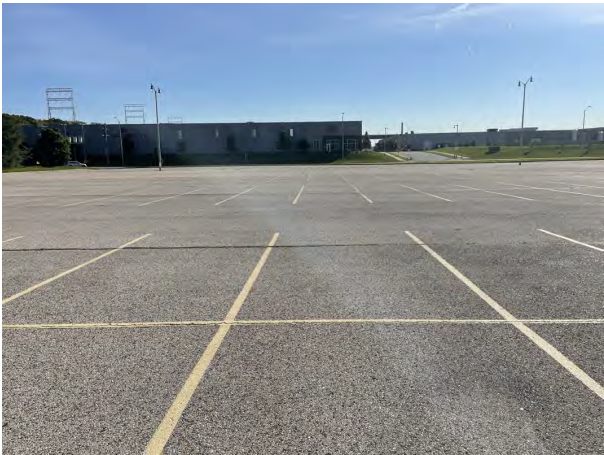
Photo 26: Yount Lot: Asphalt cap over Yount Lot: 4-inch asphalt pavement overlying 8-inches of crushed aggregate base course.
Photo taken facing east on October 4, 2022.

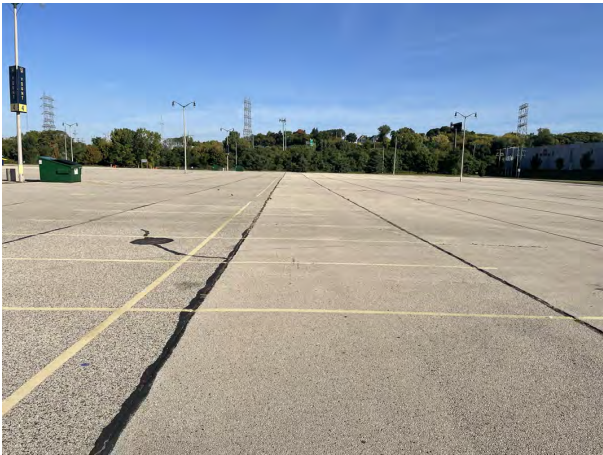
Photo 28: Yount Lot: Asphalt cap over Yount Lot: 4-inch asphalt pavement overlying 8-inches of crushed aggregate base course.
Photo taken facing north on October 4, 2022.

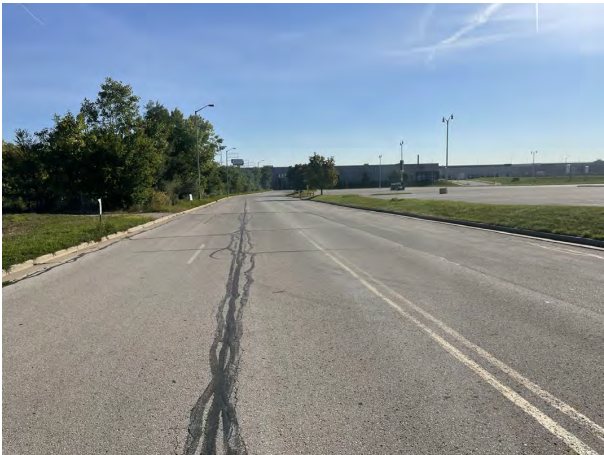
Photo 25: Yount Lot: Asphalt cap over Selig Drive north of Yount Lot: 4-inch asphalt pavement overlying 8-inches of crushed aggregate base course.
Photo taken facing east on October 4, 2022.

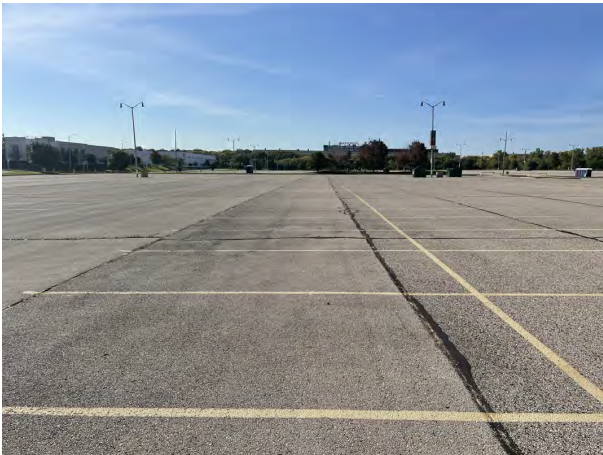
Photo 27: Yount Lot: Asphalt cap over Yount Lot: 4-inch asphalt pavement overlying 8-inches of crushed aggregate base course.
Photo taken facing south on October 4, 2022.
