**CAP MAINTENANCE PLAN**  
**SOUTHEAST WISCONSIN PROFESSIONAL BASEBALL PARK DISTRICT – RIVER WEST**

**FEBRUARY 2023**

**SITE PLAN MAP**  
SOUTHEAST WISCONSIN PROFESSIONAL BASEBALL PARK DISTRICT  
RIVER WEST PARCEL - BRRTS #02-41-001185  
110 S 44TH STREET, 201 & 301 S 46TH STREET  
MILWAUKEE, WISCONSIN

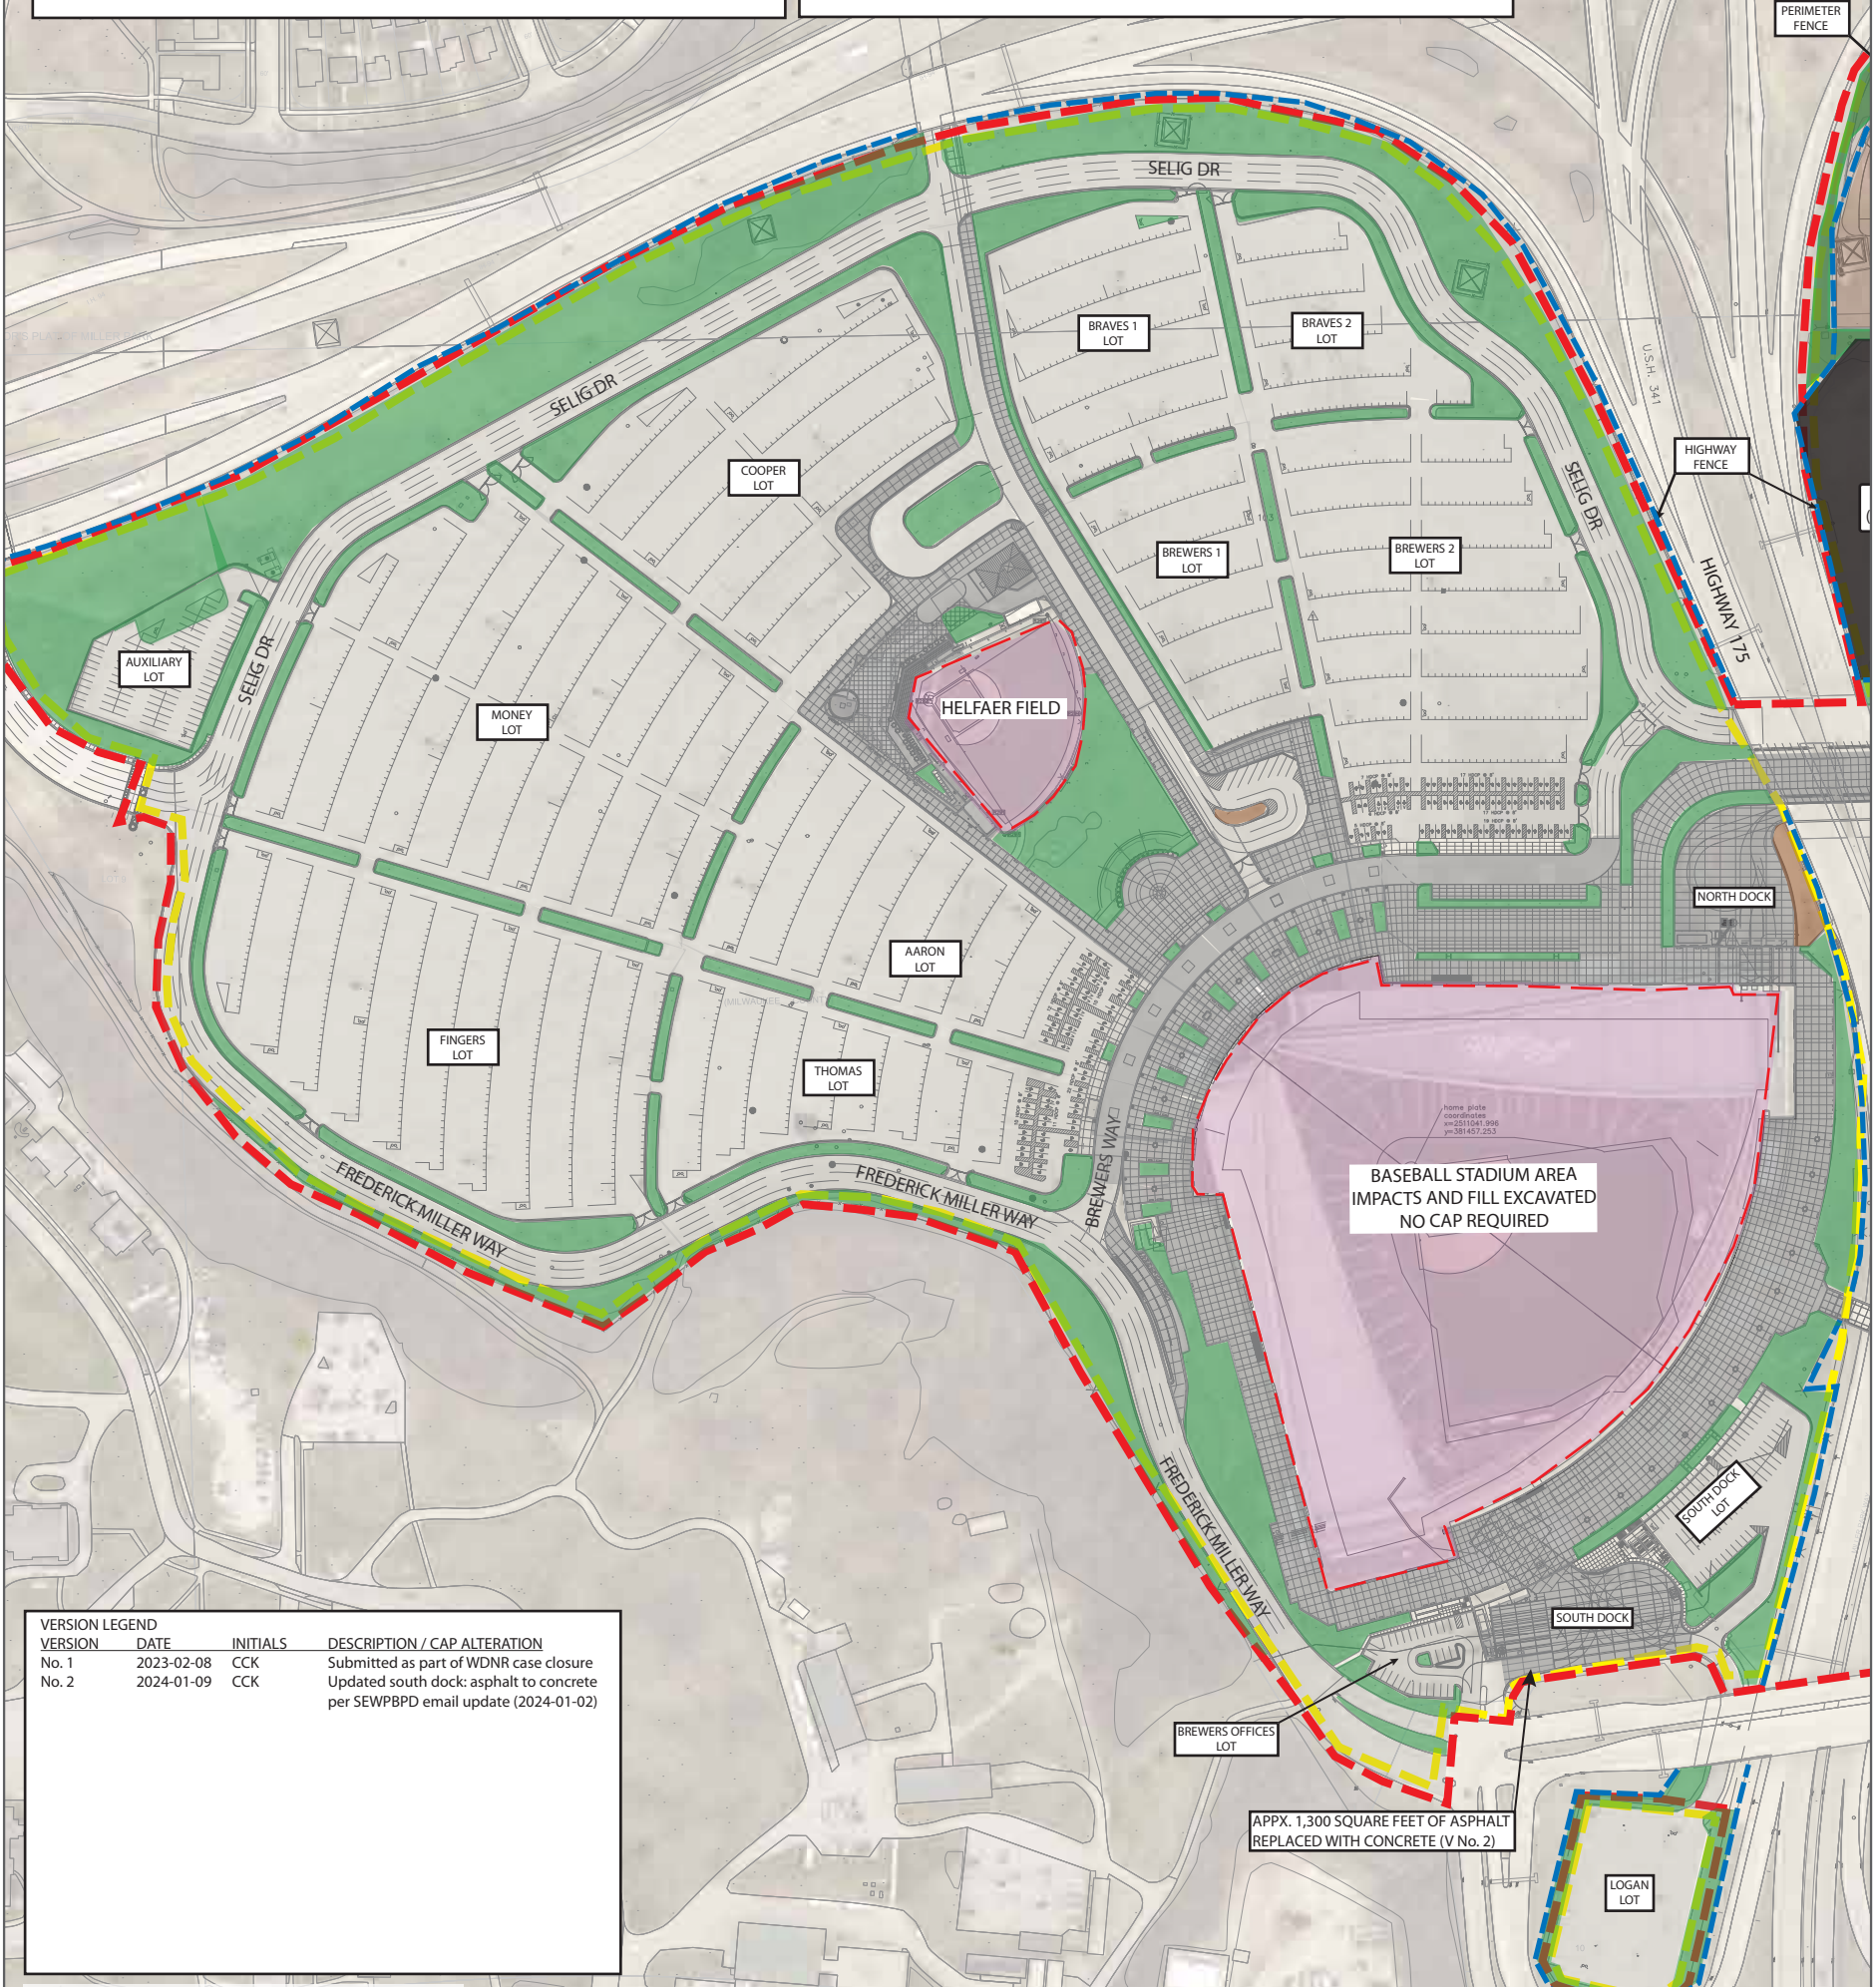
**2.3**

COVER TYPE	DESCRIPTION (PER 1996 FINAL REMEDIATION PLAN)
ASPHALT PAVEMENT	4-INCH ASPHALT PAVEMENT OVER 8-INCH CRUSHED AGGREGATE
CONCRETE PAVEMENT	6-INCH CONCRETE PAVEMENT OVER 8-INCH CRUSHED AGGREGATE 8-INCH CONCRETE PAVEMENT IN LOADING DOCK AREAS
GREENSPACE CAP	MINIMUM 12-INCH LOW-PERMEABILITY NON-IMPACTED SOIL CAP COVERED WITH 4-INCH THICK TOPSOIL (LANDSCAPE PLANTINGS VARY)
STORM WATER PONDS	LINED WITH IMPERMEABLE GEOMEMBRANE OR CONCRETE (NOT FOR PUBLIC USE)
RIVER BANKS	NATIVE PLANTINGS (NOT FOR PUBLIC USE)
EXCLUSIONS	DESCRIPTION
BASEBALL STADIUM	IMPACTED SOIL AND FILL REMOVED DURING CONSTRUCTION
HELFAER FIELD	IMPACTED SOIL AND FILL REMOVED DURING CONSTRUCTION
HIGHWAY 175	STATE HIGHWAY - NOT PART OF SITE

**CAP LOCATION MAP  
(WEST OF HIGHWAY)**

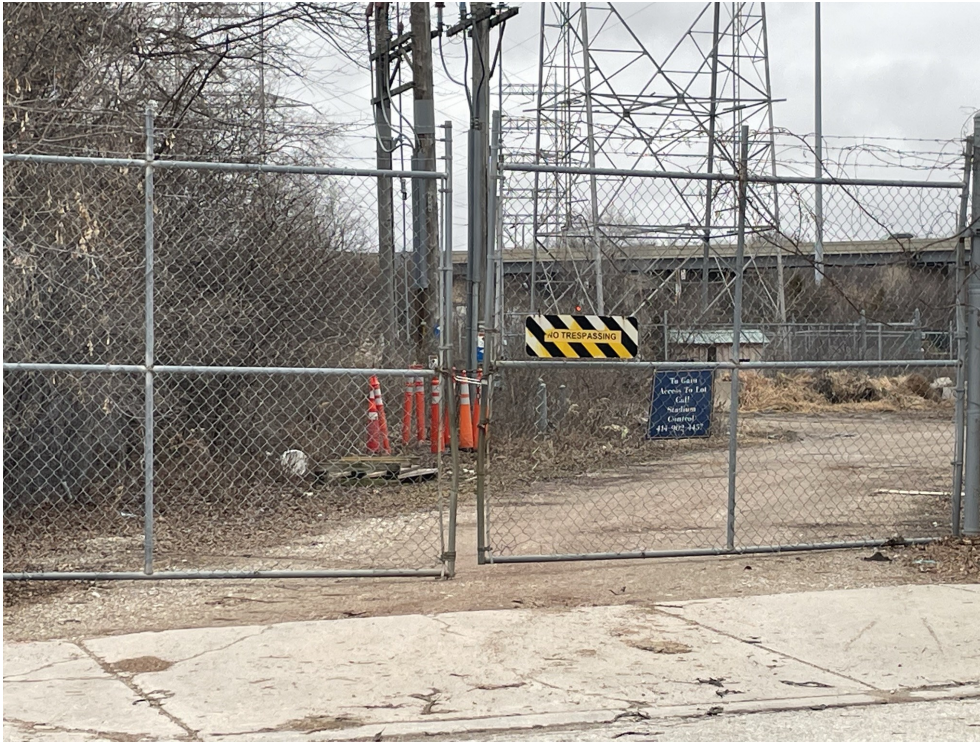
Photo 1: Storage Yard lot: Locked gate entry, public access prohibited. Concrete apron driveway cap and gravel cap along entrance road. Photo taken facing west on January 18, 2023.

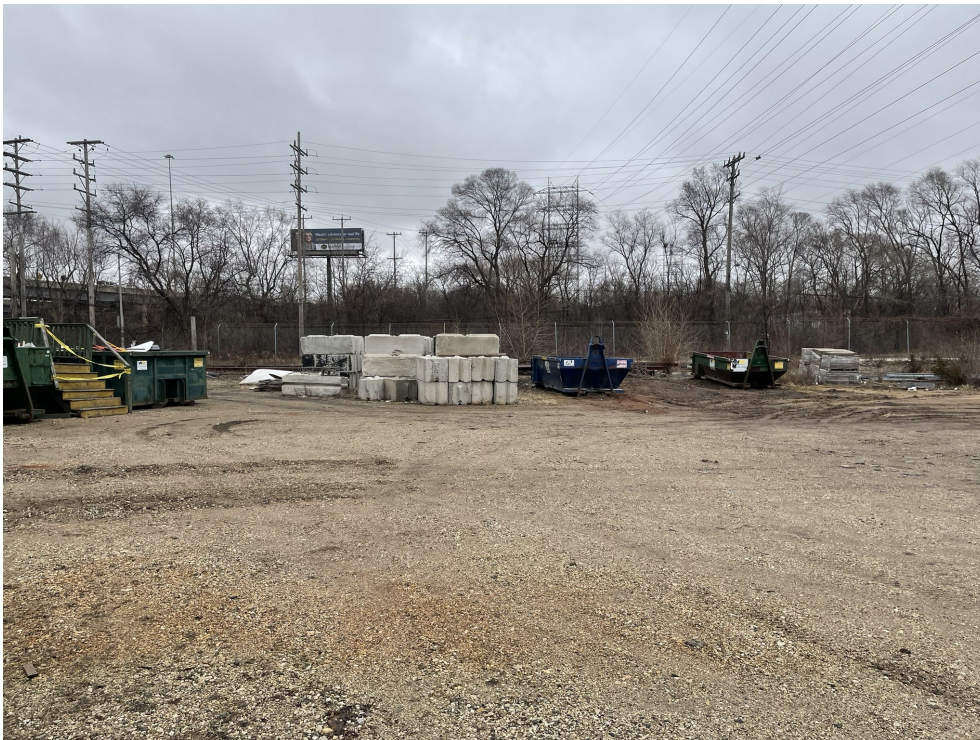
Photo 2: Storage Yard lot: Gravel cap along entrance road consisting of approximately 6-inches of gravel cap over broken asphalt pavement and subgrade. Photo taken facing east on January 18, 2023.

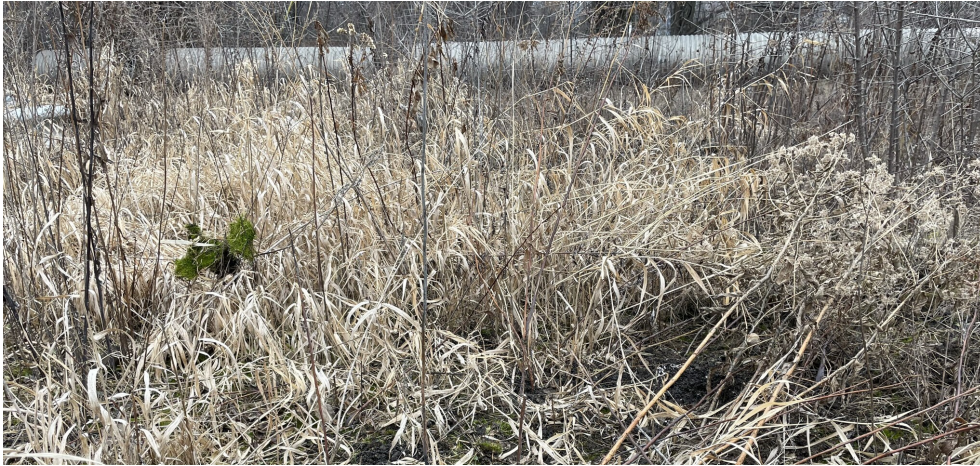
Photo 3: Storage Yard lot: Vegetated topsoil cap on east side of yard beneath and around the electric power line tower. Approximately 4-inches of vegetated topsoil over subgrade. Photo taken facing east on January 18, 2023.

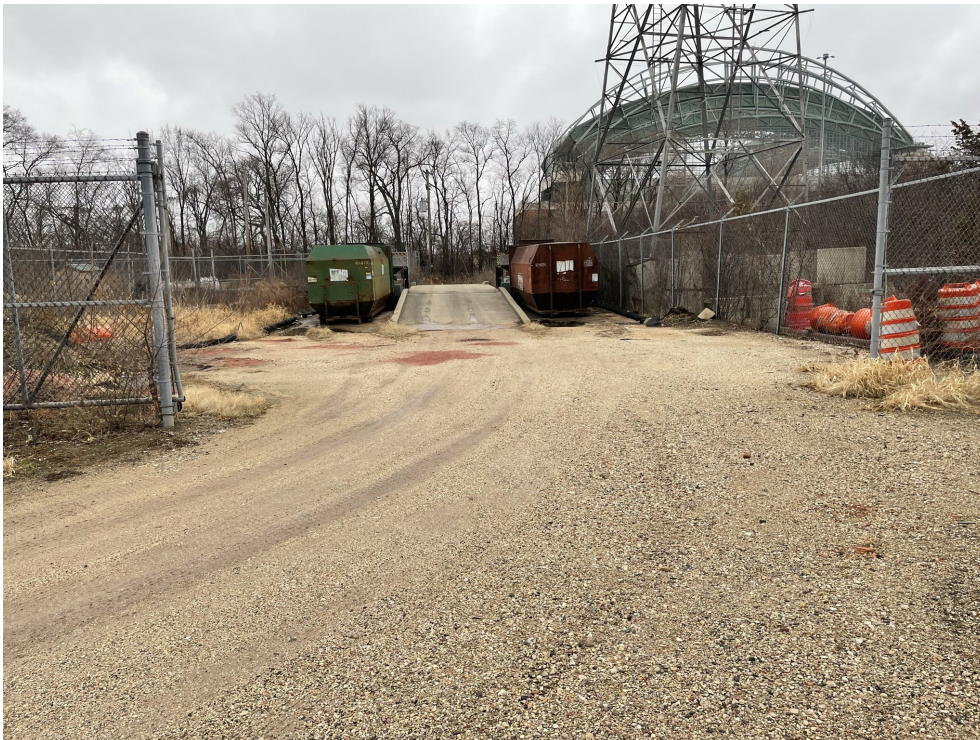
Photo 4: Storage Yard lot: Gravel cap consisting of approximately 6-inches of gravel over broken asphalt pavement and subgrade. Concrete drive pad for disposal vehicles shown in center of photo. Photo taken facing south on January 18, 2023.

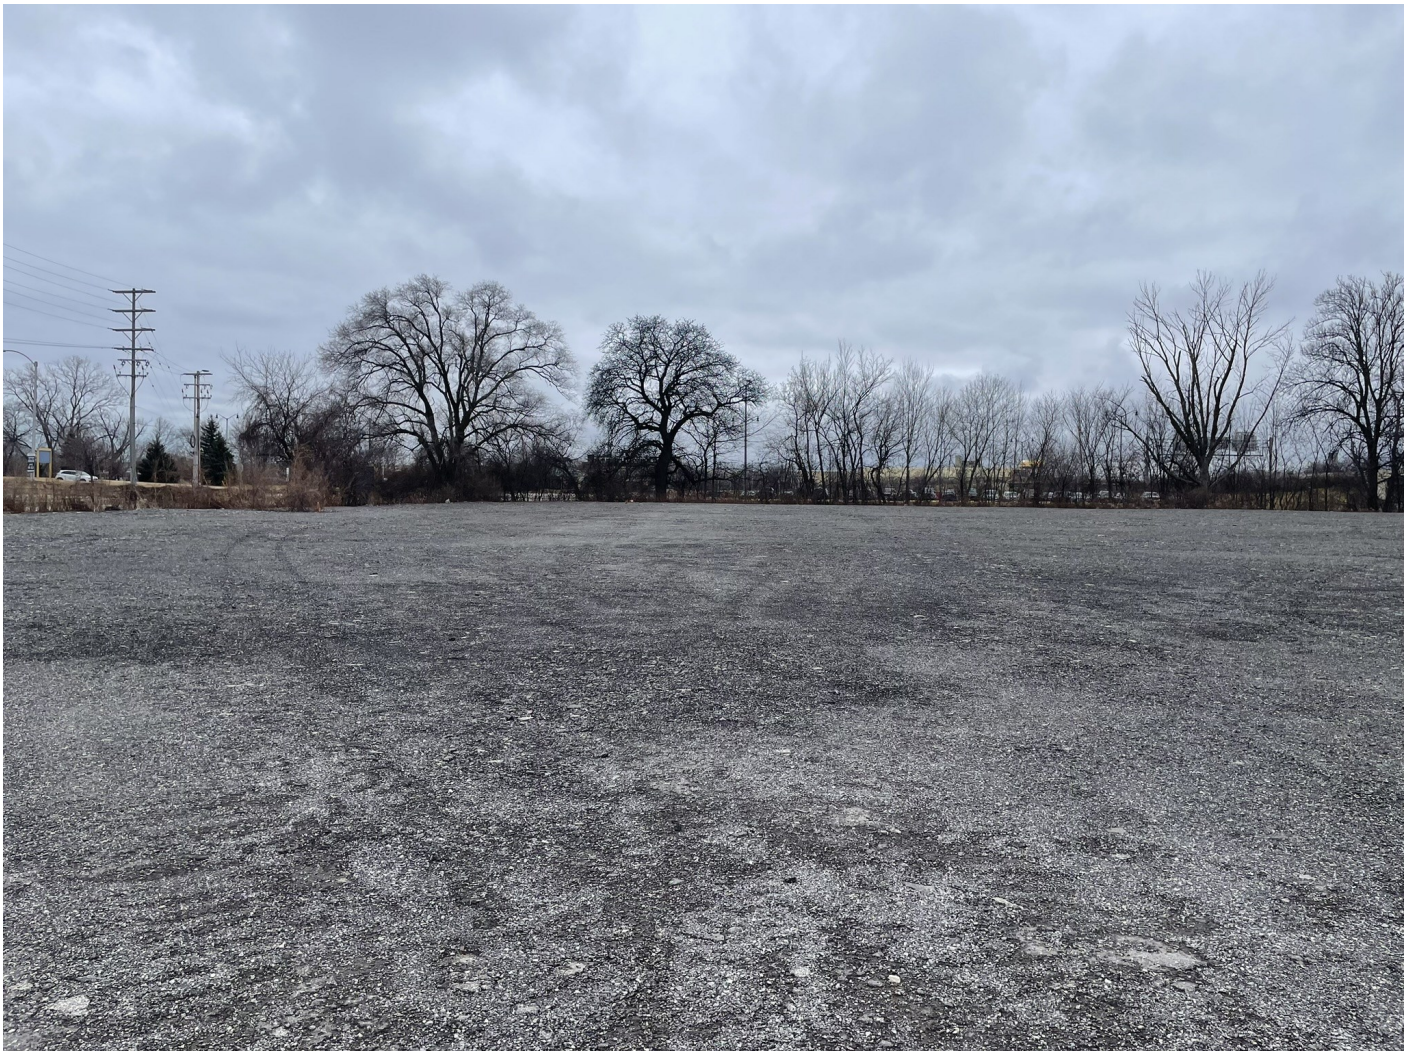
Photo 5: Staff Lot: Compacted milled asphalt cap across the Staff Lot. Between 6 and 12 inches thick.  
Photo taken facing south on January 18, 2023.

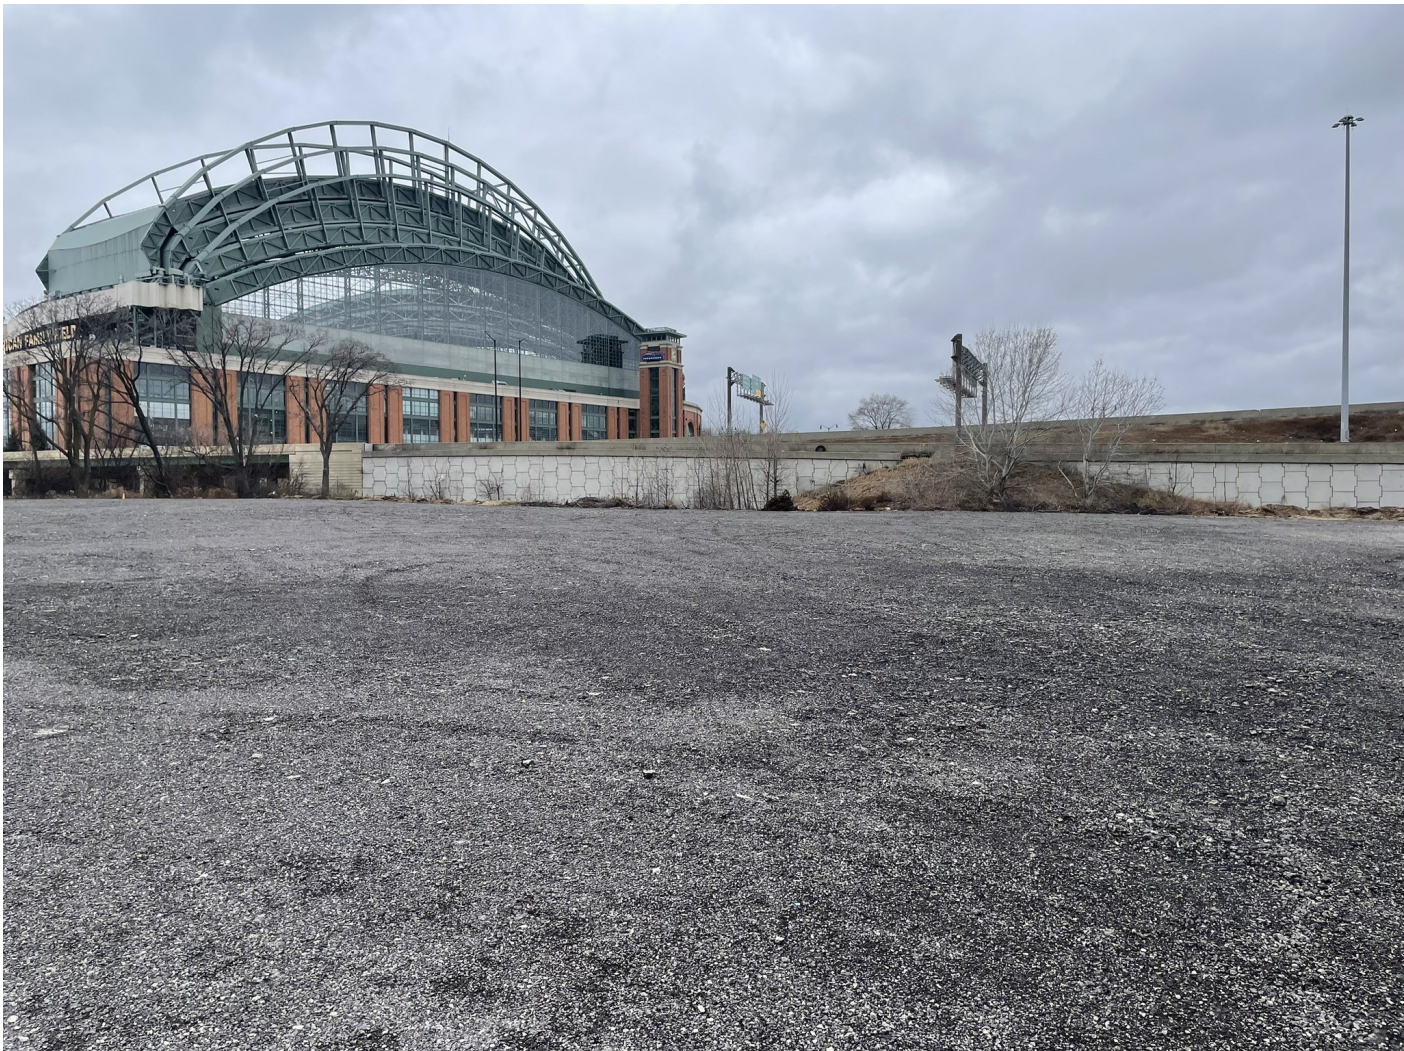
Photo 6: Staff Lot: Compacted milled asphalt cap across the Staff Lot. Between 6 and 12 inches thick.  
Photo taken facing southwest on January 18, 2023.

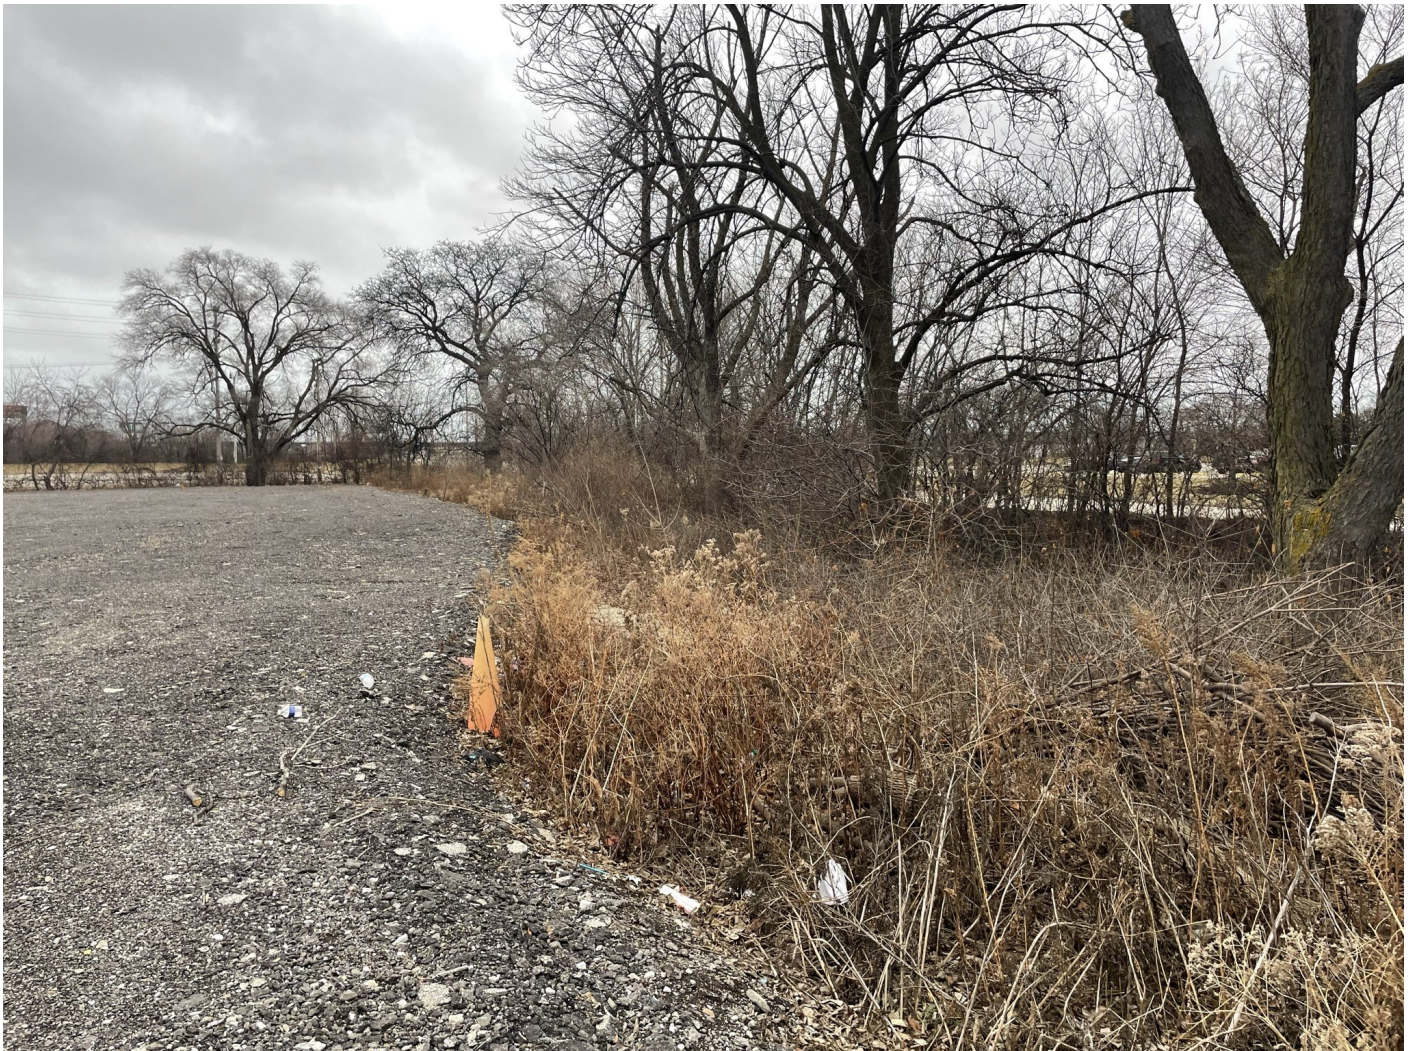
Photo 7: Staff Lot: Compacted milled asphalt cap across the Staff Lot. Between 6 and 12 inches thick. Overgrown vegetation and topsoil along perimeter, within perimeter fence. Photo taken facing east on January 18, 2023.

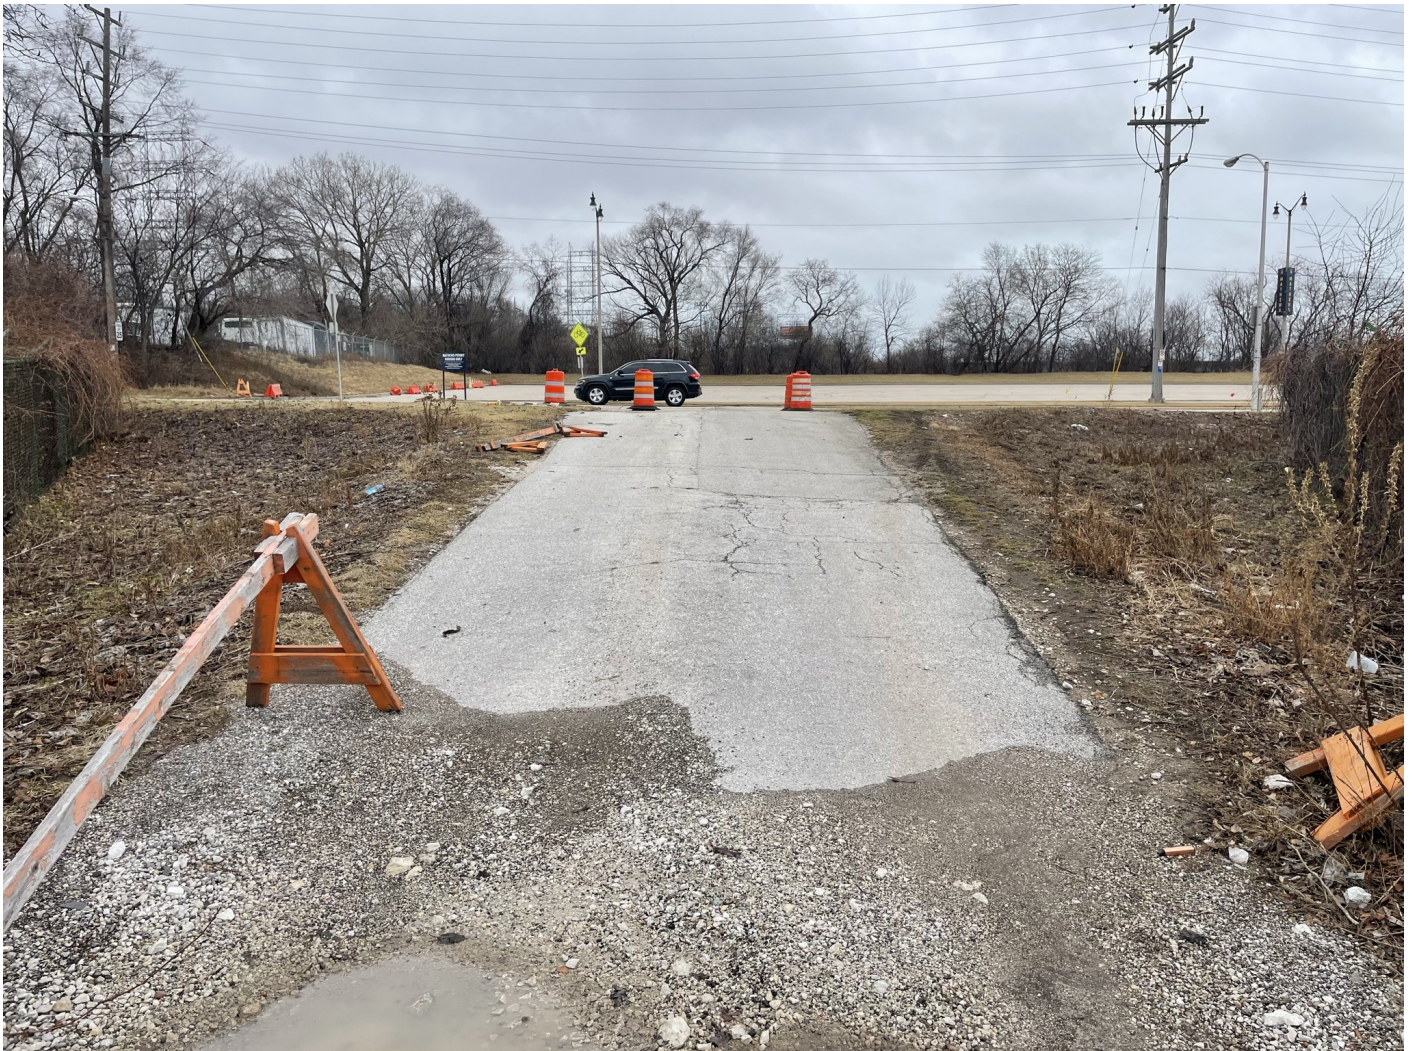
Photo 8: Staff Lot: Entrance driveway to the Staff Lot paved with asphalt (cap). Adjacent greenspace cap on each side of driveway.  
Photo taken facing east on January 18, 2023.

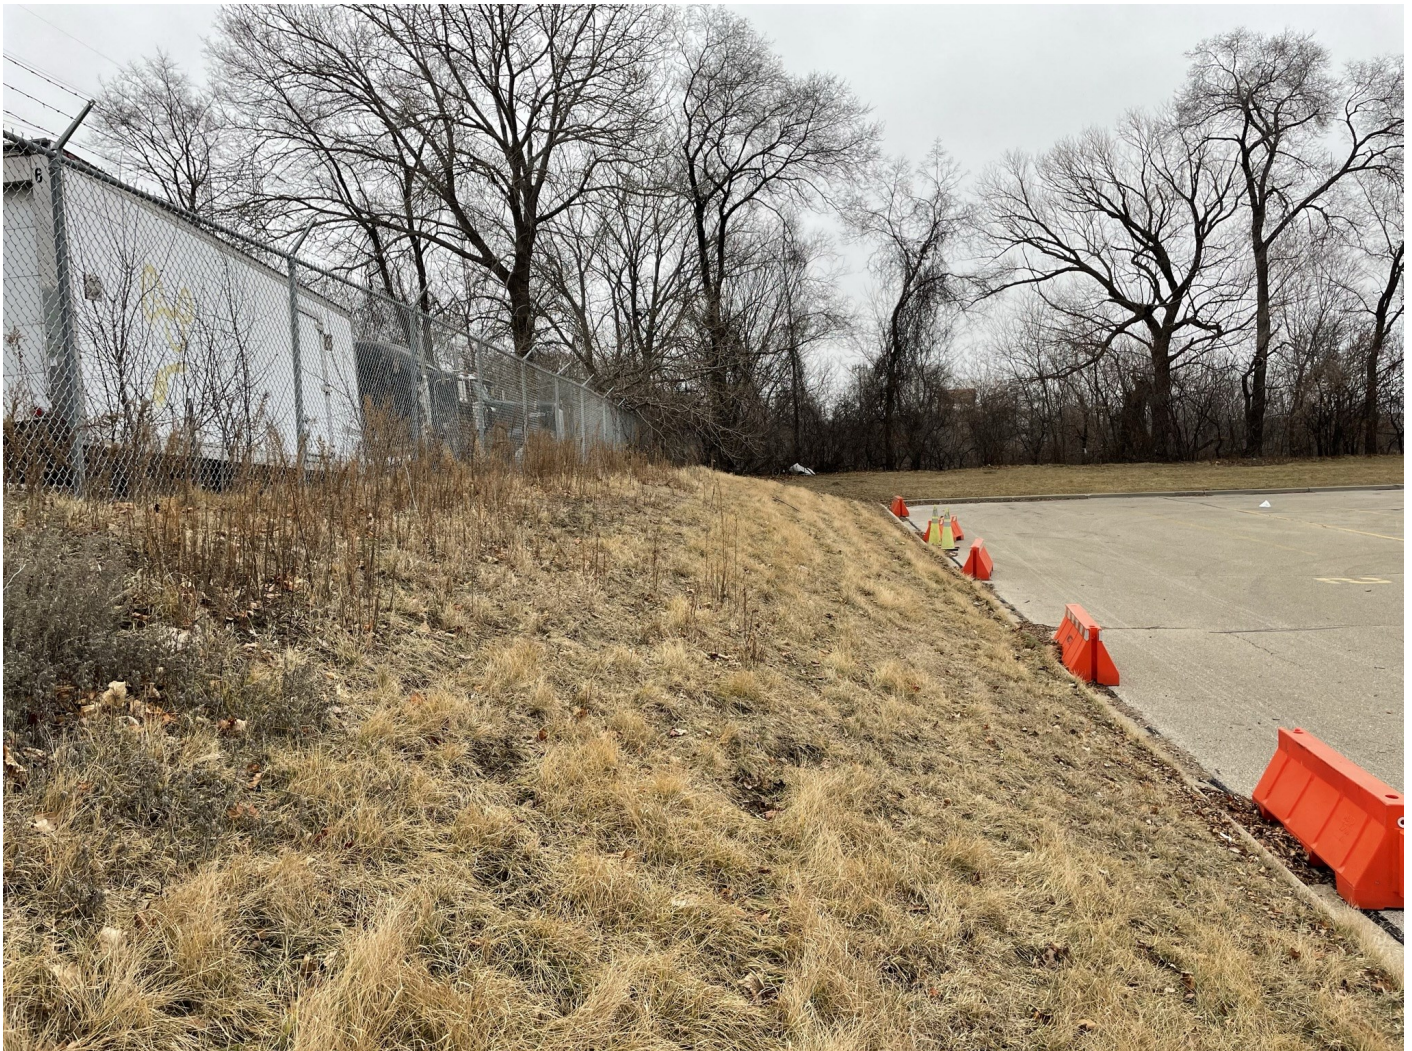
Photo 9: Matthews Lot: Greenspace cap along northern edge of Matthews Lot. 12-inch low-permeability non-impacted soil cap covered with vegetated topsoil.  
Photo taken facing east on January 18, 2023.

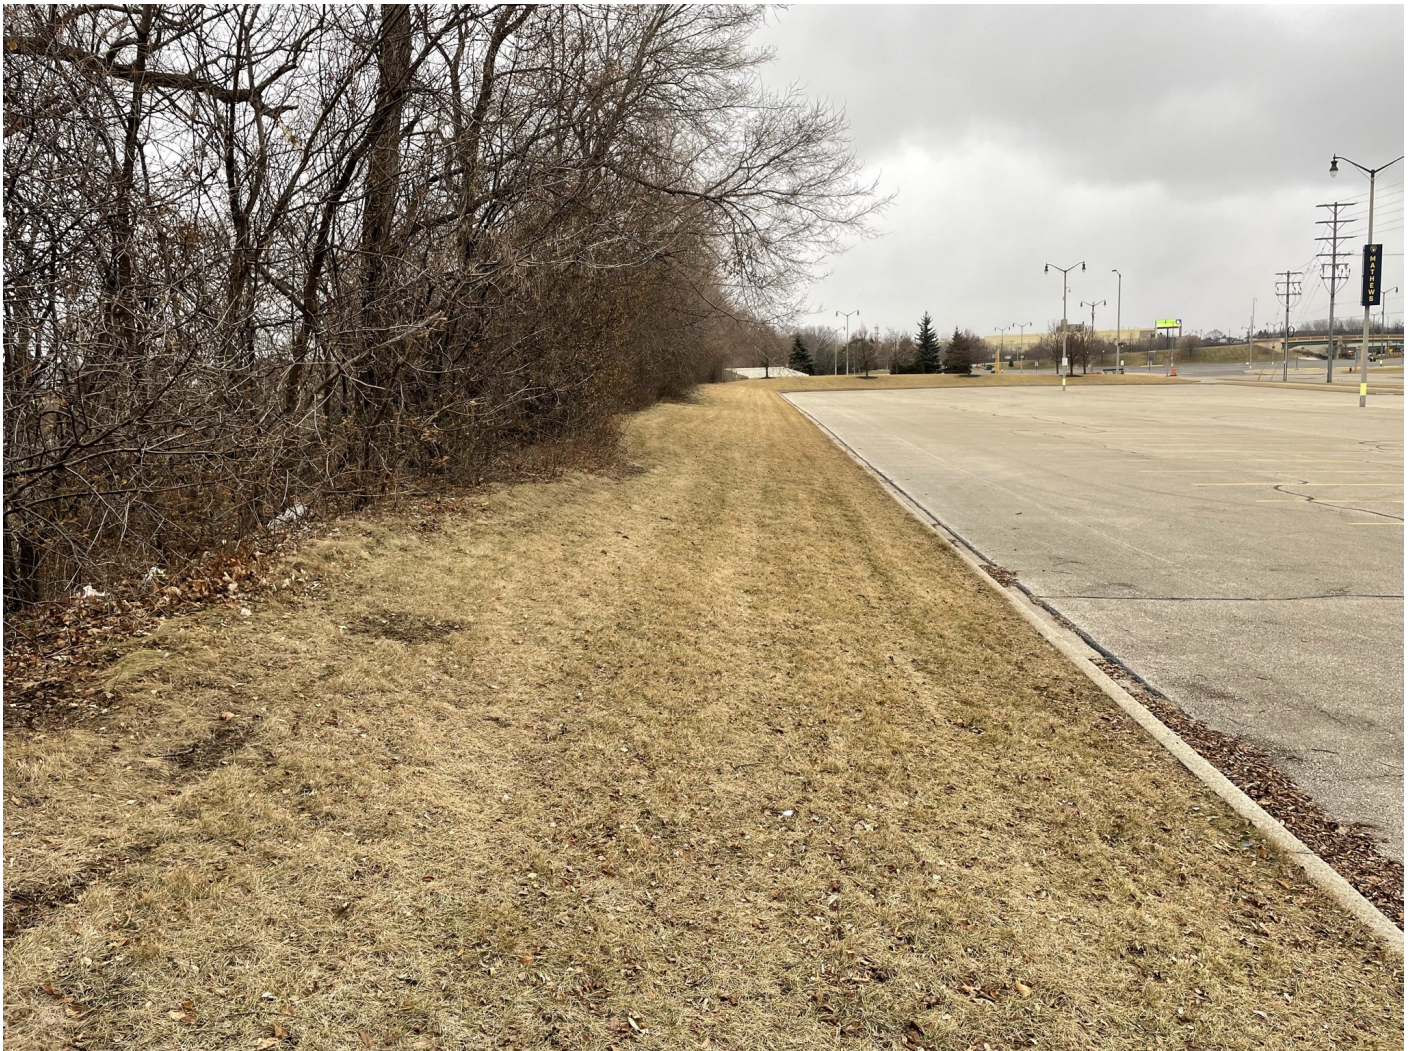
Photo 10: Matthews Lot: Greenspace cap along eastern edge of Matthews Lot, representative of greenspace across the River West site. 12-inch low-permeability non-impacted soil cap covered with vegetated topsoil. Trees and overgrowth shown on left side of photo, which represents the surface cover conditions along the Menomonee River banks on-site. Photo taken facing south on January 18, 2023.

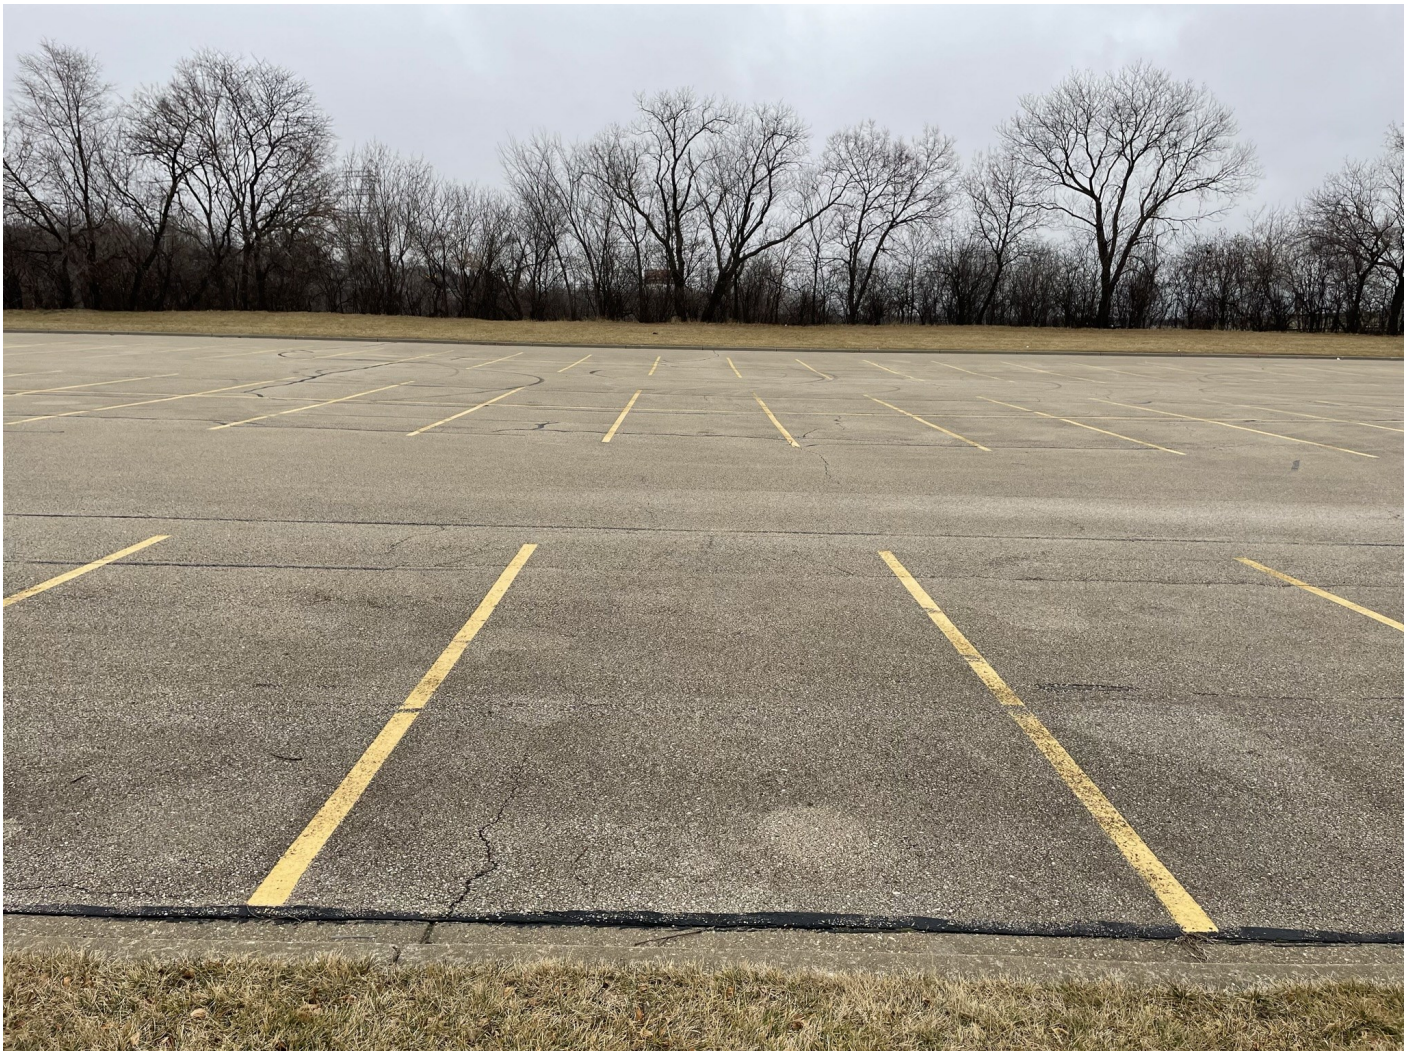
Photo 11: Matthews Lot: Asphalt cap across the entire Matthews Lot parking space, representative of asphalt parking lot caps across the River West site. 4-inch asphalt pavement over 8-inches of crushed aggregate (base course). Photo taken facing east on January 18, 2023.

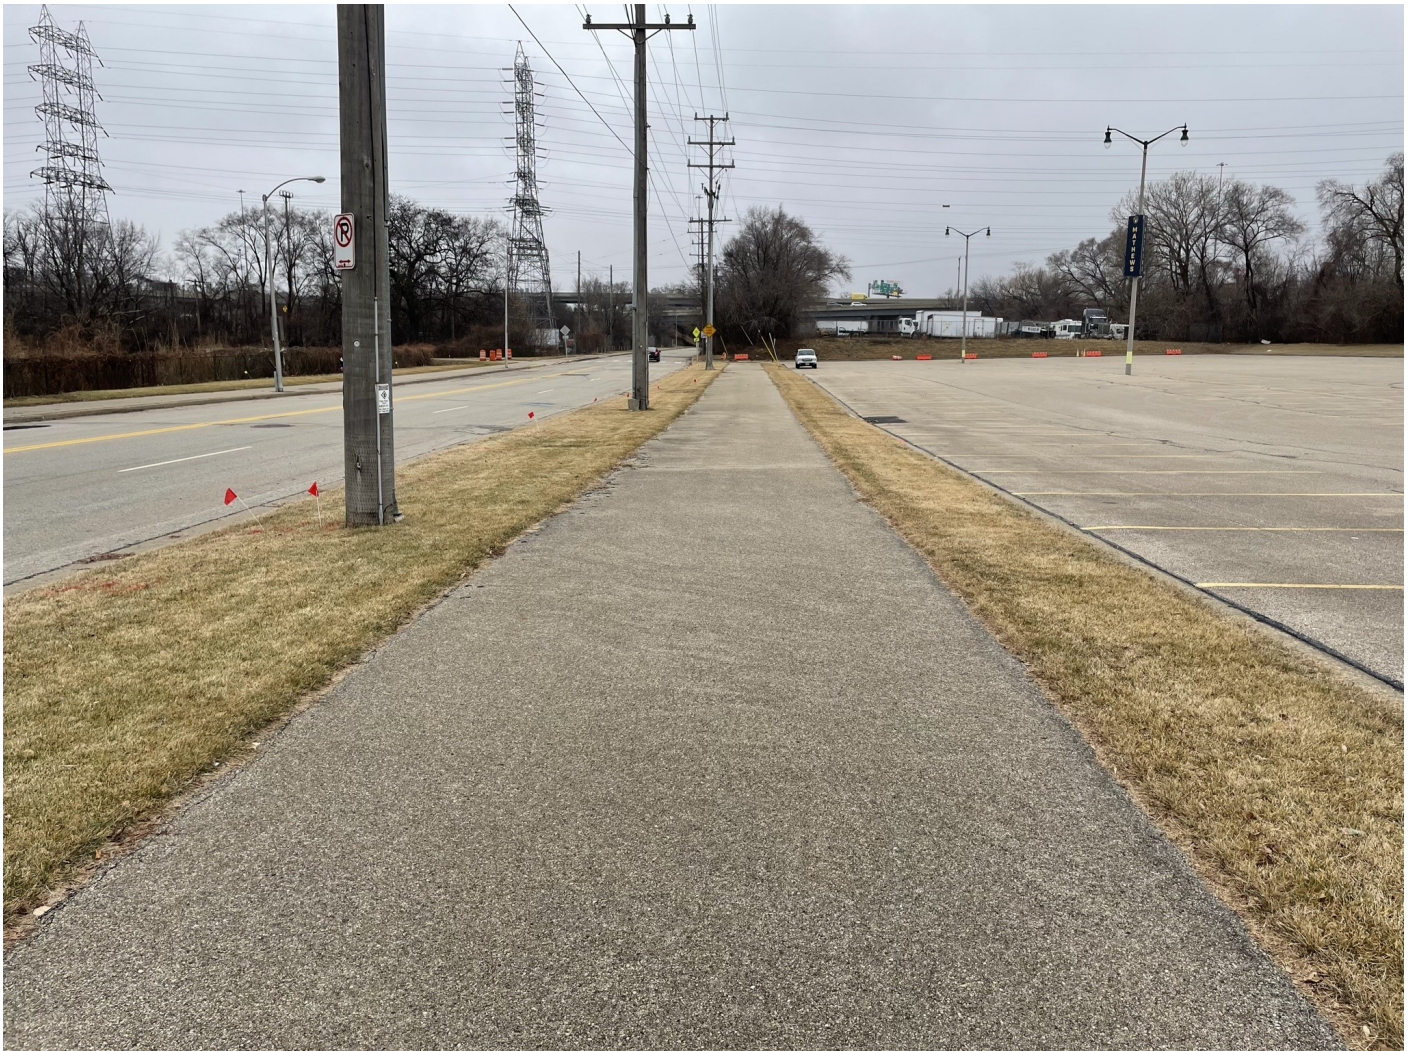
Photo 12: Matthews Lot: Asphalt cap across the pedestrian path along the western edge of Matthews Lot, representative of asphalt pedestrian path caps across the River West site. 4-inch asphalt pavement over 8-inches of crushed aggregate (base course). Photo taken facing north on January 18, 2023.

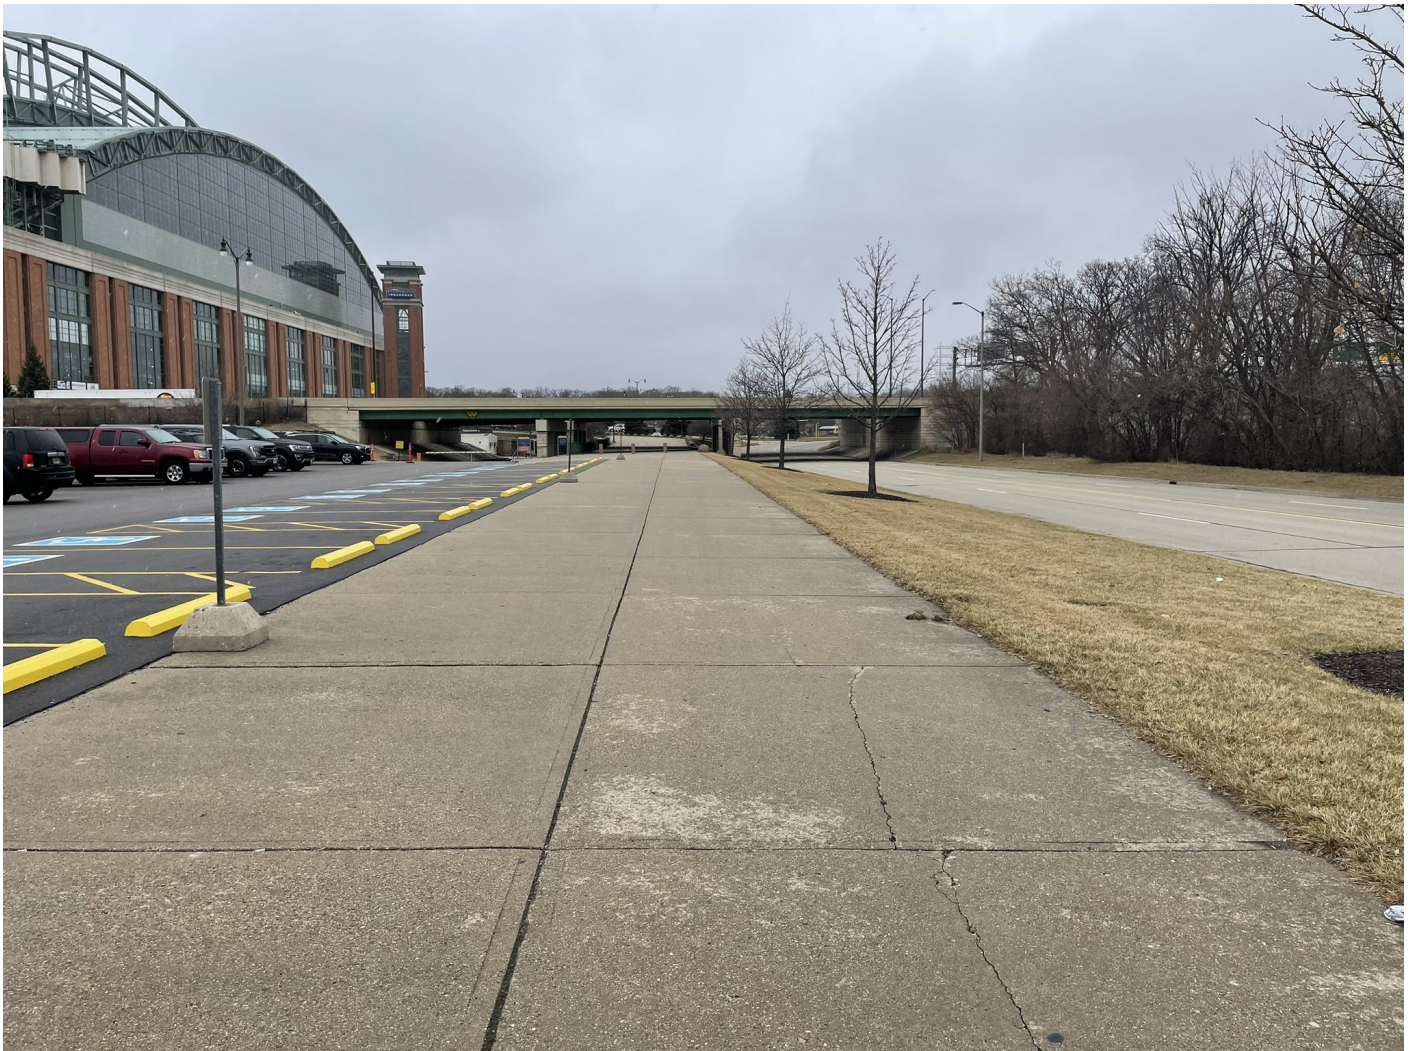
Photo 13: American Family Lot: Concrete pedestrian path cap along northern edge of the lot. 6-inches of concrete pavement over 8-inches of crushed aggregate. Asphalt parking lot cap shown on left side of photo. Greenspace cap shown on right side of photo. Selig Drive on far right side of photo, asphalt pavement cap same construction as asphalt parking lot space. Photo taken facing west on January 18, 2023.

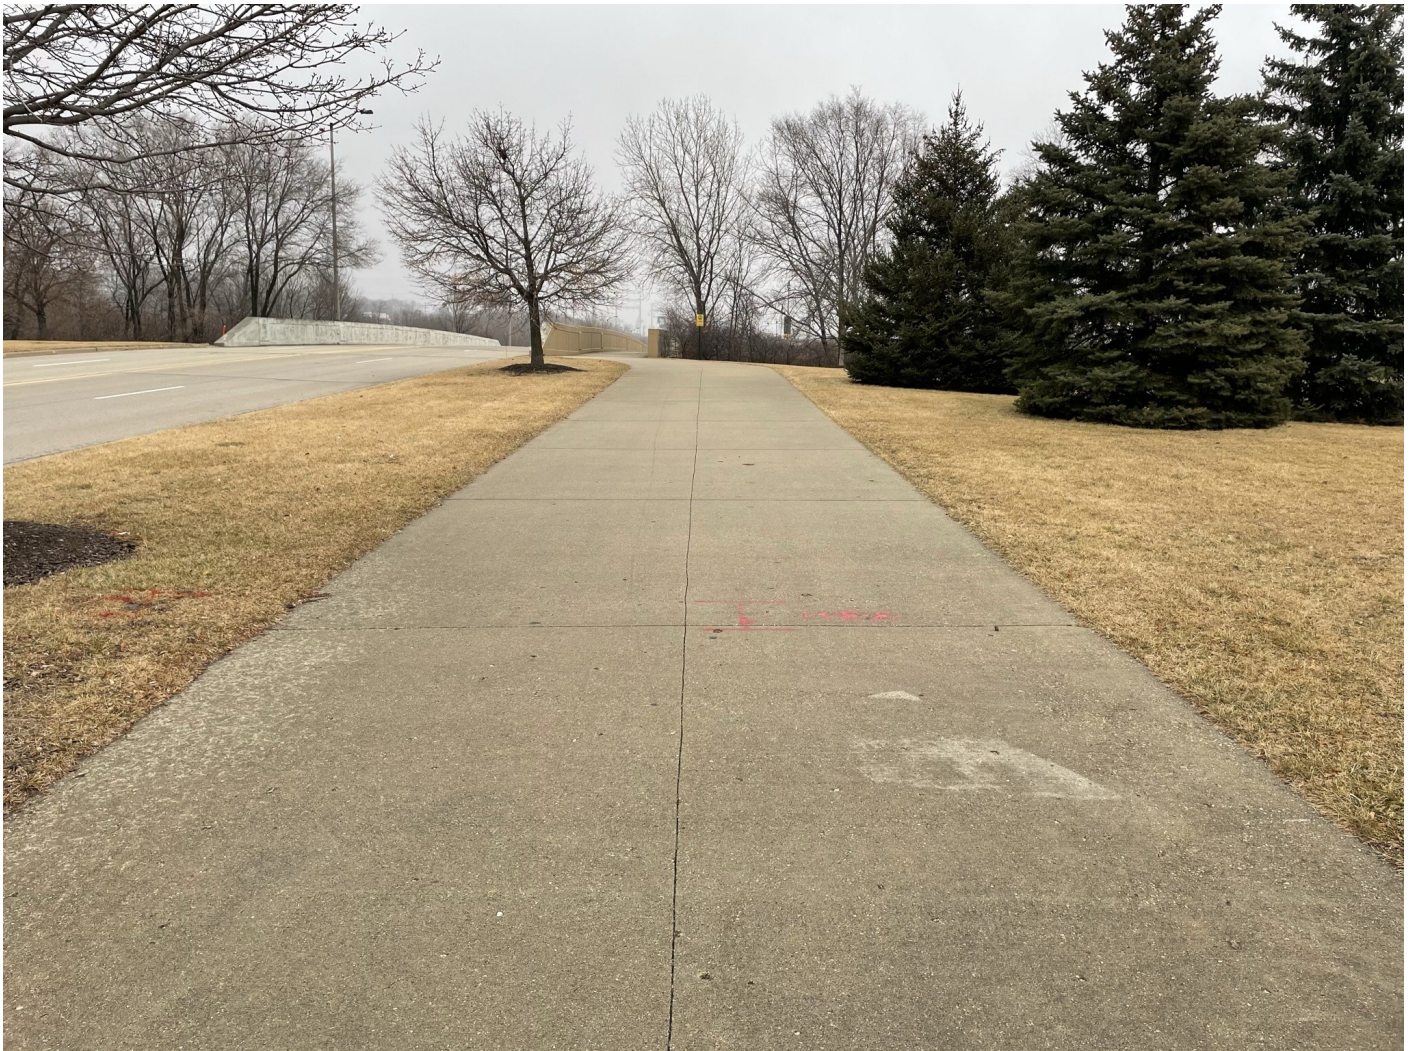
Photo 14: American Family Lot: Concrete pedestrian path cap along northern edge of the lot. 6-inches of concrete pavement over 8-inches of crushed aggregate. Greenspace cap shown on left and right side of photo. Photo taken facing east on January 18, 2023.
