**CAP MAINTENANCE PLAN**  
**SOUTHEAST WISCONSIN PROFESSIONAL BASEBALL PARK DISTRICT – RIVER WEST**

**FEBRUARY 2023**

**SITE PLAN MAP**  
SOUTHEAST WISCONSIN PROFESSIONAL BASEBALL PARK DISTRICT  
RIVER WEST PARCEL - BRRTS #02-41-001185  
110 S 44TH STREET, 201 & 301 S 46TH STREET  
MILWAUKEE, WISCONSIN

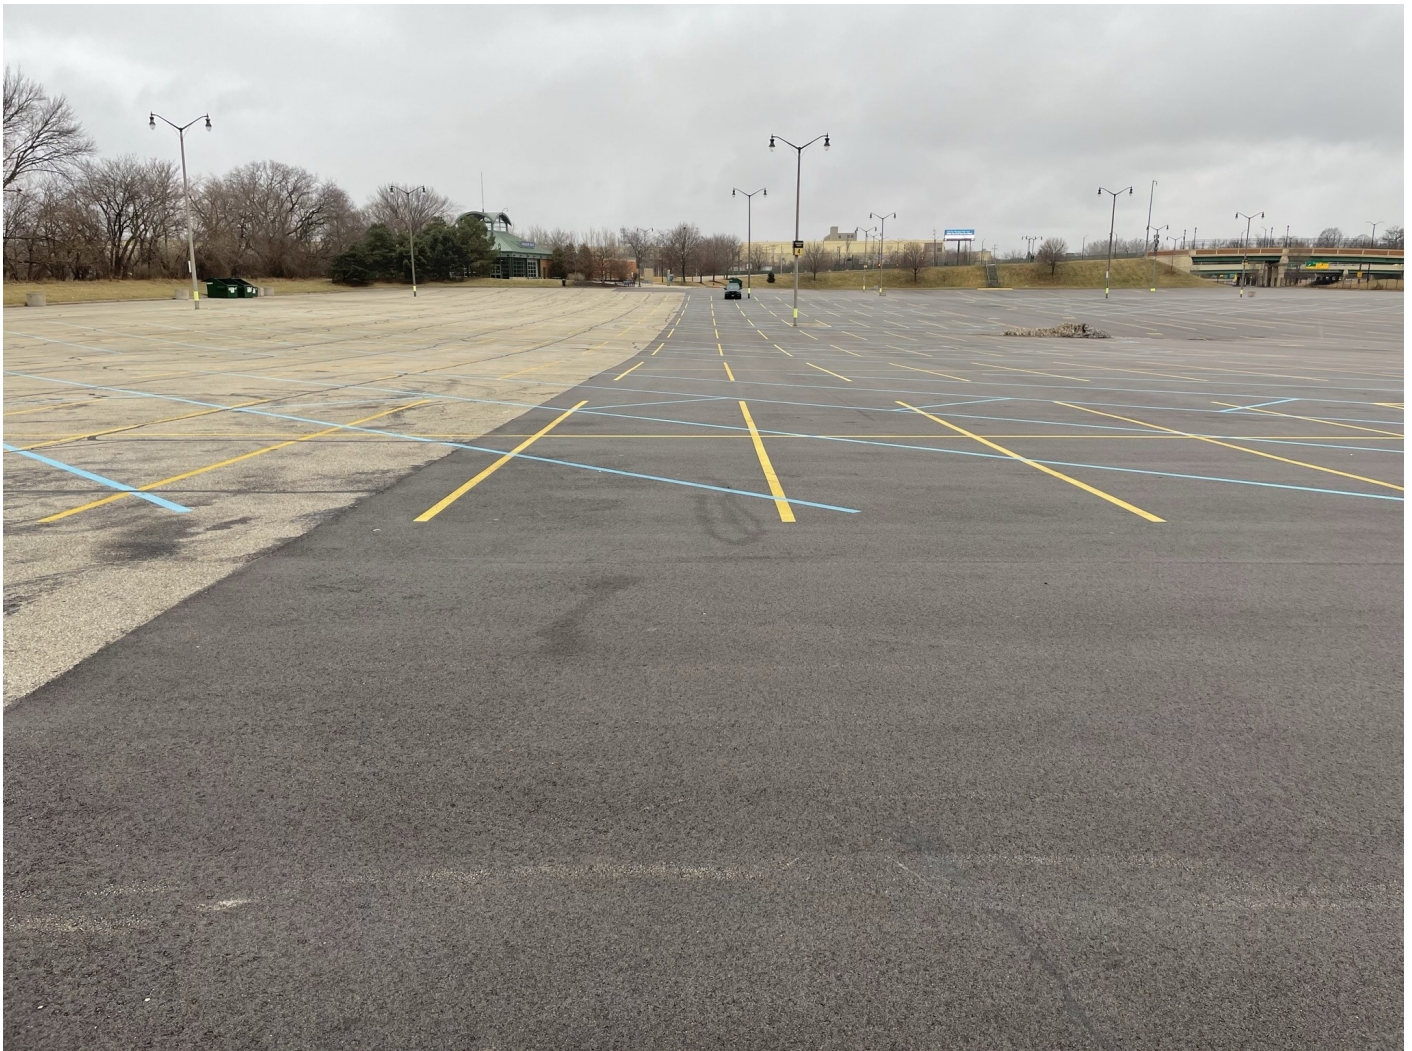
Photo 15: American Family Lot: Asphalt capped surface parking lot (American Family Lot). 4-inches of asphalt pavement over 8-inches of crushed aggregate. Older asphalt shown on left side of photo. Newer asphalt shown on right side of photo. Photo taken facing south on January 18, 2023.

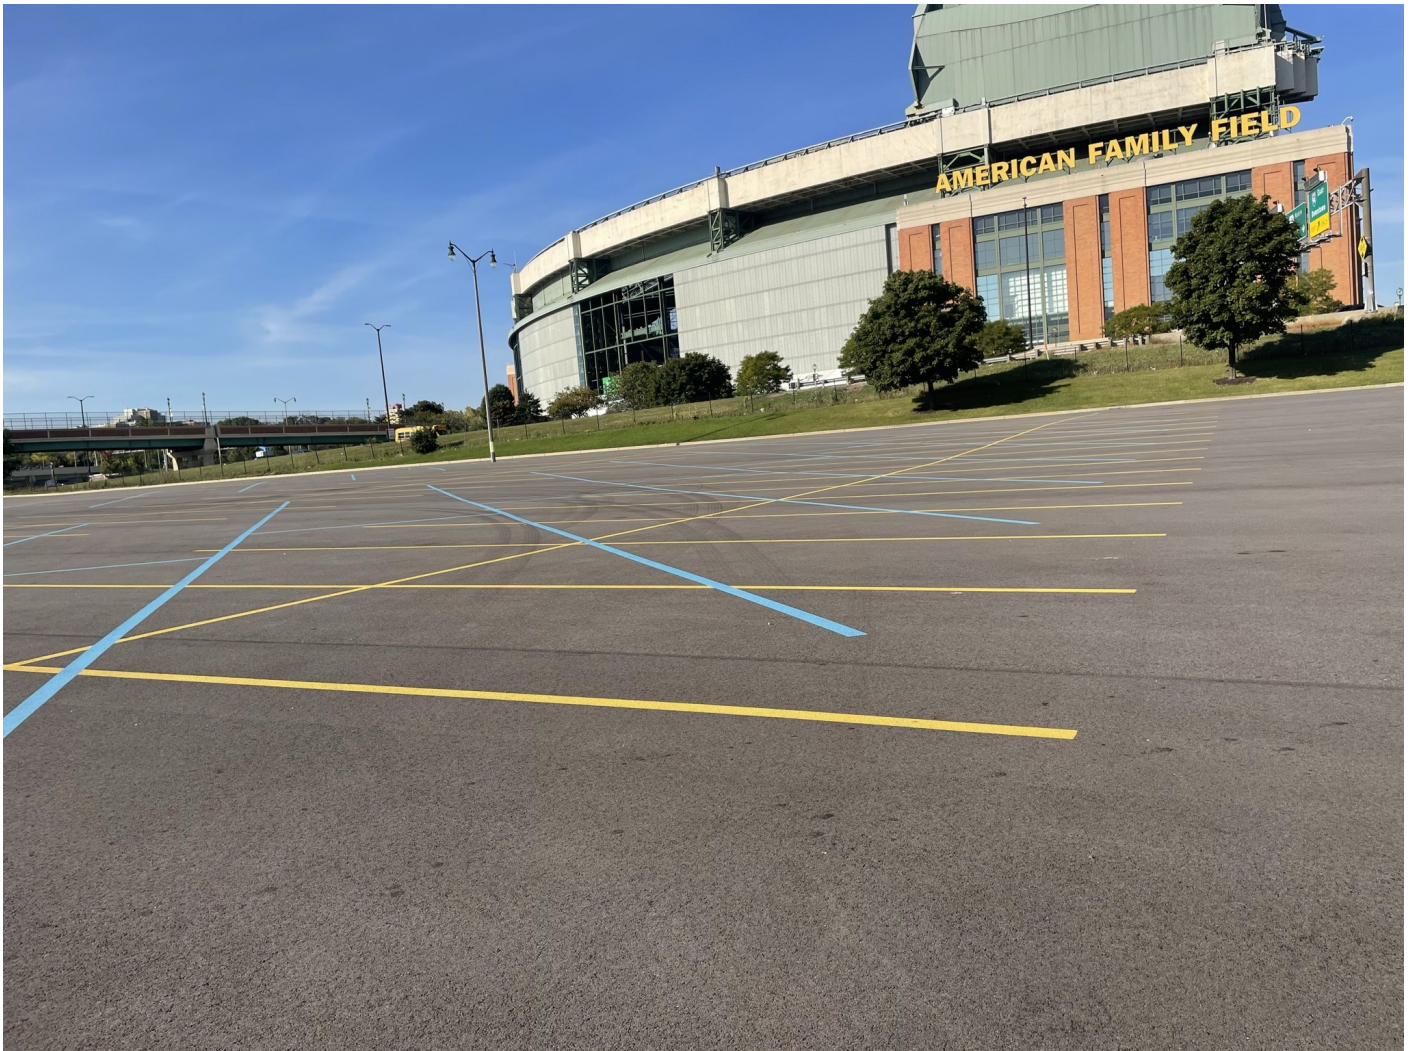
Photo 16: American Family Lot: Asphalt capped surface parking lot (American Family Lot). 4-inches of asphalt pavement over 8-inches of crushed aggregate.  
Photo taken facing southwest on October 4, 2022.

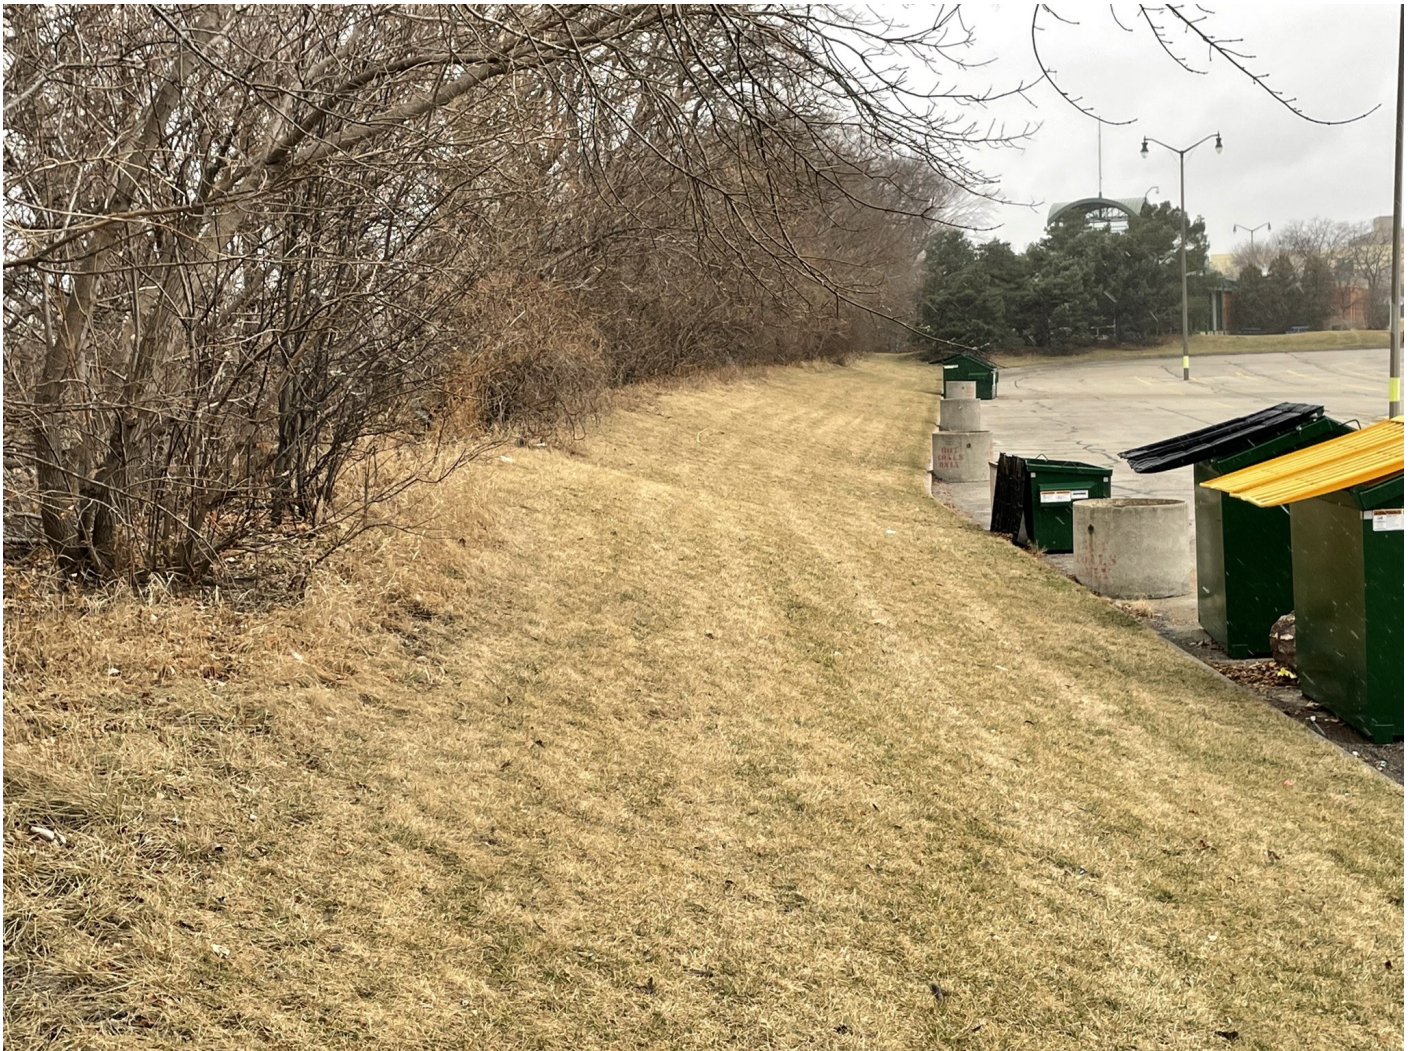
Photo 17: American Family Lot: Greenspace cap along eastern edge of parking lot. 12-inches low permeability non-impacted soil covered with vegetated topsoil. Trees, shrubs, and native plant overgrown shown on left side of photo, which line the Menomonee River banks.

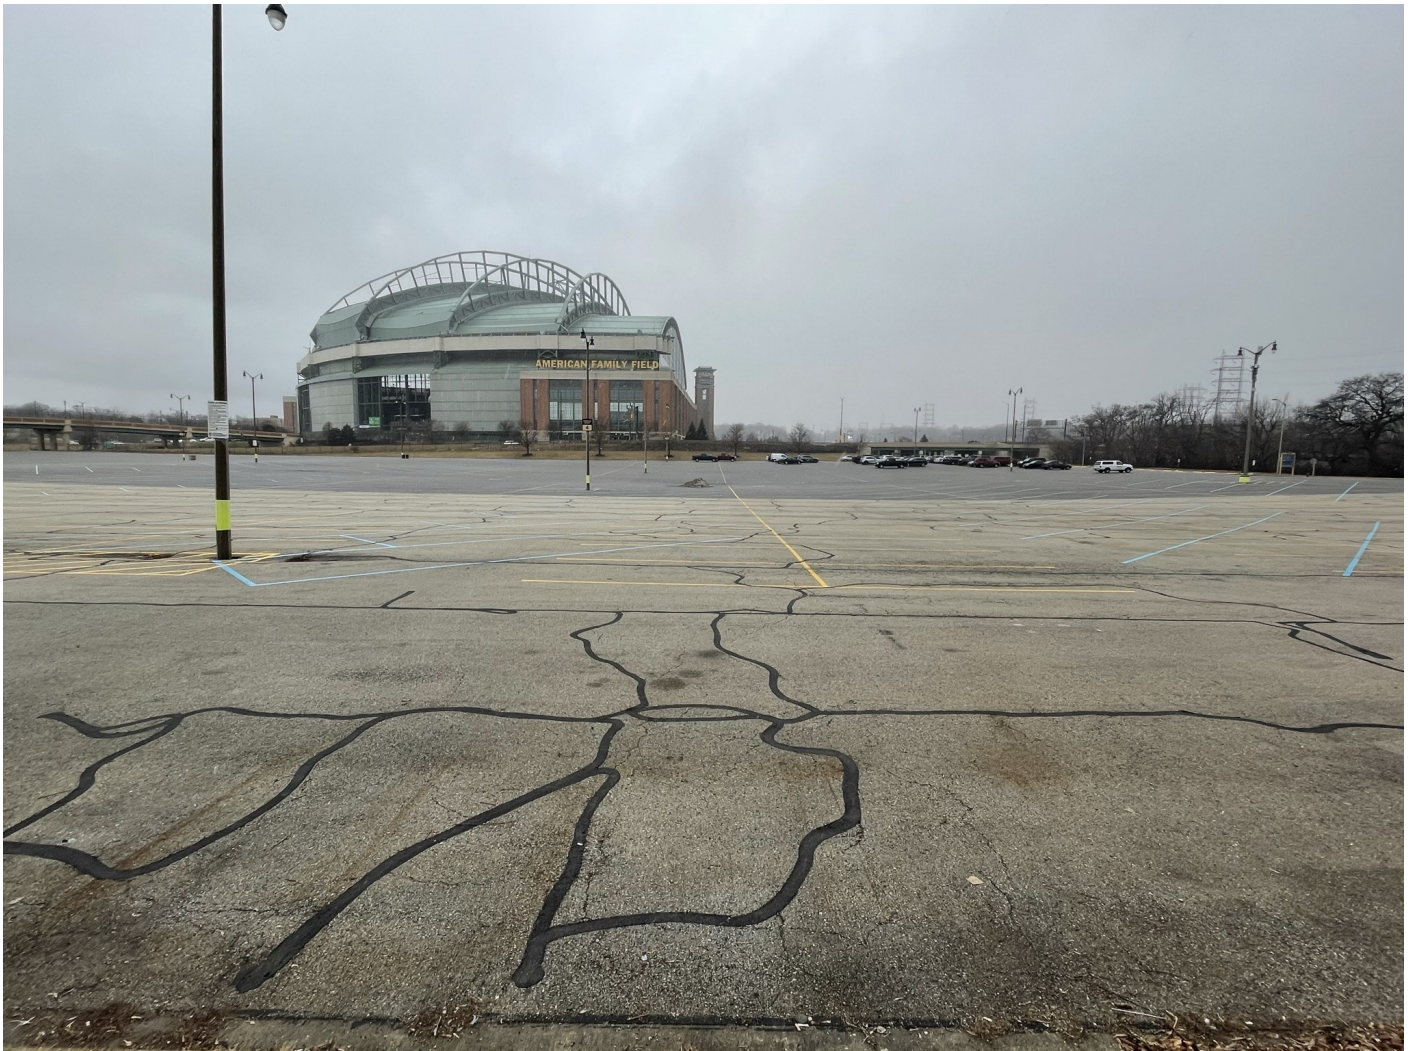
Photo 18: American Family Lot: Asphalt capped surface parking lot (American Family Lot). 4-inches of asphalt pavement over 8-inches of crushed aggregate. Older asphalt shown on in photo foreground, patched along cracks with asphalt tar. Newer asphalt shown in photo background.

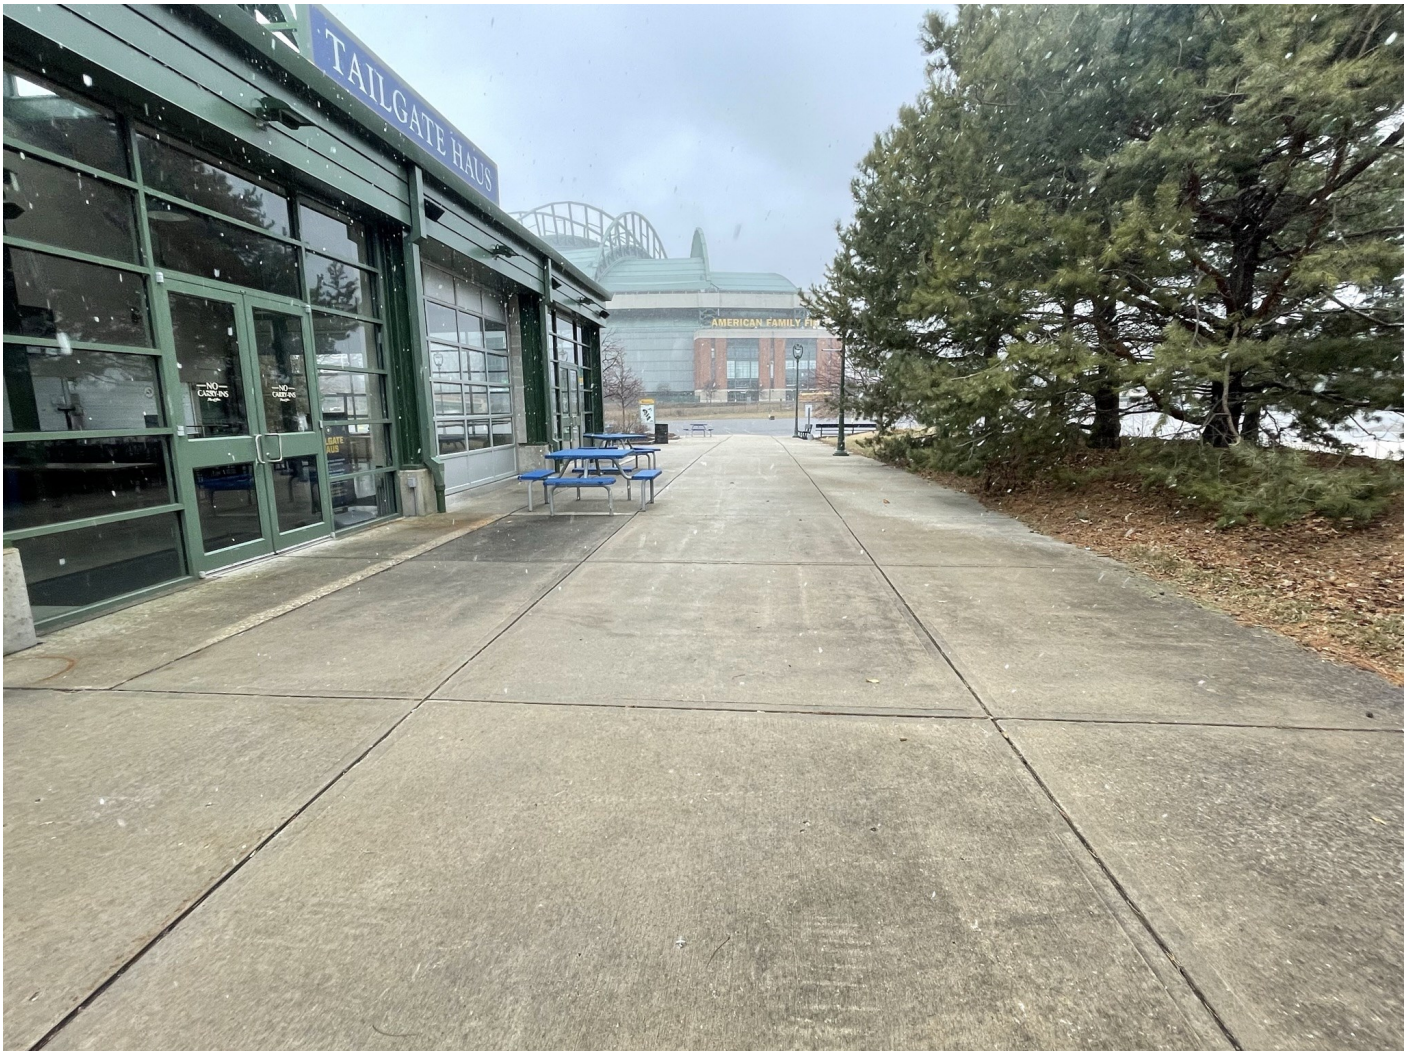
Photo 19: American Family Lot: Concrete pavement plaza area / pedestrian walk along north side of Tailgate Haus in the American Family Lot. 6-inches of concrete over 8-inches crushed aggregate. Tailgate Haus with concrete floor slab/foundation shown on left side of photo. Landscaped berm (greenspace cap) shown on right side of photo. Photo taken facing west on January 18, 2023.

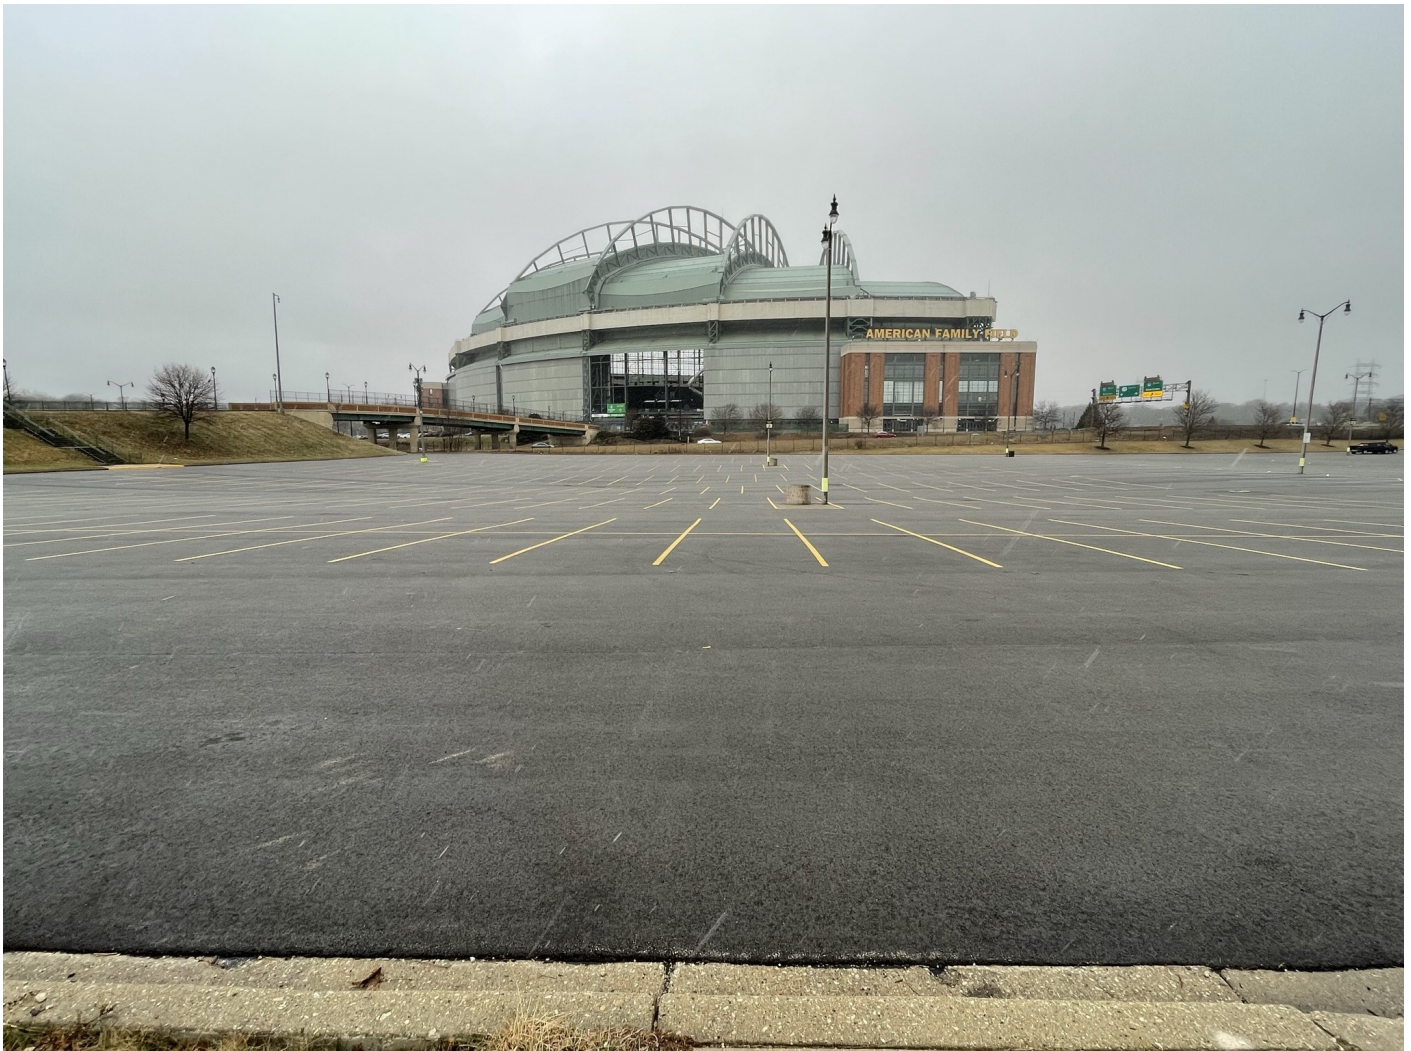
Photo 20: American Family Lot: Asphalt capped surface parking lot (American Family Lot). 4-inches of asphalt pavement over 8-inches of crushed aggregate. Concrete curb and gutter shown in photo foreground, consisting of 6-inch thick concrete (curb) or 8-inch thick concrete (gutter) over crushed aggregate base.  
Photo taken facing west on January 18, 2023.

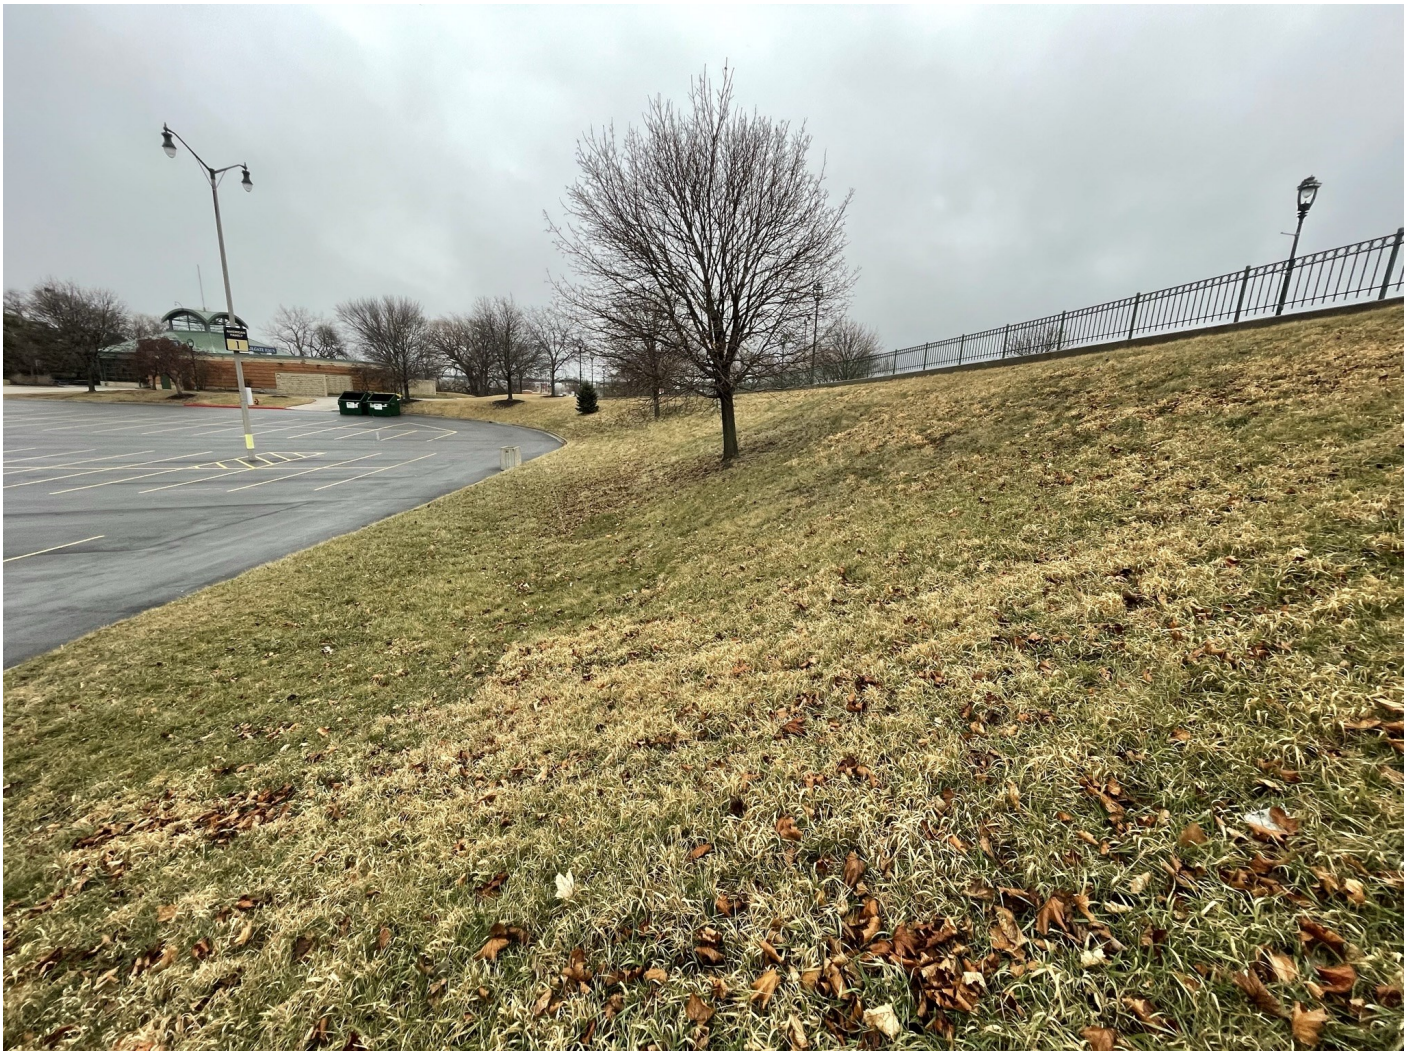
Photo 21: American Family Lot: Greenspace cap along southern edge of parking lot. 12-inches low permeability non-impacted soil covered with vegetated topsoil (grass cover as shown). Photo taken facing east on January 18, 2023.

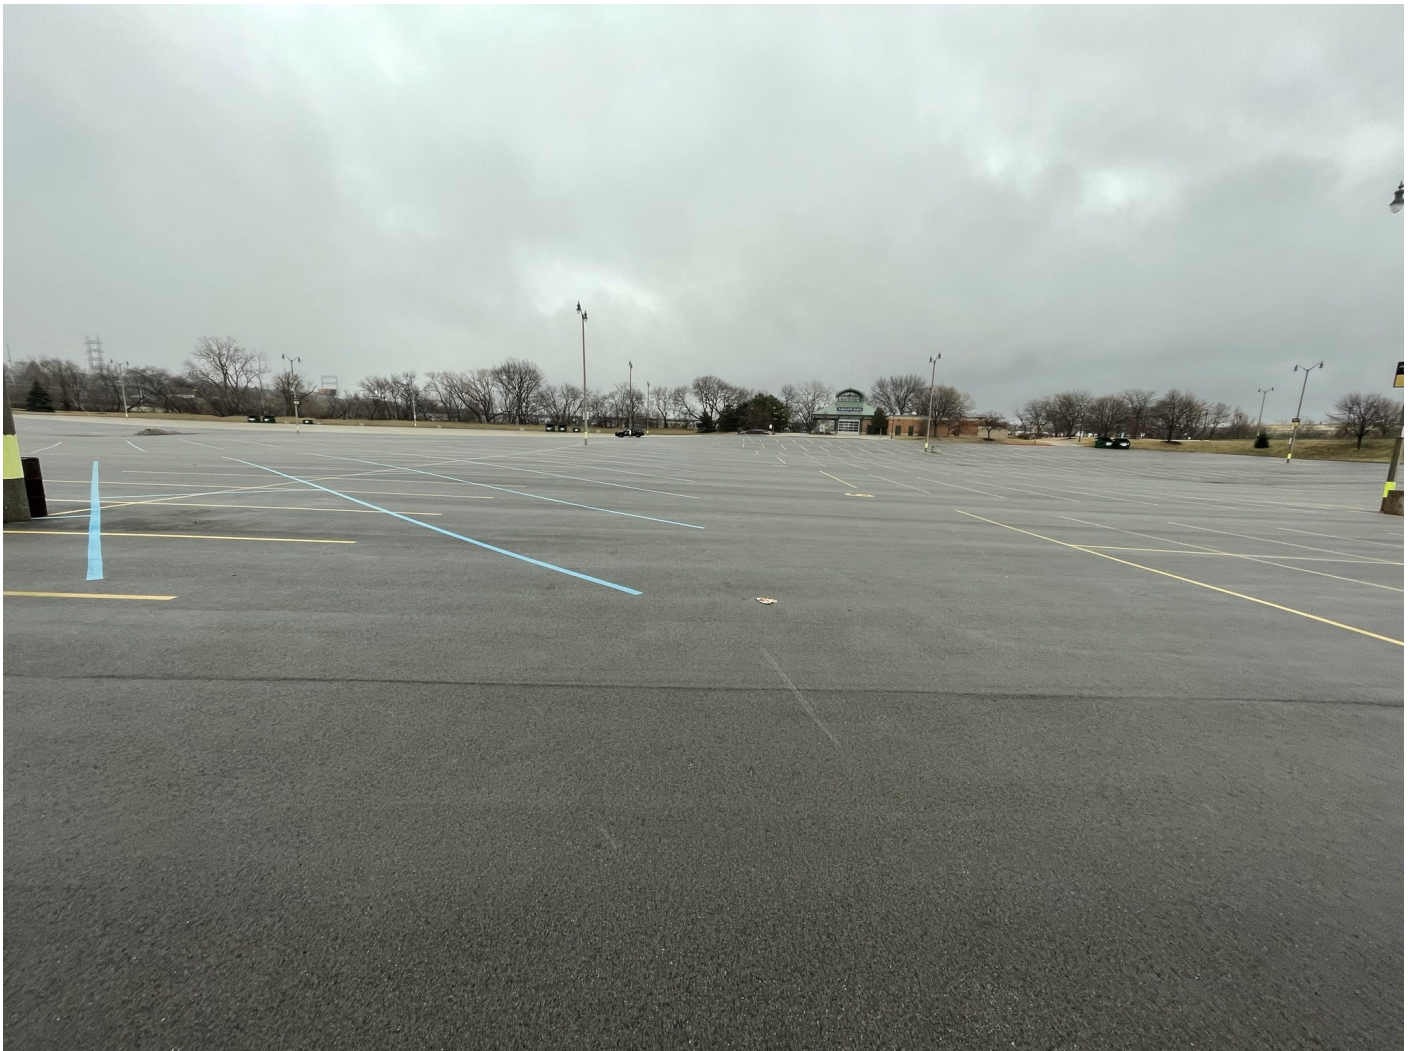
Photo 22: American Family Lot: Asphalt capped surface parking lot (American Family Lot). 4-inches of asphalt pavement over 8-inches of crushed aggregate. Photo taken facing east on January 18, 2023.

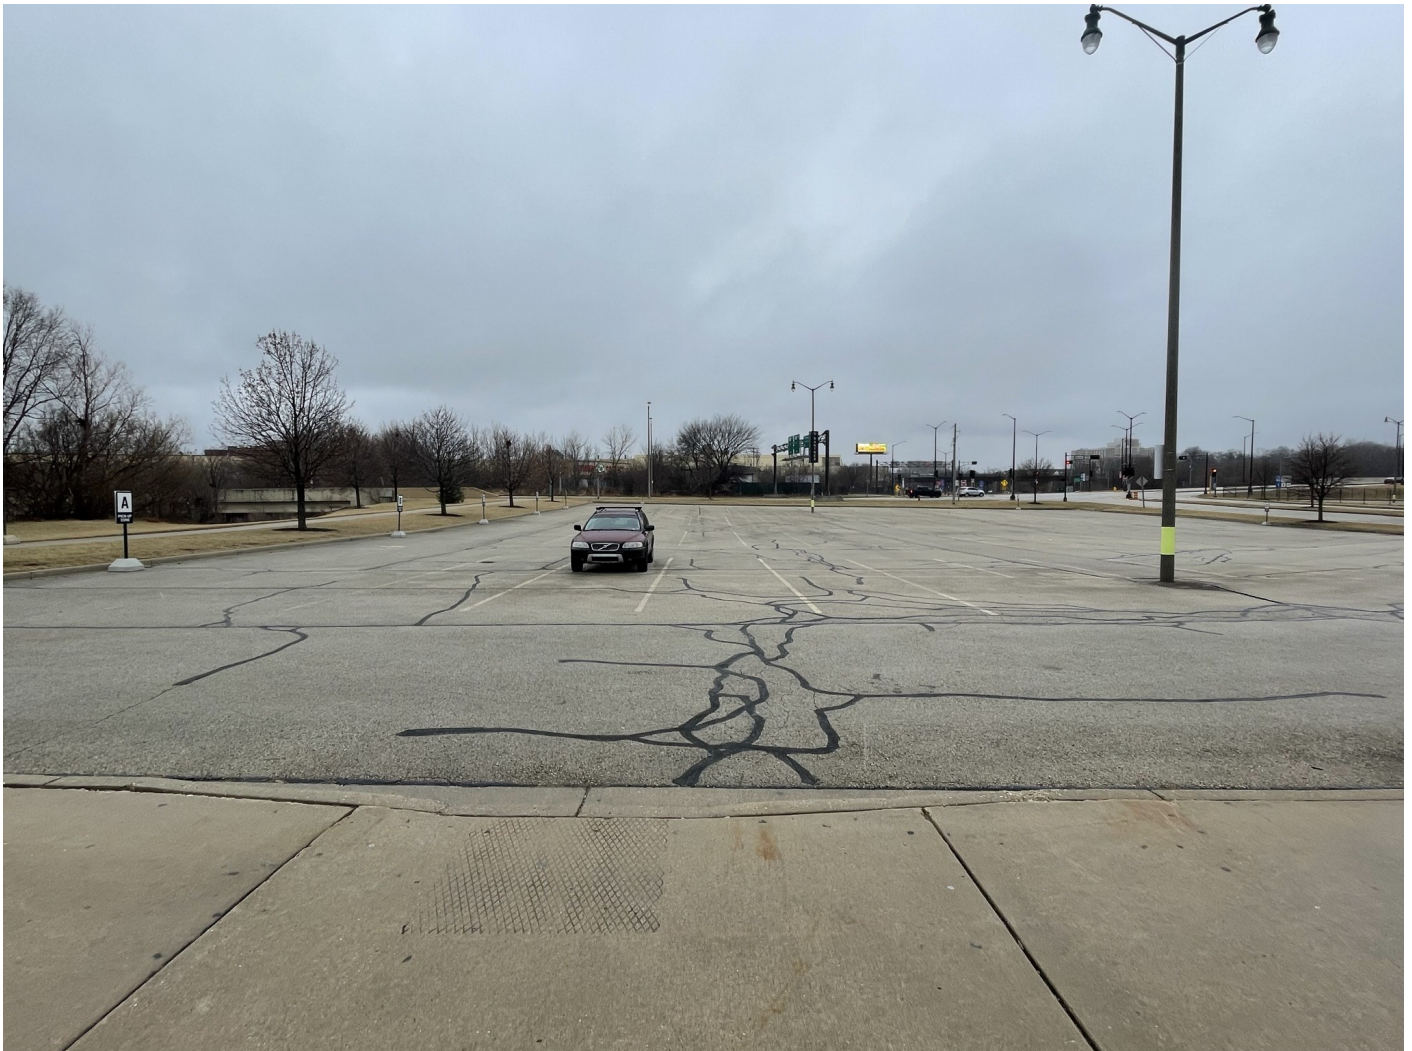
Photo 23: Ganter Lot: Asphalt cap across the entire Ganter Lot parking lot, representative of asphalt parking lot caps across the River West site. 4-inch asphalt pavement over 8-inches of crushed aggregate (base course). Concrete paved pedestrian sidewalk cap with curb and gutter cap in photo foreground. Sidewalk and curb 6-inch thick concrete, gutter 8-inch thick concrete over crushed aggregate.

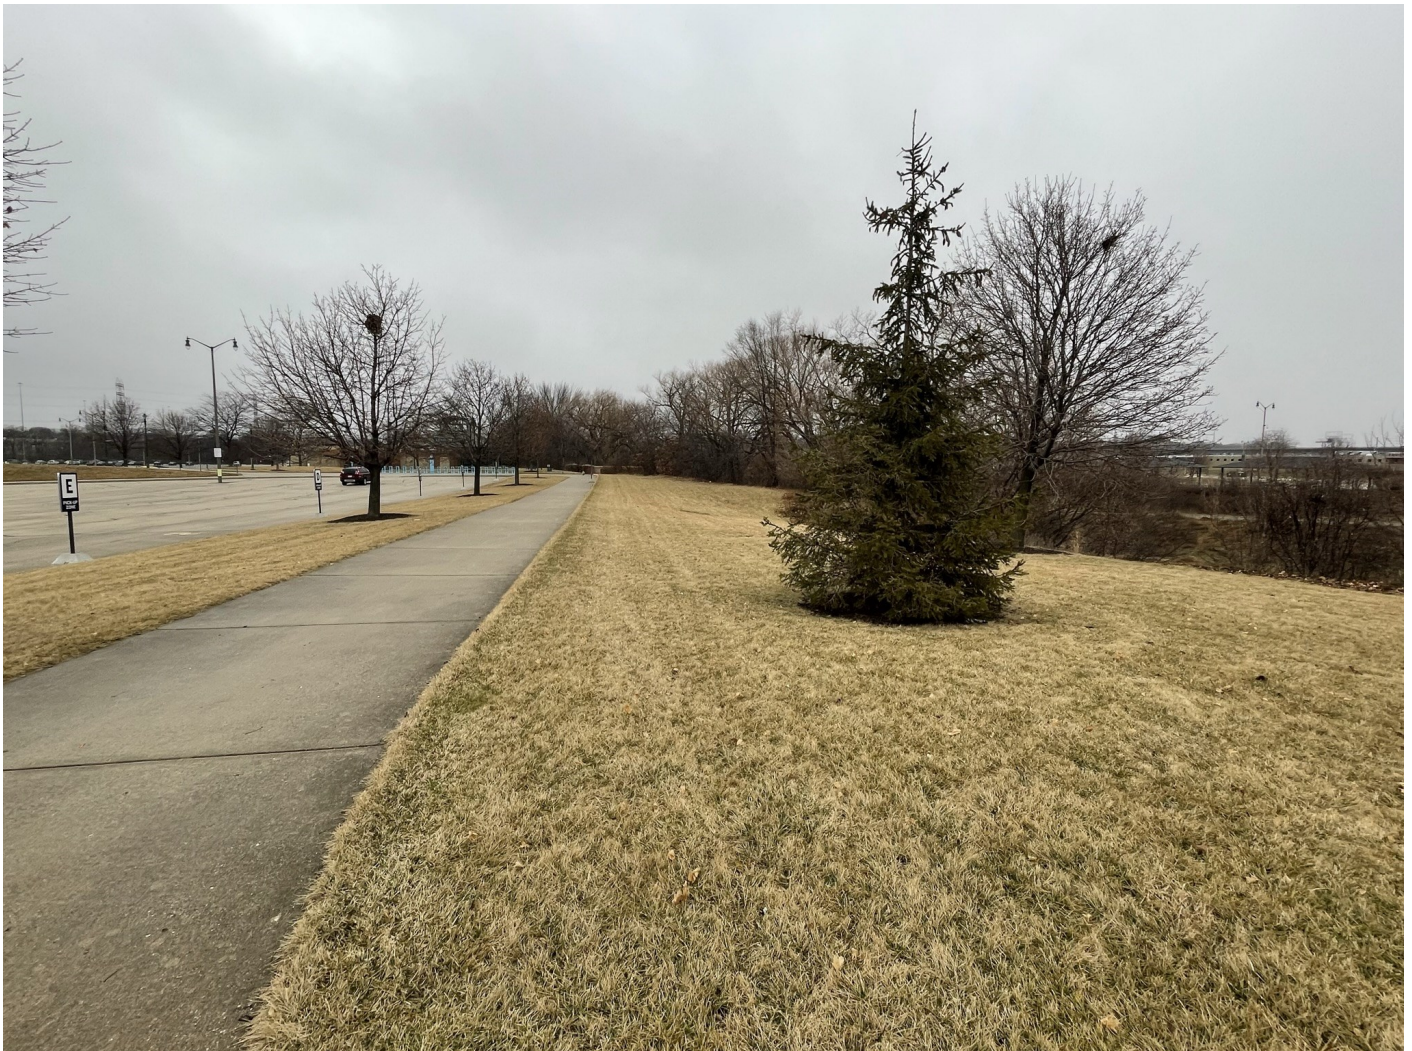
Photo 24: Ganter Lot: Greenspace cap along eastern edge of Ganter Lot. 12-inches low permeability non-impacted soil covered with 4 inches of vegetated topsoil (grass shown here) with various plantings. Asphalt cap pedestrian path shown on left side of photo.

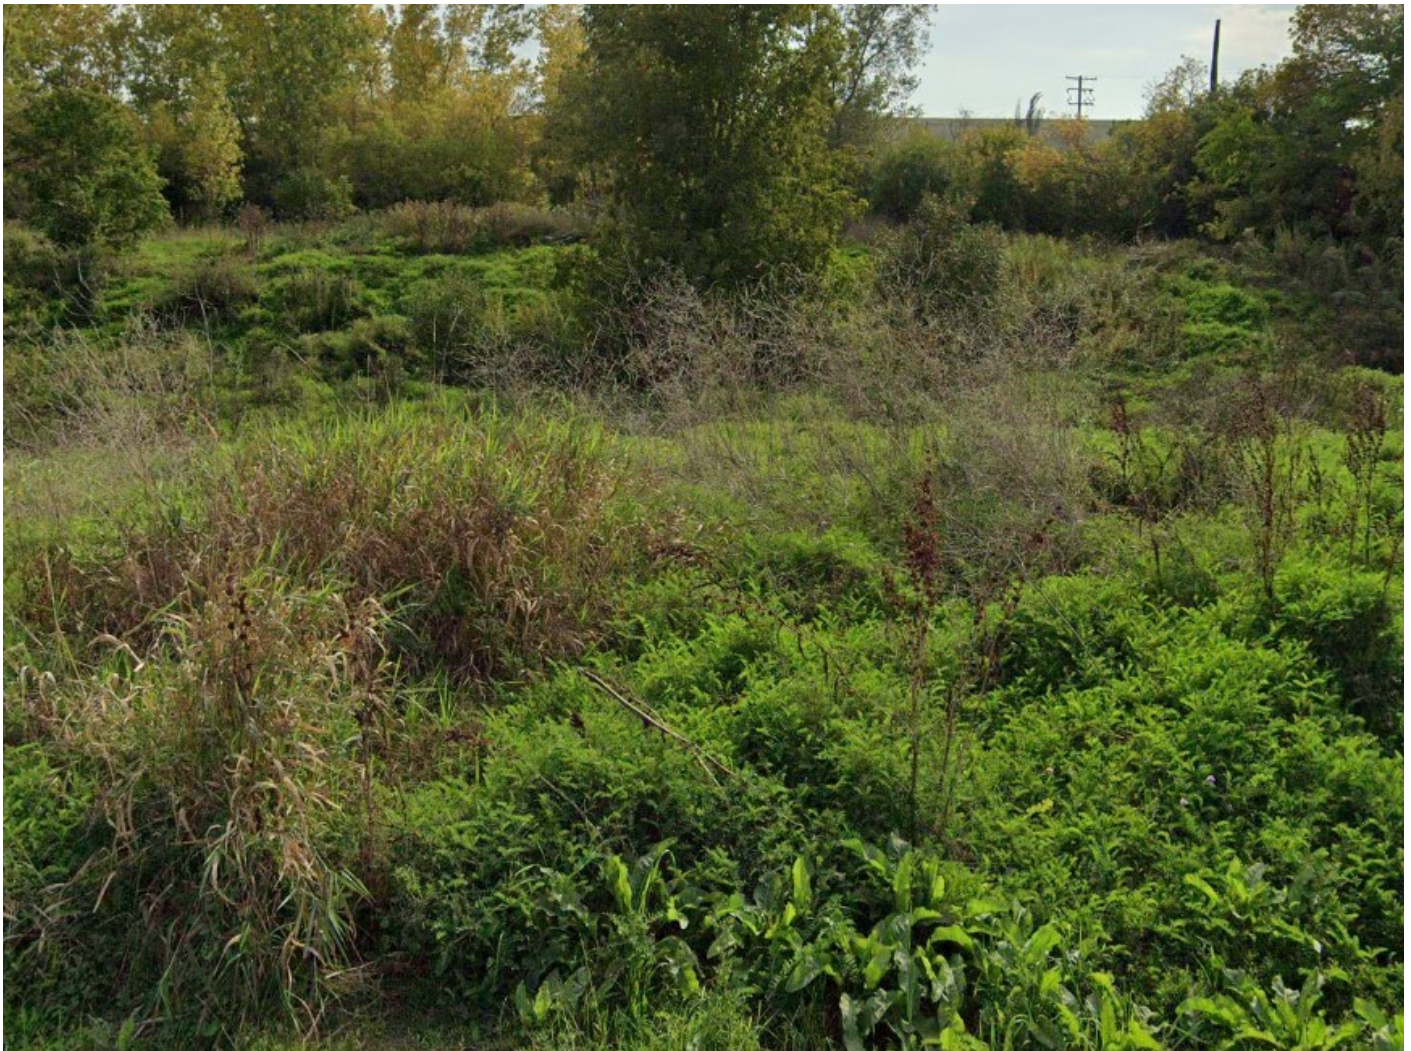
Photo 25: Ganter Lot (area to the south of Frederick Miller Way): Native plant overgrowth, trees, and shrubs over topsoil. Area not used by the District, facility staff, public, or others. Photo taken facing south in October 2019.

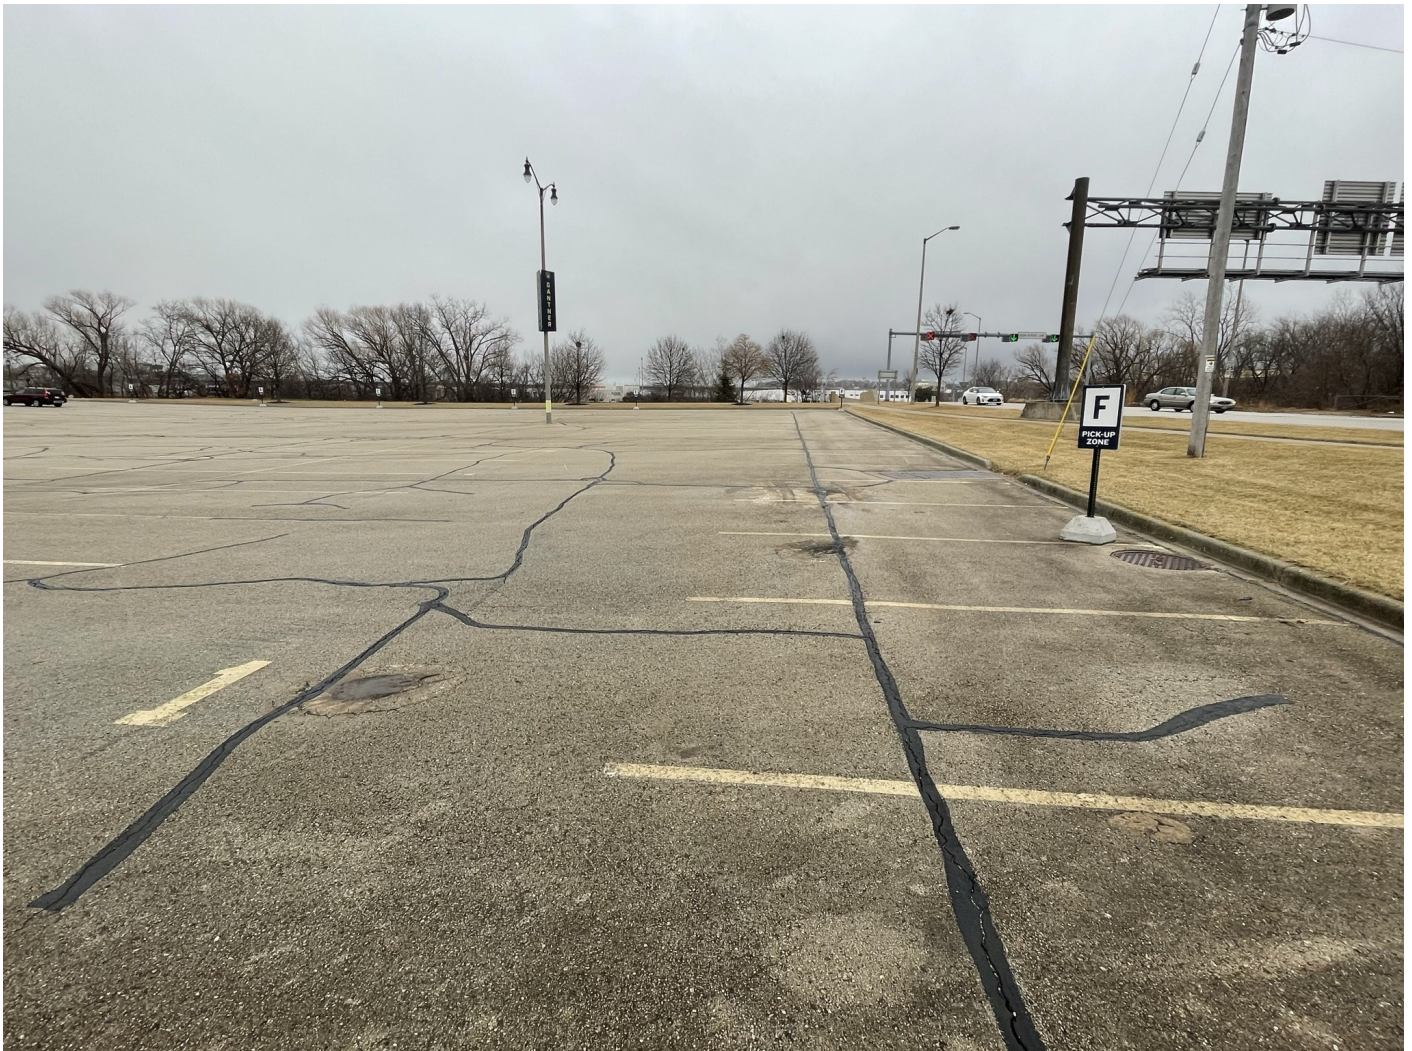
Photo 26: Ganter Lot: Asphalt cap across the entire Ganter Lot parking lot, representative of asphalt parking lot caps across the River West site. 4-inch asphalt pavement over 8-inches of crushed aggregate (base course). Photo taken facing east on January 18, 2023.

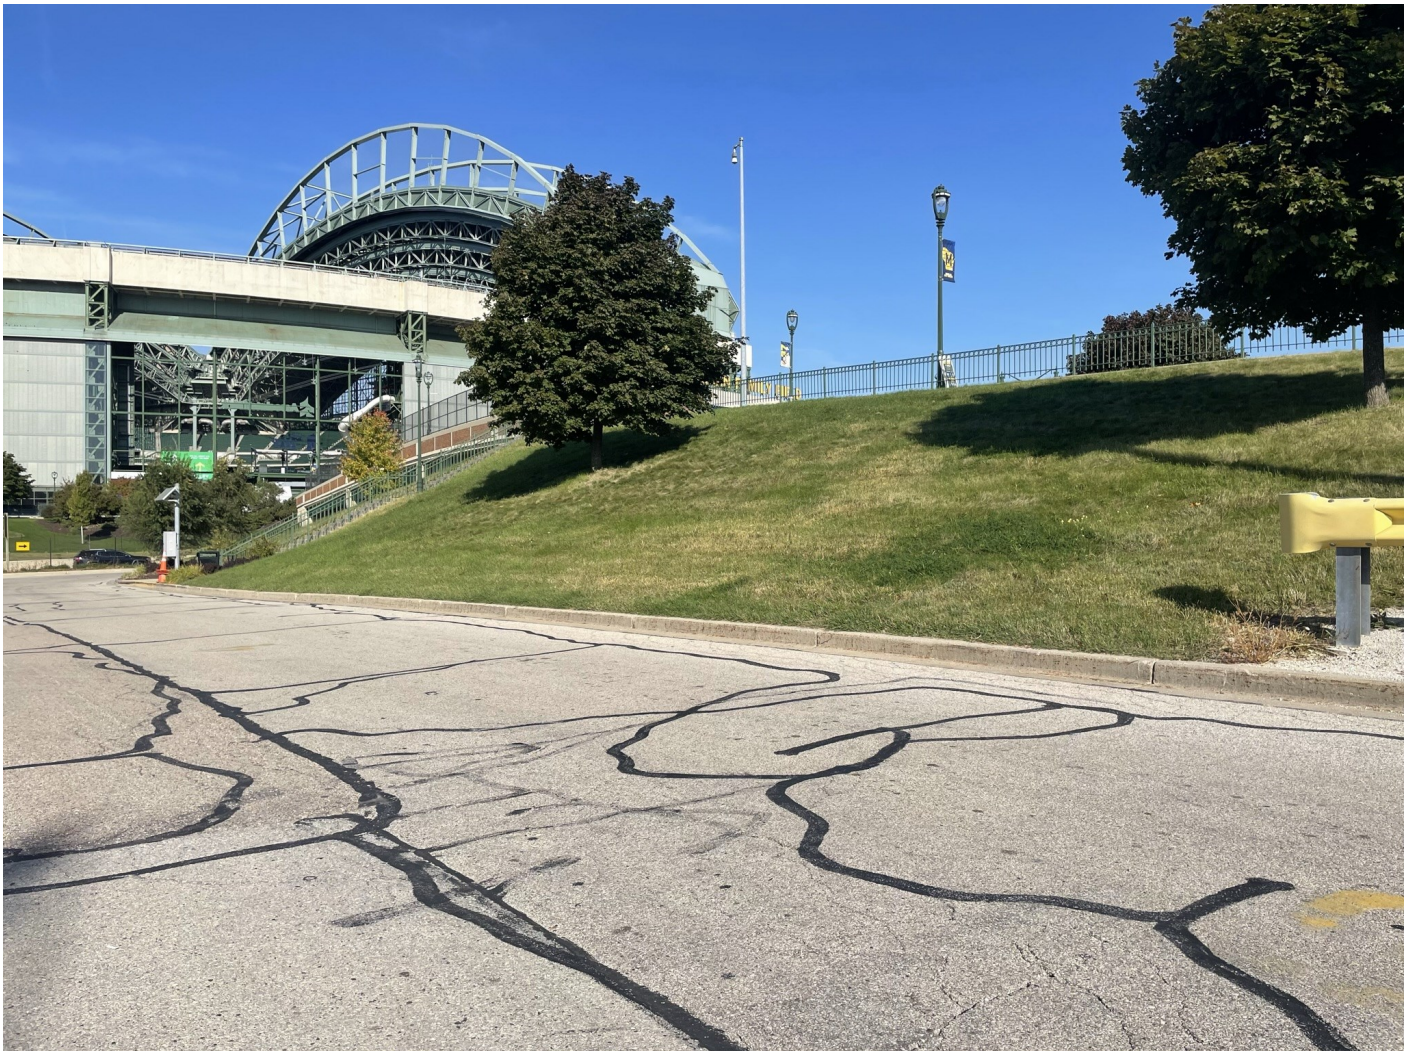
Photo 27: Kuenn Lot: Asphalt cap across Kuenn Lot parking lot, representative of asphalt parking lot caps across the River West site. 4-inch asphalt pavement over 8-inches of crushed aggregate. Concrete curb (6-inch thick concrete) and gutter (8-inch thick concrete) over crushed aggregate. Greenspace cap shown on right side of photo: 12-inches of low-permeability non-impacted soil covered with vegetated (grass) topsoil.  
Photo taken facing northwest on October 4, 2022.

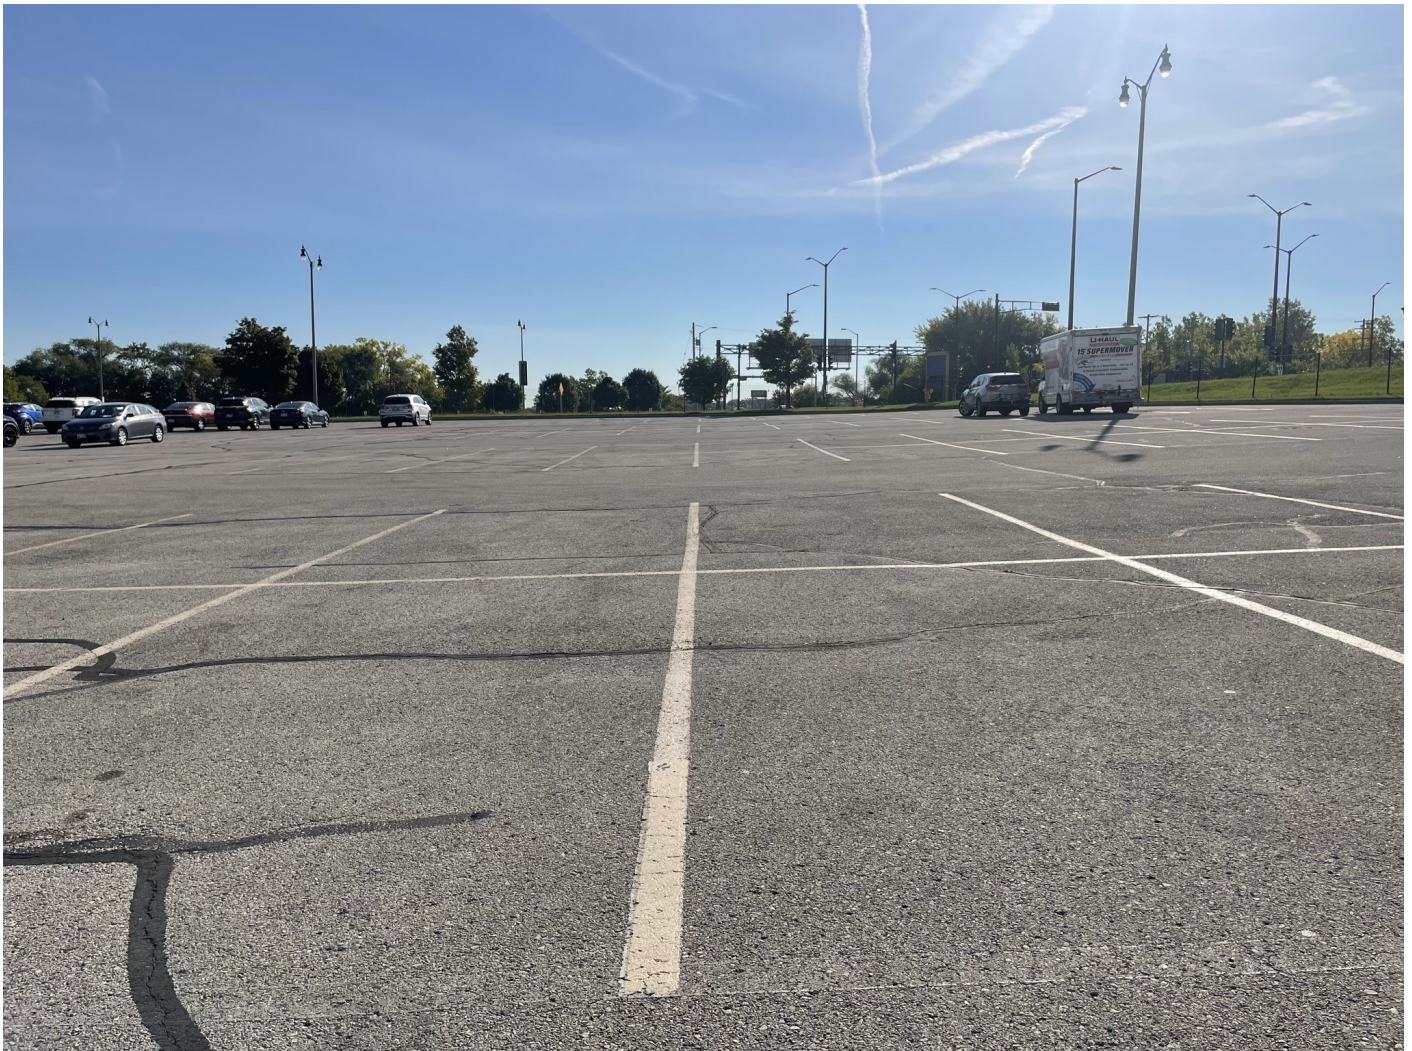
Photo 28: Kuenn Lot: Asphalt cap across Kuenn Lot parking lot, representative of asphalt parking lot caps across the River West site. 4-inch asphalt pavement over 8-inches of crushed aggregate.  
Photo taken facing east on October 4, 2022.
