**CAP MAINTENANCE PLAN**  
**SOUTHEAST WISCONSIN PROFESSIONAL BASEBALL PARK DISTRICT – RIVER WEST**

**FEBRUARY 2023**

**SITE PLAN MAP**  
SOUTHEAST WISCONSIN PROFESSIONAL BASEBALL PARK DISTRICT  
RIVER WEST PARCEL - BRRTS #02-41-001185  
110 S 44TH STREET, 201 & 301 S 46TH STREET  
MILWAUKEE, WISCONSIN

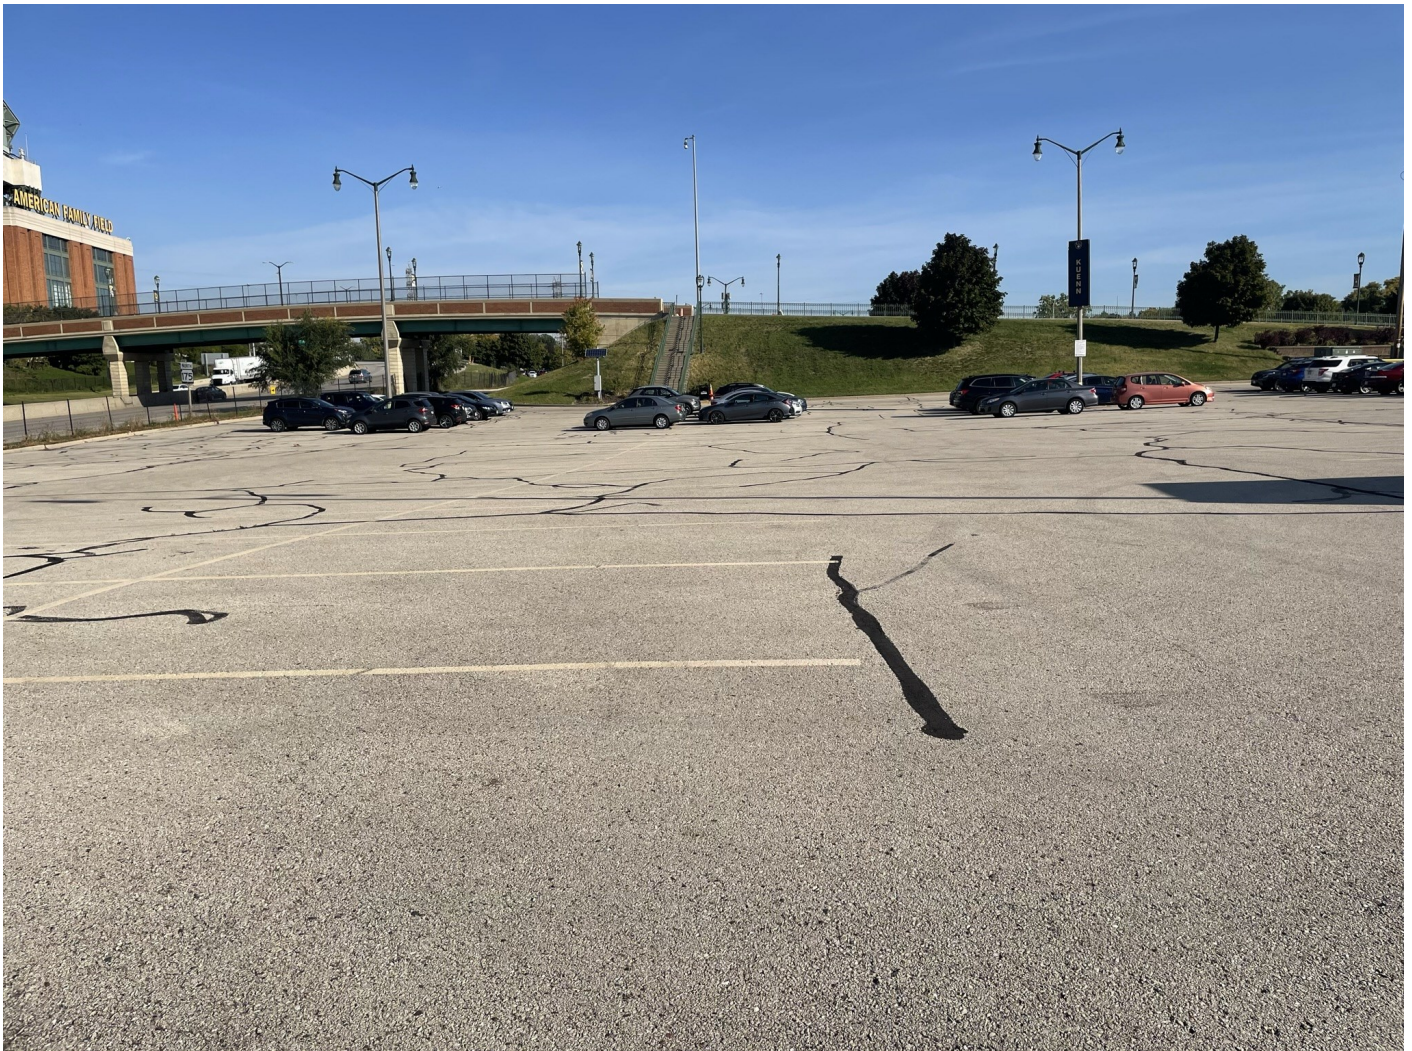
Photo 29: Kuenn Lot: Asphalt cap across Kuenn Lot parking lot, representative of asphalt parking lot caps across the River West site. 4-inch asphalt pavement over 8-inches of crushed aggregate.  
Photo taken facing north on October 4, 2022.

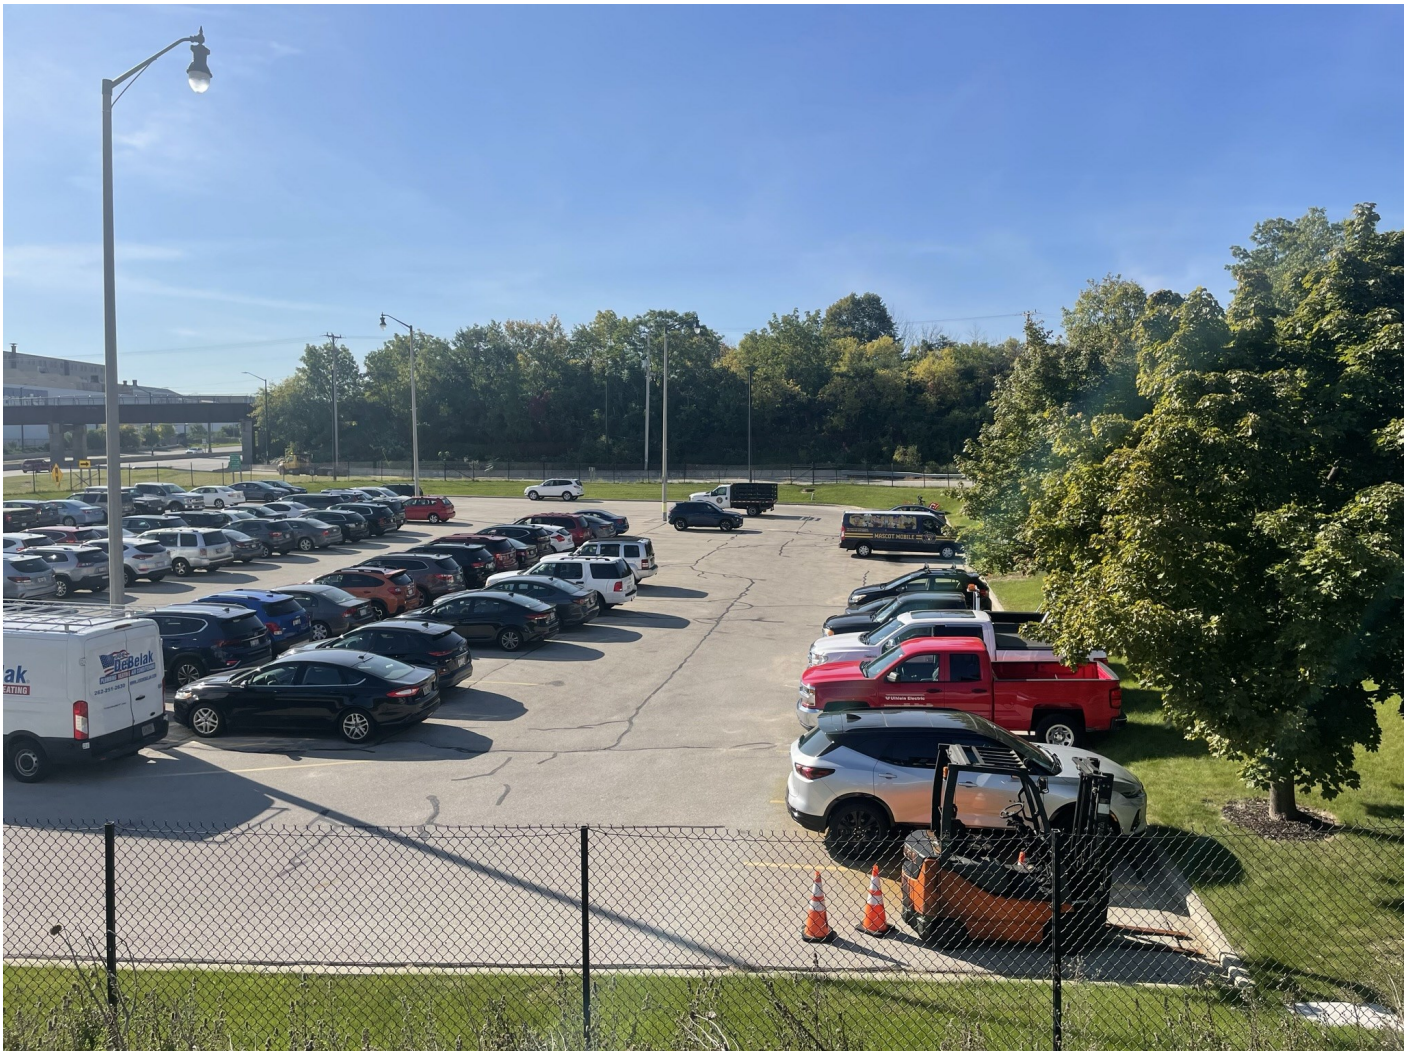
Photo 31: Logan Lot: Asphalt cap across Logan Lot parking lot, representative of asphalt parking lot caps across the River West site. 4-inch asphalt pavement over 8-inches of crushed aggregate. Concrete curb (6-inch thick concrete) and gutter (8-inch thick concrete) over crushed aggregate shown in photo foreground. Greenspace cap shown in photo foreground and on right side of photo: 12-inches of low-permeability non-impacted soil covered with vegetated (grass) topsoil. Photo taken facing south on October 4, 2022.

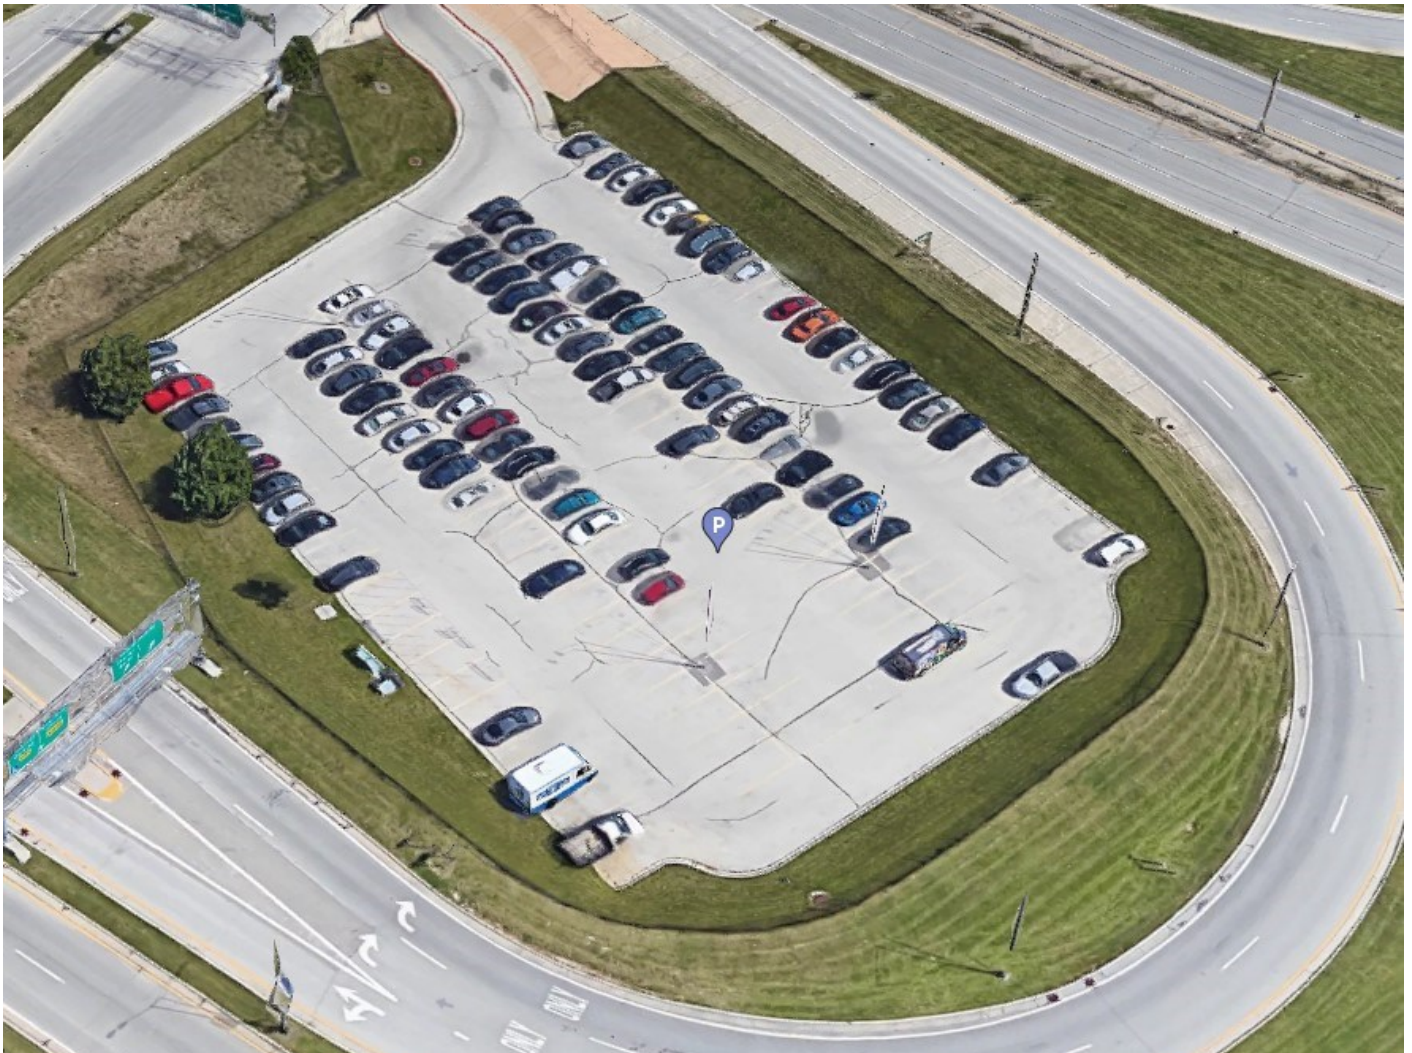
Photo 32: Logan Lot: Aerial photograph of Logan Lot, which depicts the asphalt lot cap, perimeter curb and gutter, and surrounding greenspace cap within the fence line around the property. Aerial imagery (2023).

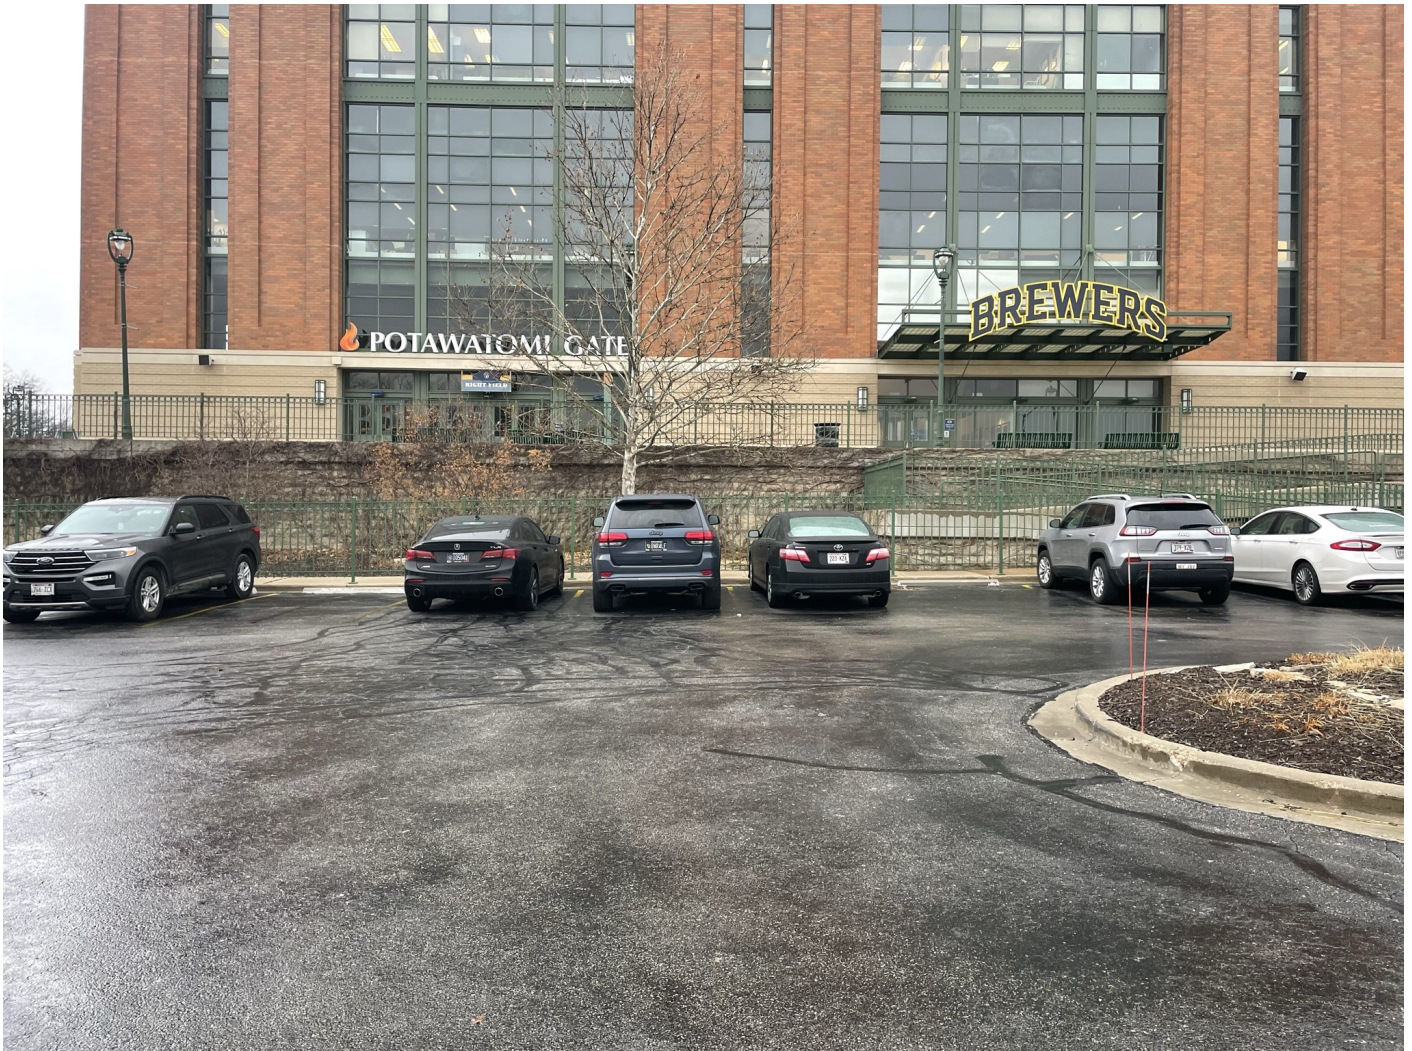
Photo 33: Brewers Offices Lot: Asphalt cap across Brewers Offices staff parking lot, representative of asphalt parking lot caps across the River West site. 4-inch asphalt pavement over 8-inches of crushed aggregate. Concrete curb (6-inch thick concrete) and gutter (8-inch thick concrete) over crushed aggregate shown on right side of photo. Greenspace cap within parking lot island shown on right side of photo: 12-inches of low-permeability non-impacted soil covered with mulched landscaping. Photo taken facing north on January 18, 2023.

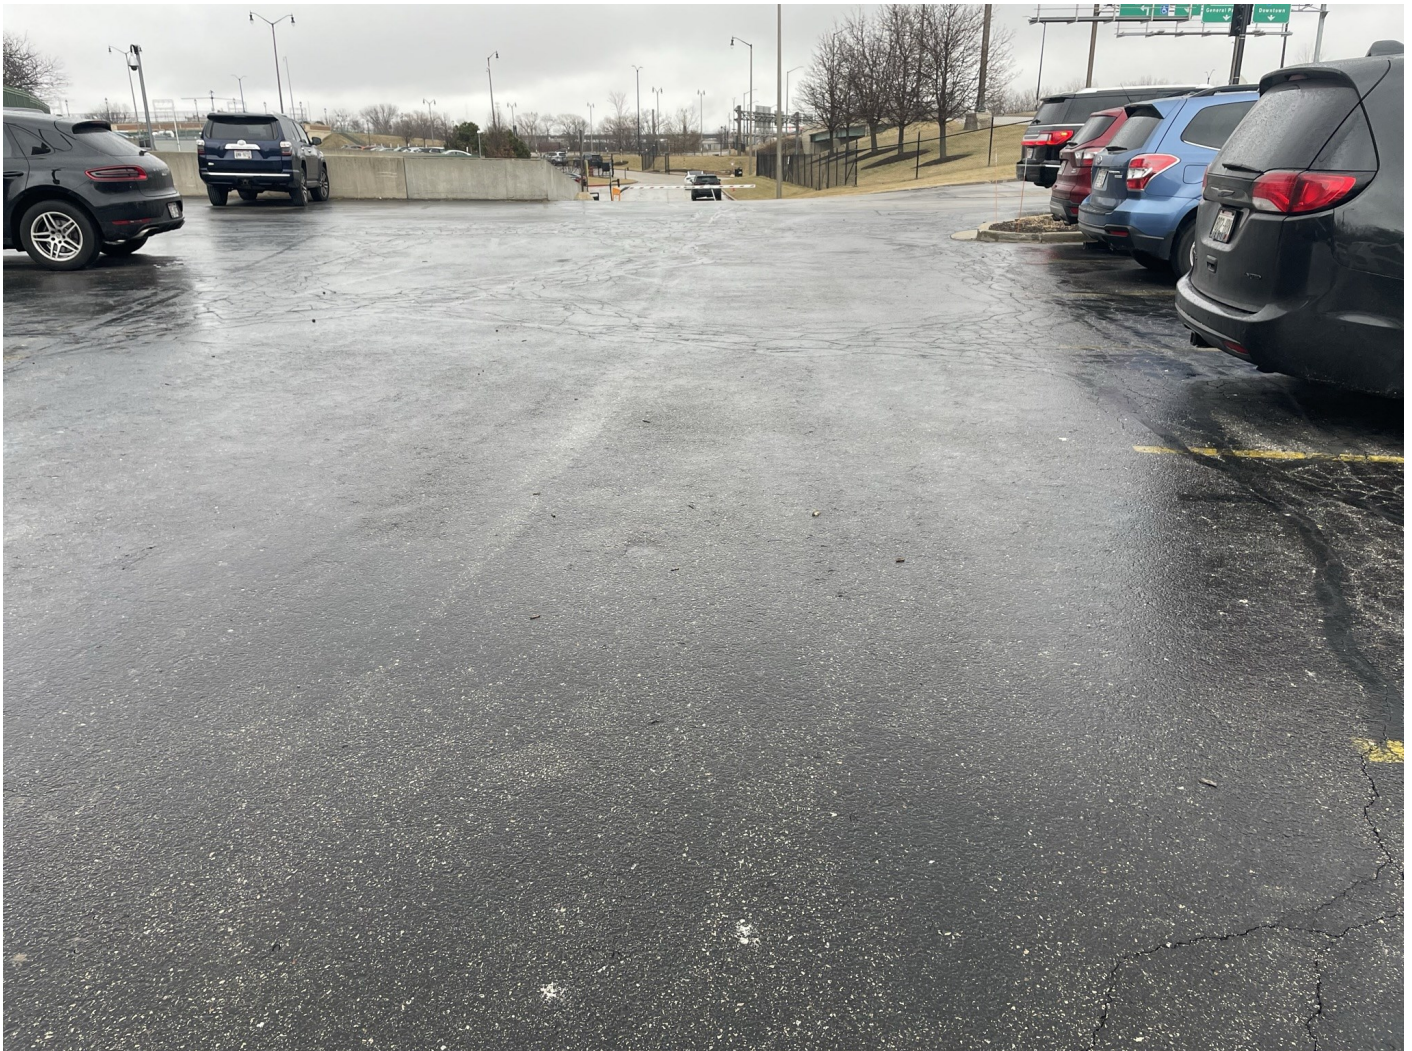
Photo 34: Brewers Offices Lot: Asphalt cap across Brewers Offices staff parking lot, representative of asphalt parking lot caps across the River West site. 4-inch asphalt pavement over 8-inches of crushed aggregate. Photo taken facing east on January 18, 2023.

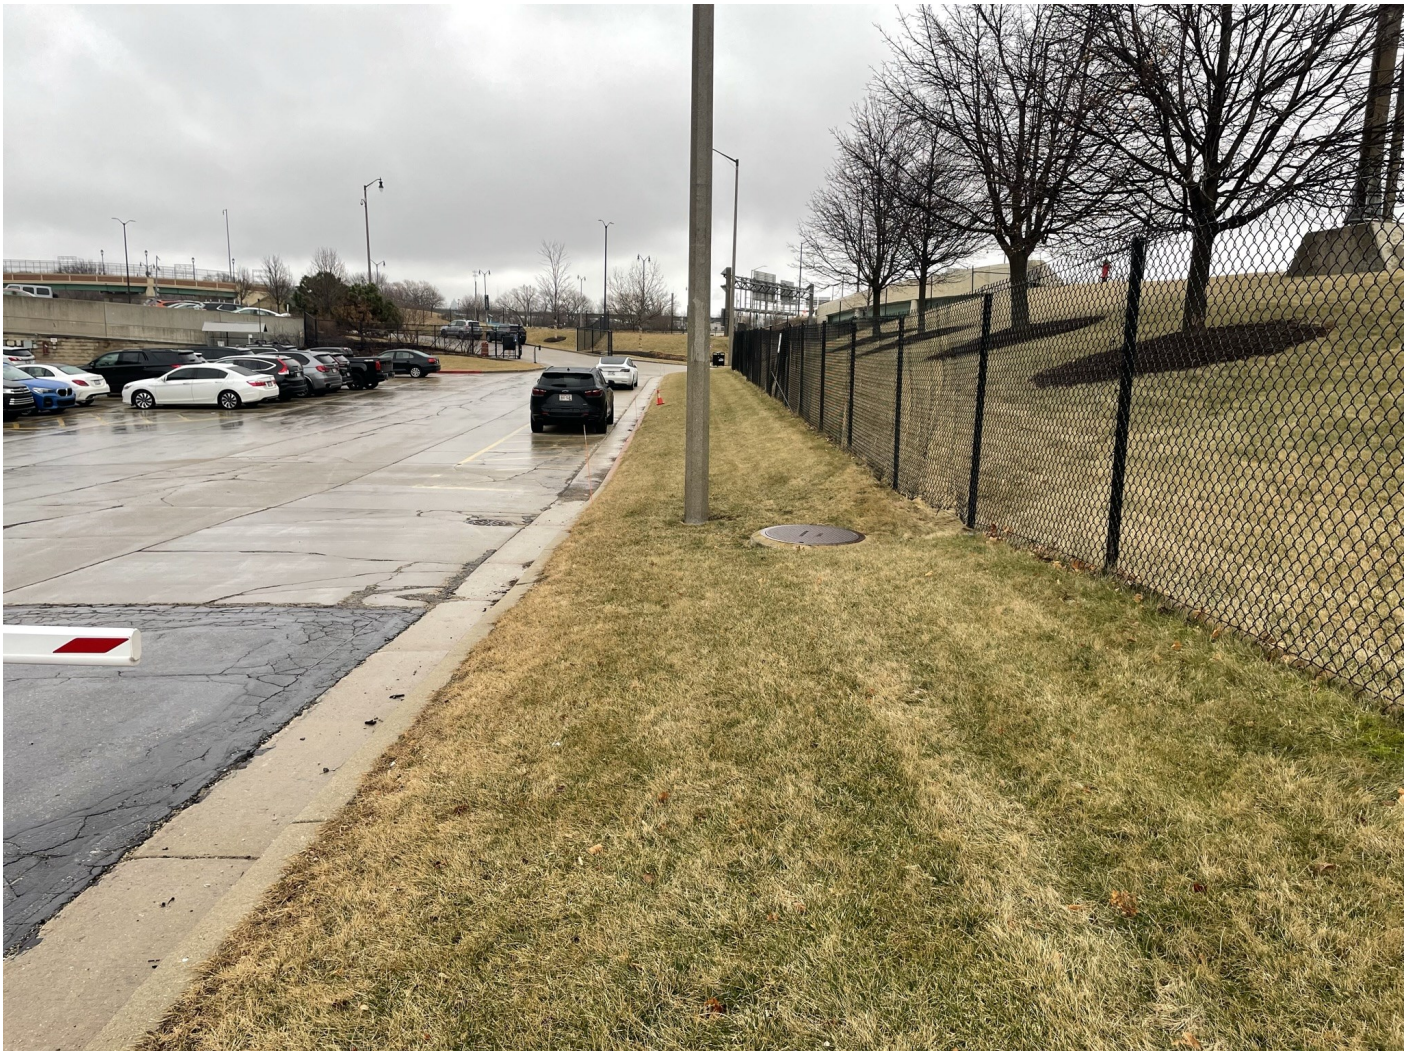
Photo 35: South Dock: Transition of asphalt pavement cap across Brewers Offices staff parking lot into concrete pavement South Dock area shown on left side of photo. Asphalt pavement is 4-inch asphalt over 8 inches crushed aggregate. Concrete loading dock pavement is 8-inch thick concrete over 8-inches crushed aggregate. Greenspace cap shown in central and right side portions of the photo: 12-inches low permeability non-impacted soil covered with vegetated (grass) topsoil. Photo taken facing east on January 18, 2023.

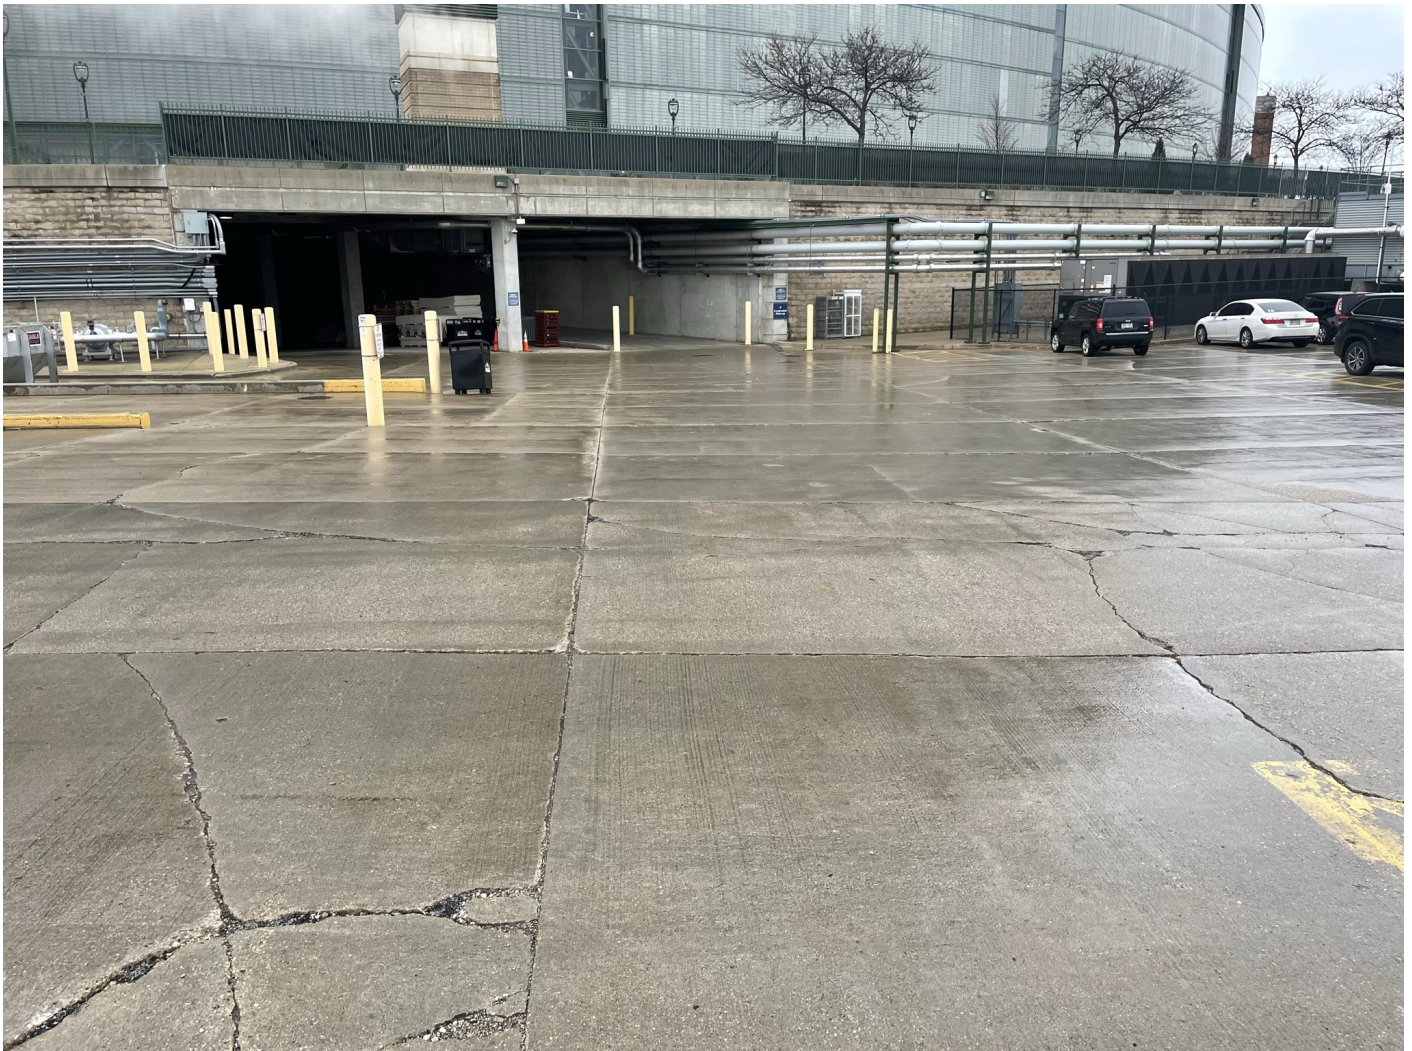
Photo 36: South Dock: Concrete loading dock pavement is 8-inch thick concrete over 8-inches crushed aggregate.  
Photo taken facing north on January 18, 2023.

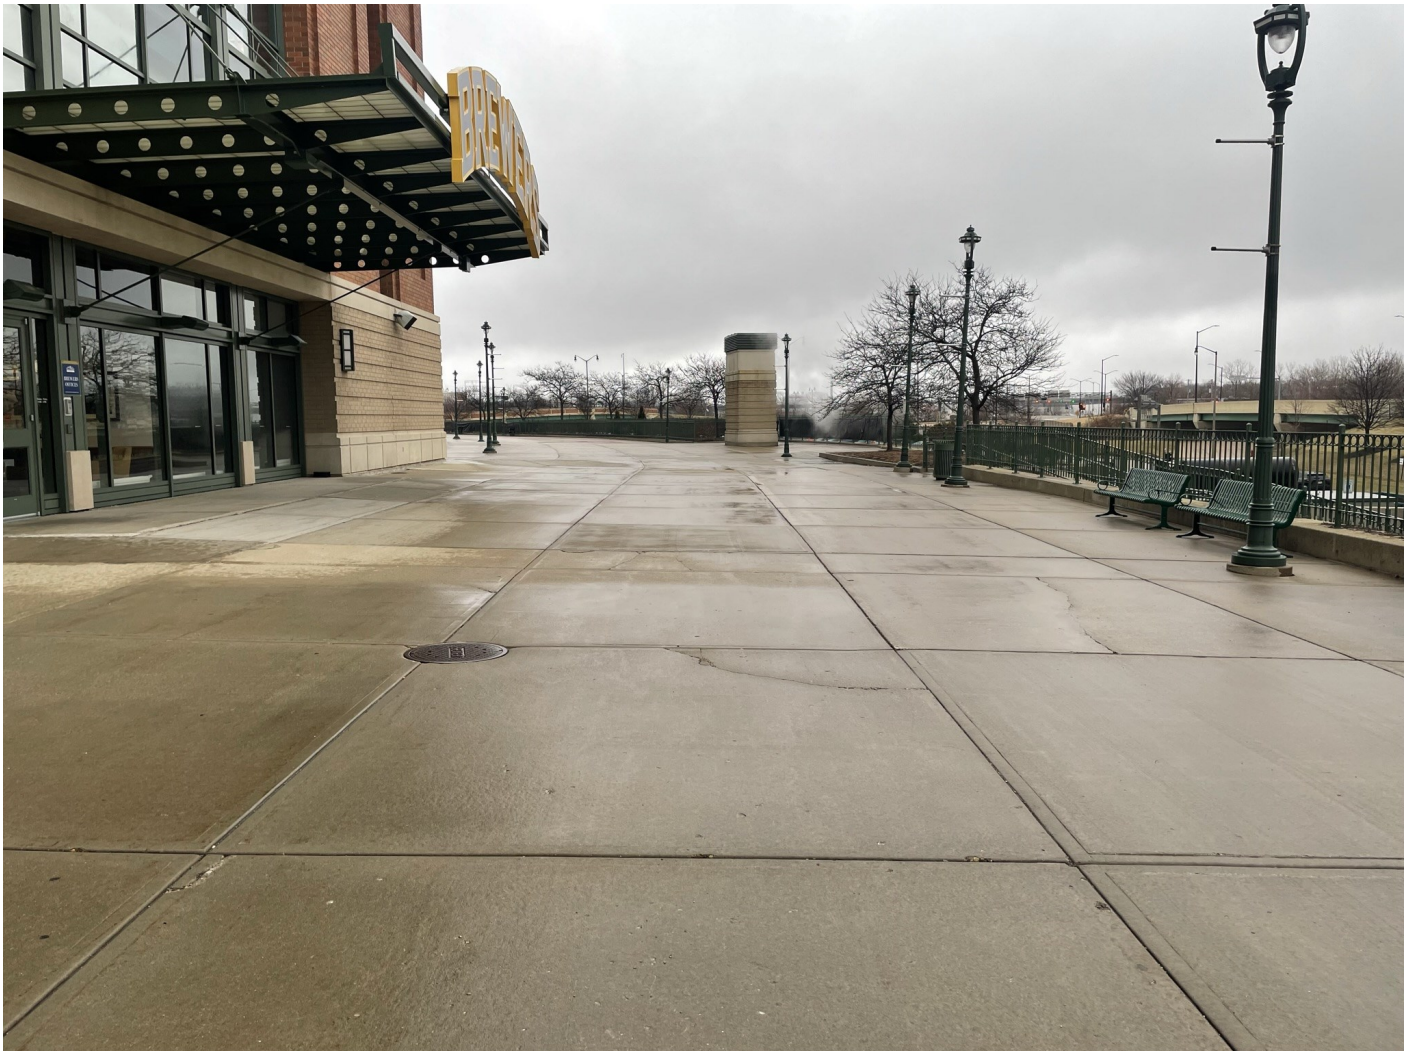
Photo 37: Stadium Plaza area (south side of stadium): Concrete pavement cap along exterior plaza sections and pedestrian sidewalk. 6-inches of concrete pavement over crushed aggregate.  
Photo taken facing east on January 18, 2023.

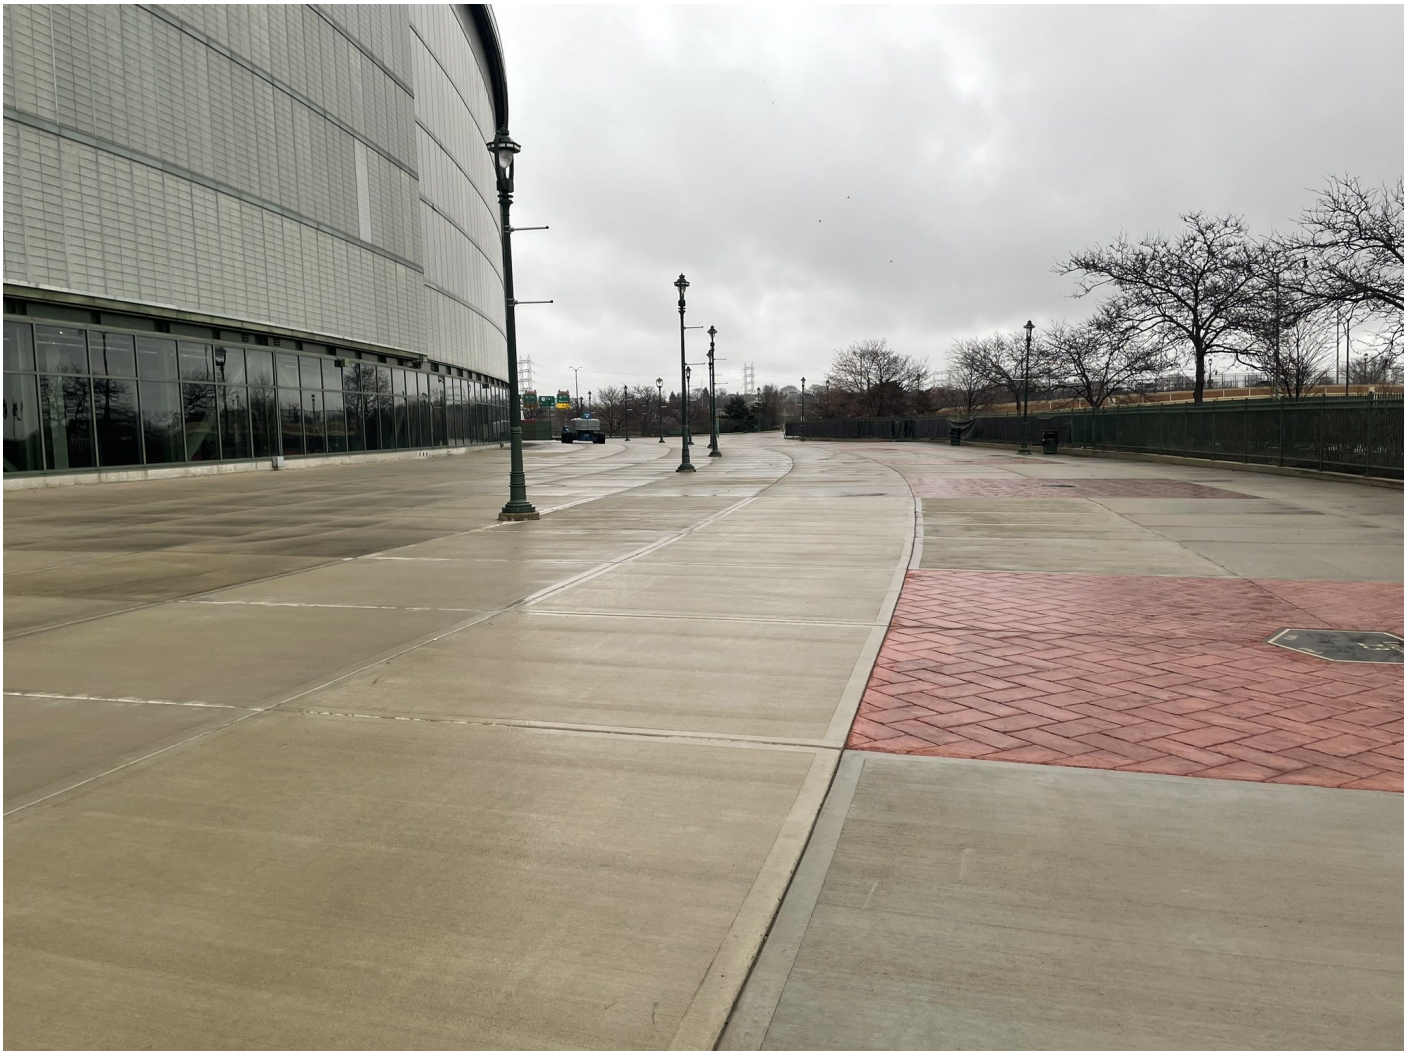
Photo 38: Stadium Plaza area (south side of stadium): Concrete pavement cap along exterior plaza sections and pedestrian sidewalk. 6-inches of concrete pavement over crushed aggregate. Decorative brick pavers within memorial sections of the plaza shown on the right side of the photo.

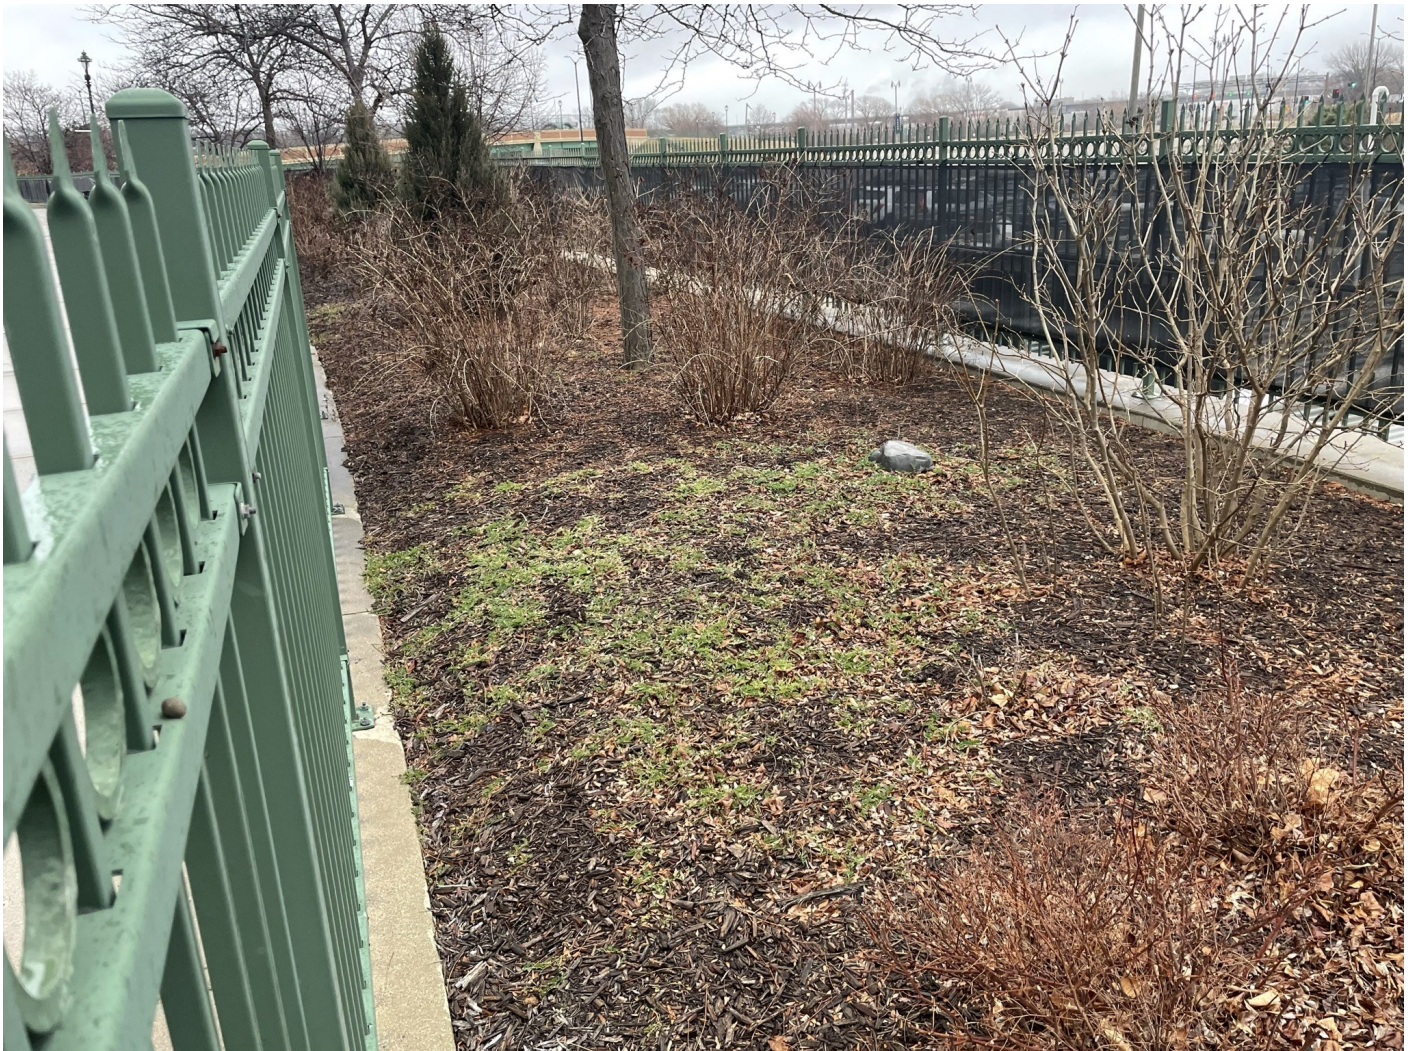
Photo 39: Stadium Plaza area (south side of stadium): Landscaped strip along plaza perimeter. Mulch landscaping over 12-inches low permeability non-impacted soil, consistent with islands and medians across the site. Photo taken facing southeast on January 18, 2023.

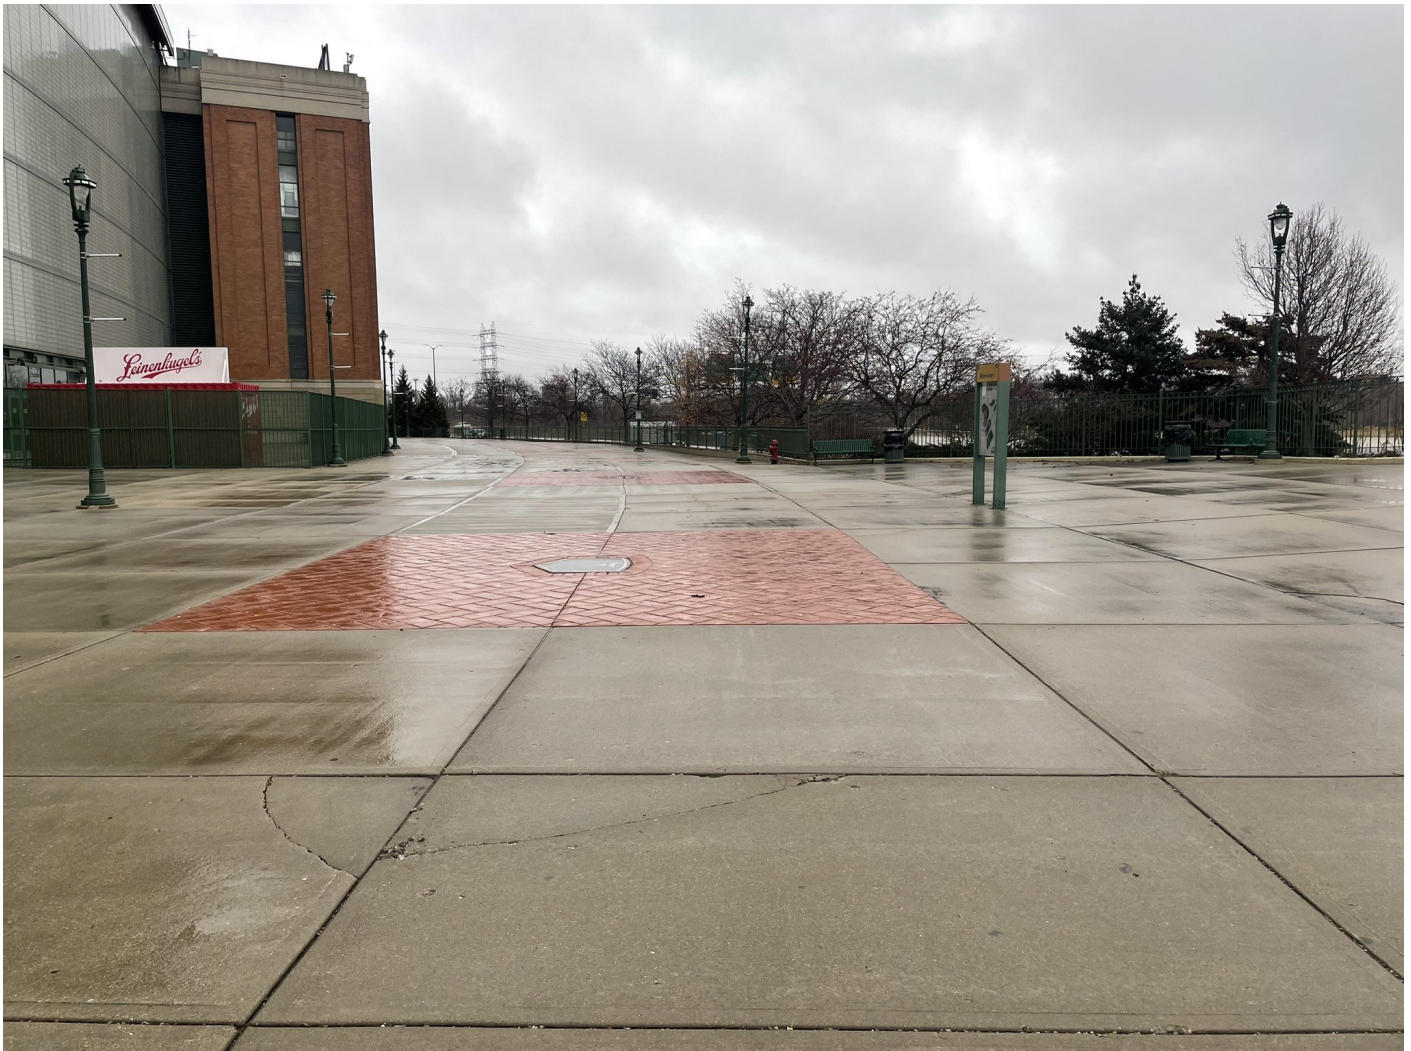
Photo 40: Stadium Plaza area (southeast side of stadium): Concrete pavement cap along exterior plaza sections and pedestrian sidewalk. 6-inches of concrete pavement over crushed aggregate. Decorative brick pavers within memorial sections of the plaza shown in central portion of the photo.

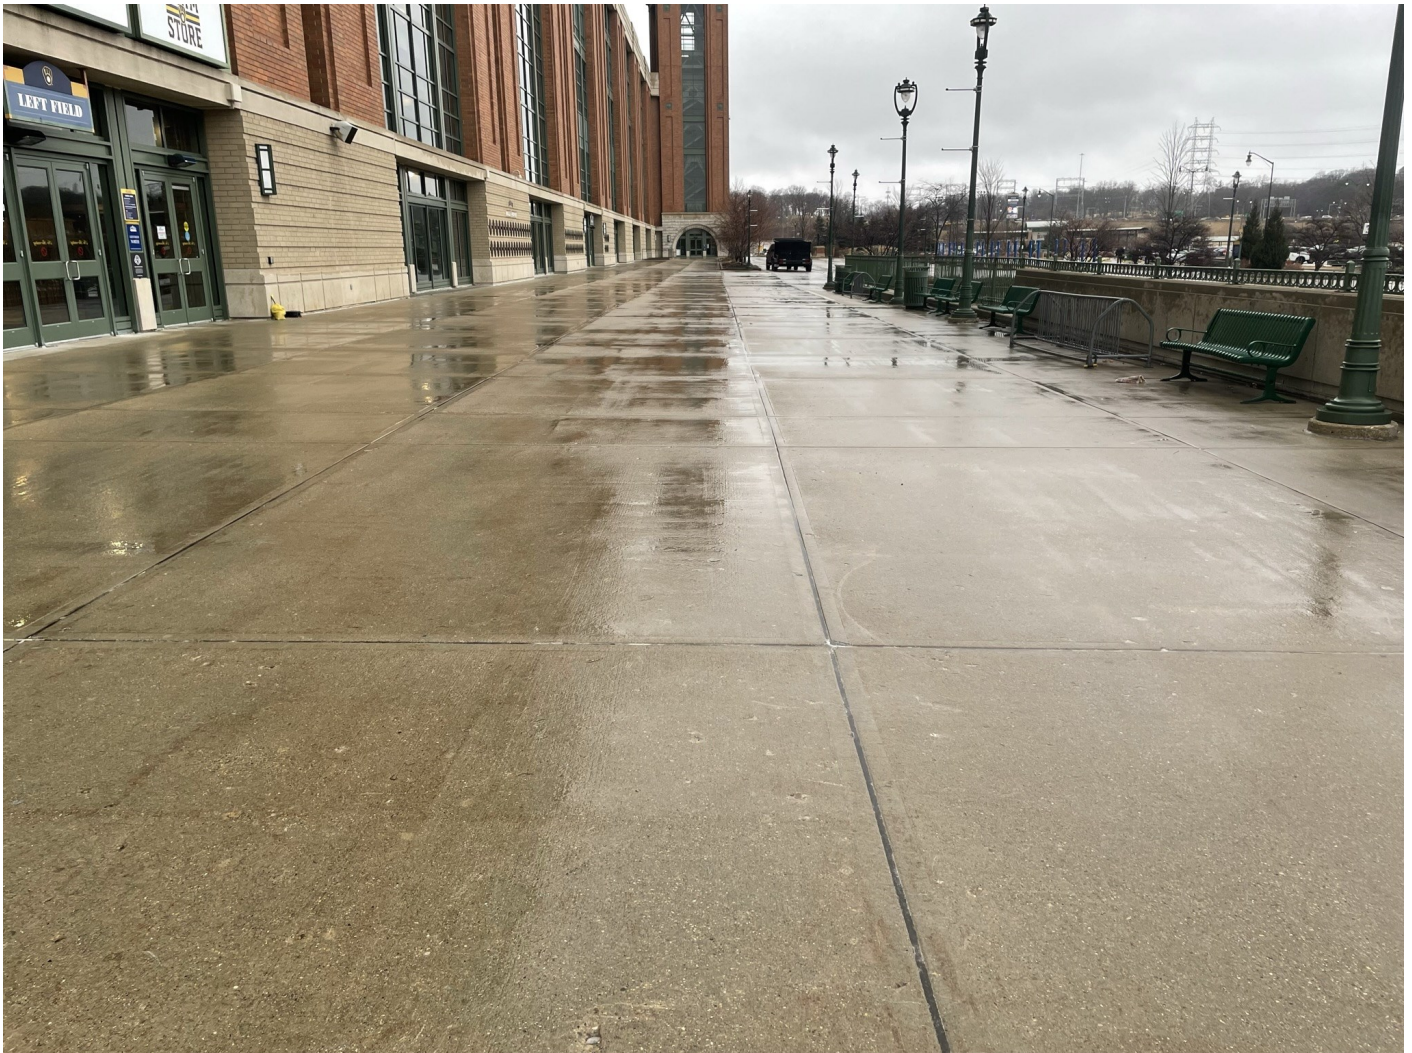
Photo 41: Stadium Plaza area (northeast side of stadium): Concrete pavement cap along exterior plaza sections and pedestrian sidewalk. 6-inches of concrete pavement over crushed aggregate.  
Photo taken facing west on January 18, 2023.

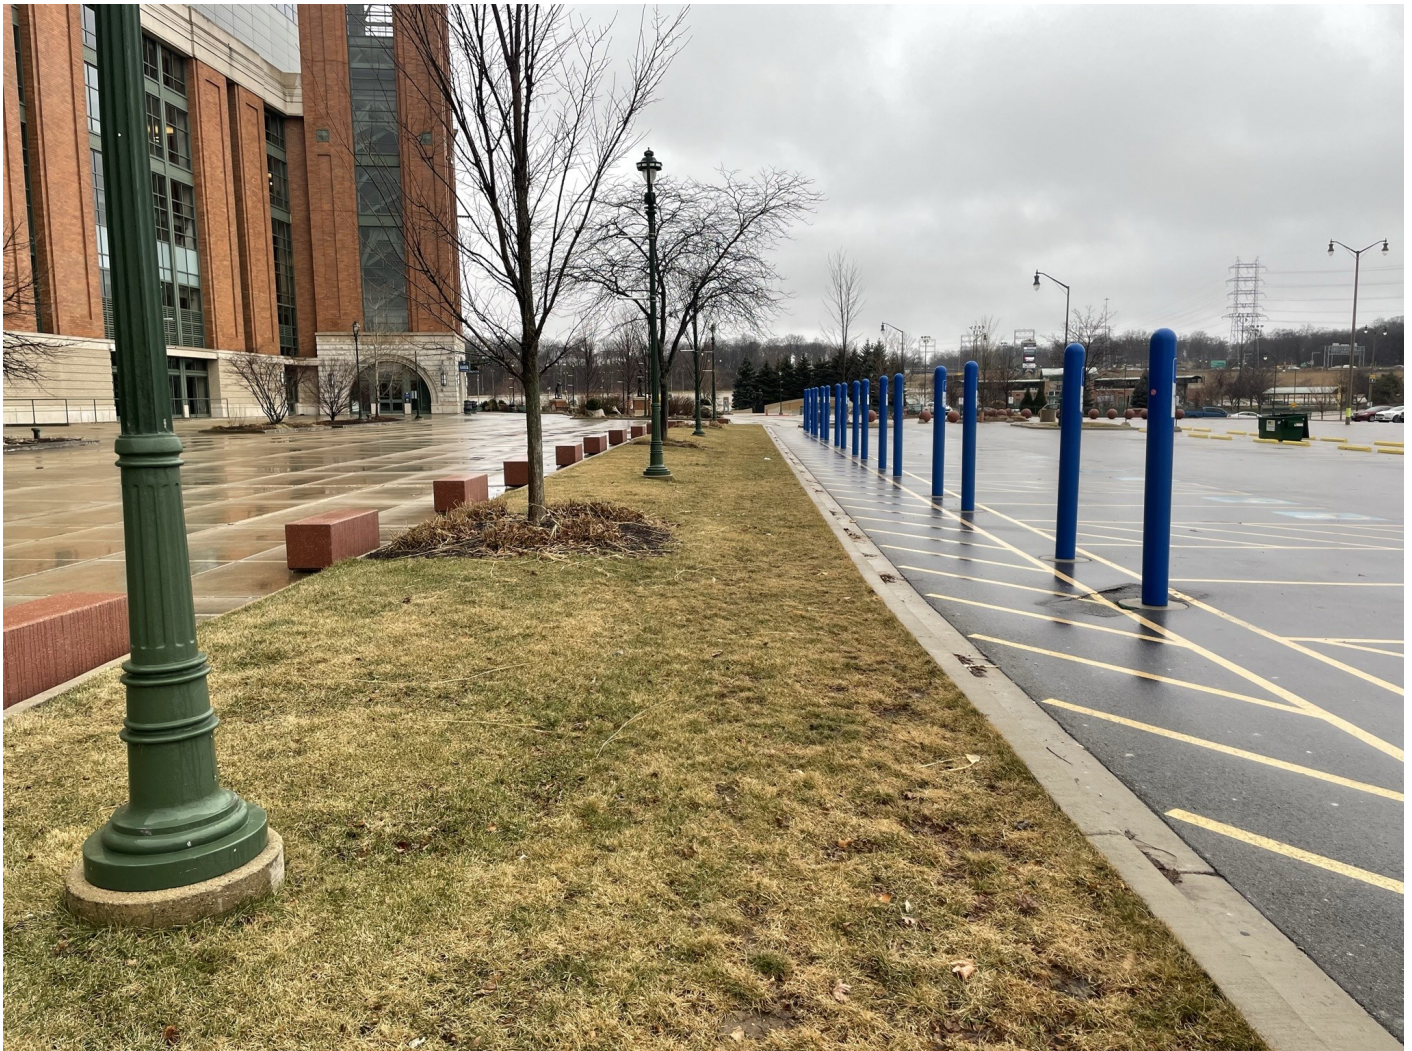
Photo 42: Stadium Plaza area (north side of stadium): Landscaped strip along plaza perimeter. Grass landscaping over 12-inches low permeability non-impacted soil, consistent with islands and medians across the site. Photo taken facing west on January 18, 2023.

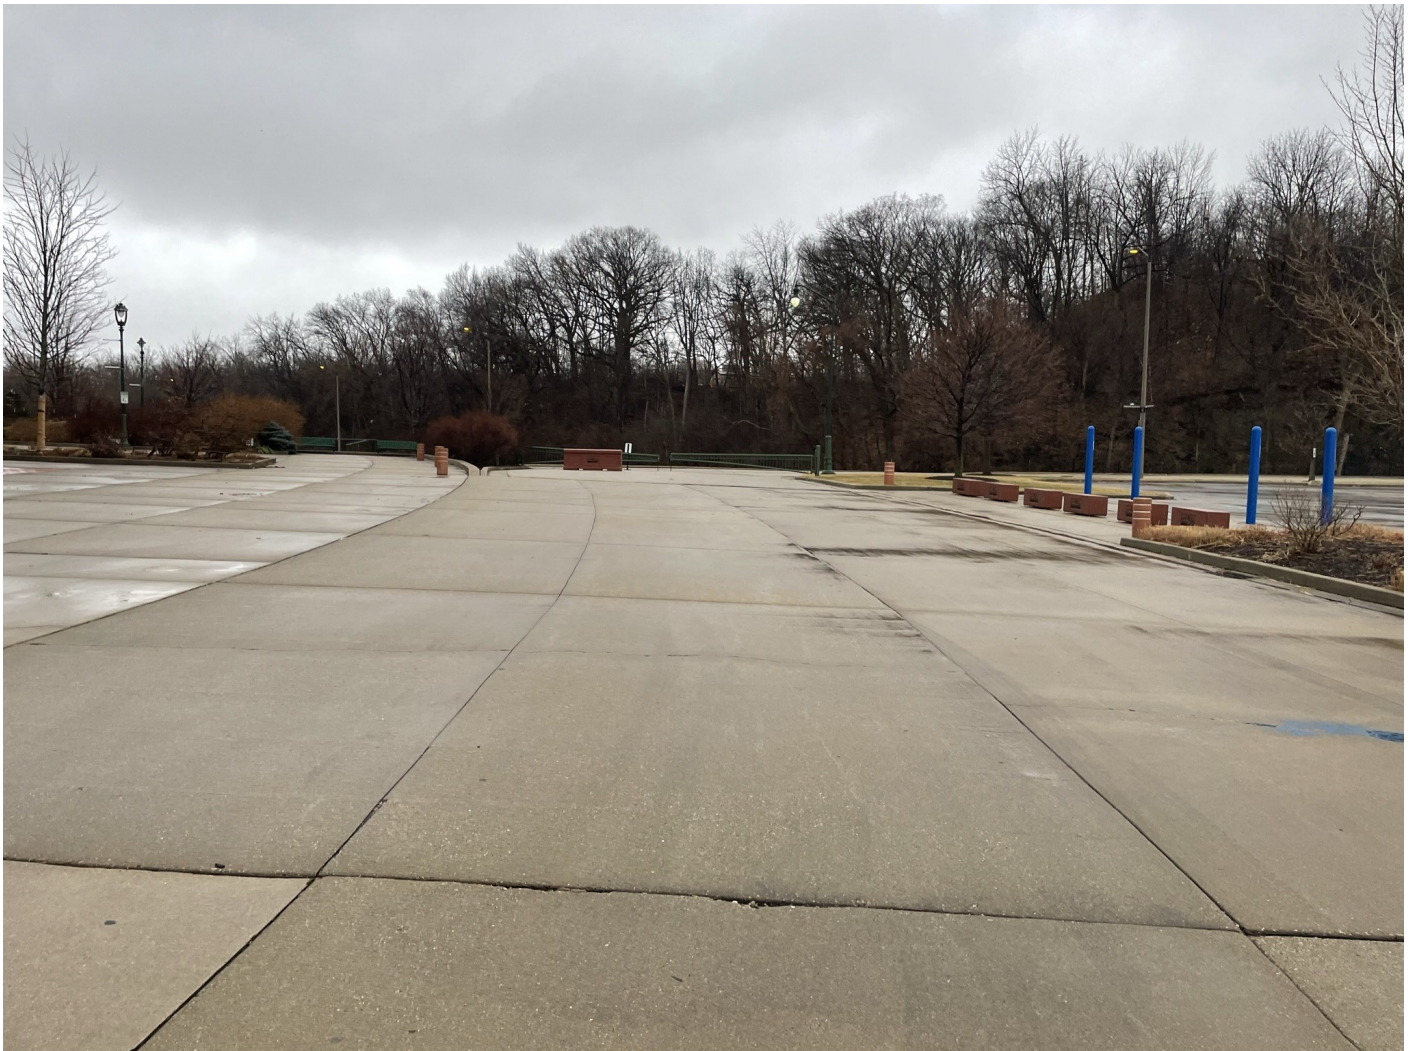
Photo 43: Stadium Plaza area (northwest side of stadium): Concrete pavement cap along exterior plaza sections, Brewers Way, and pedestrian sidewalk. 6-inches of concrete pavement over crushed aggregate. Photo taken facing southwest on January 18, 2023.
