**CAP MAINTENANCE PLAN**  
**SOUTHEAST WISCONSIN PROFESSIONAL BASEBALL PARK DISTRICT – RIVER WEST**

**FEBRUARY 2023**

**SITE PLAN MAP**  
SOUTHEAST WISCONSIN PROFESSIONAL BASEBALL PARK DISTRICT  
RIVER WEST PARCEL - BRRTS #02-41-001185  
110 S 44TH STREET, 201 & 301 S 46TH STREET  
MILWAUKEE, WISCONSIN

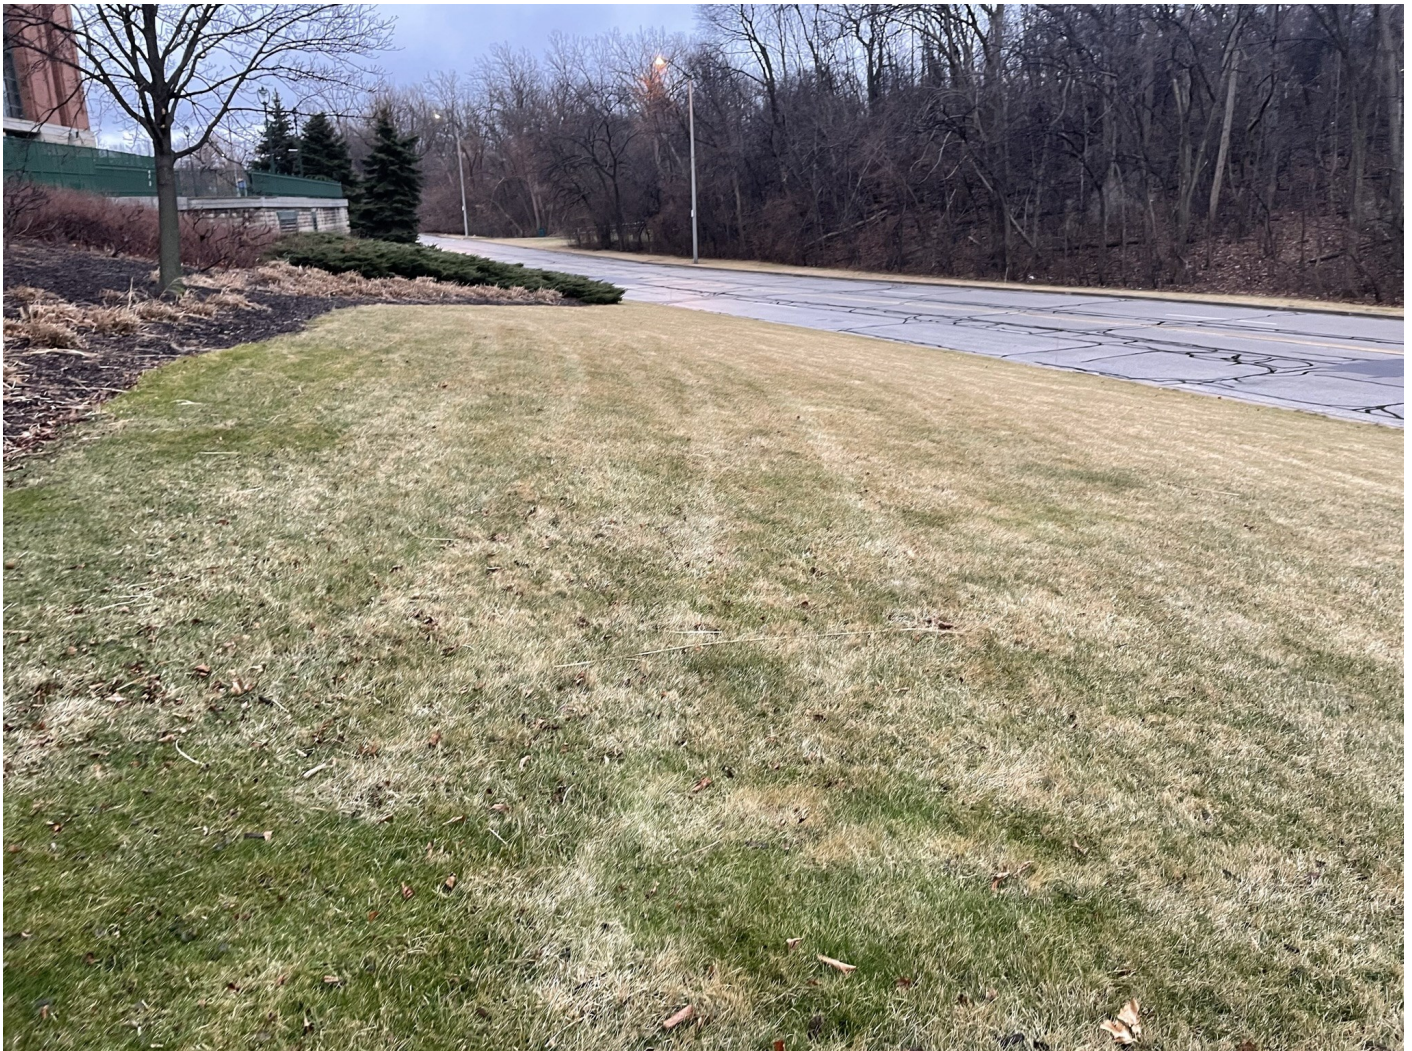
Photo 44: Stadium Plaza area (west side of stadium): Landscaping cap along west side of stadium plaza and east side of Frederick Miller Way: Grass landscaping over 12-inches low permeability non-impacted soil, consistent with greenspace across the site. Frederick Miller Way capped with asphalt pavement cap.  
Photo taken facing south on January 18, 2023.

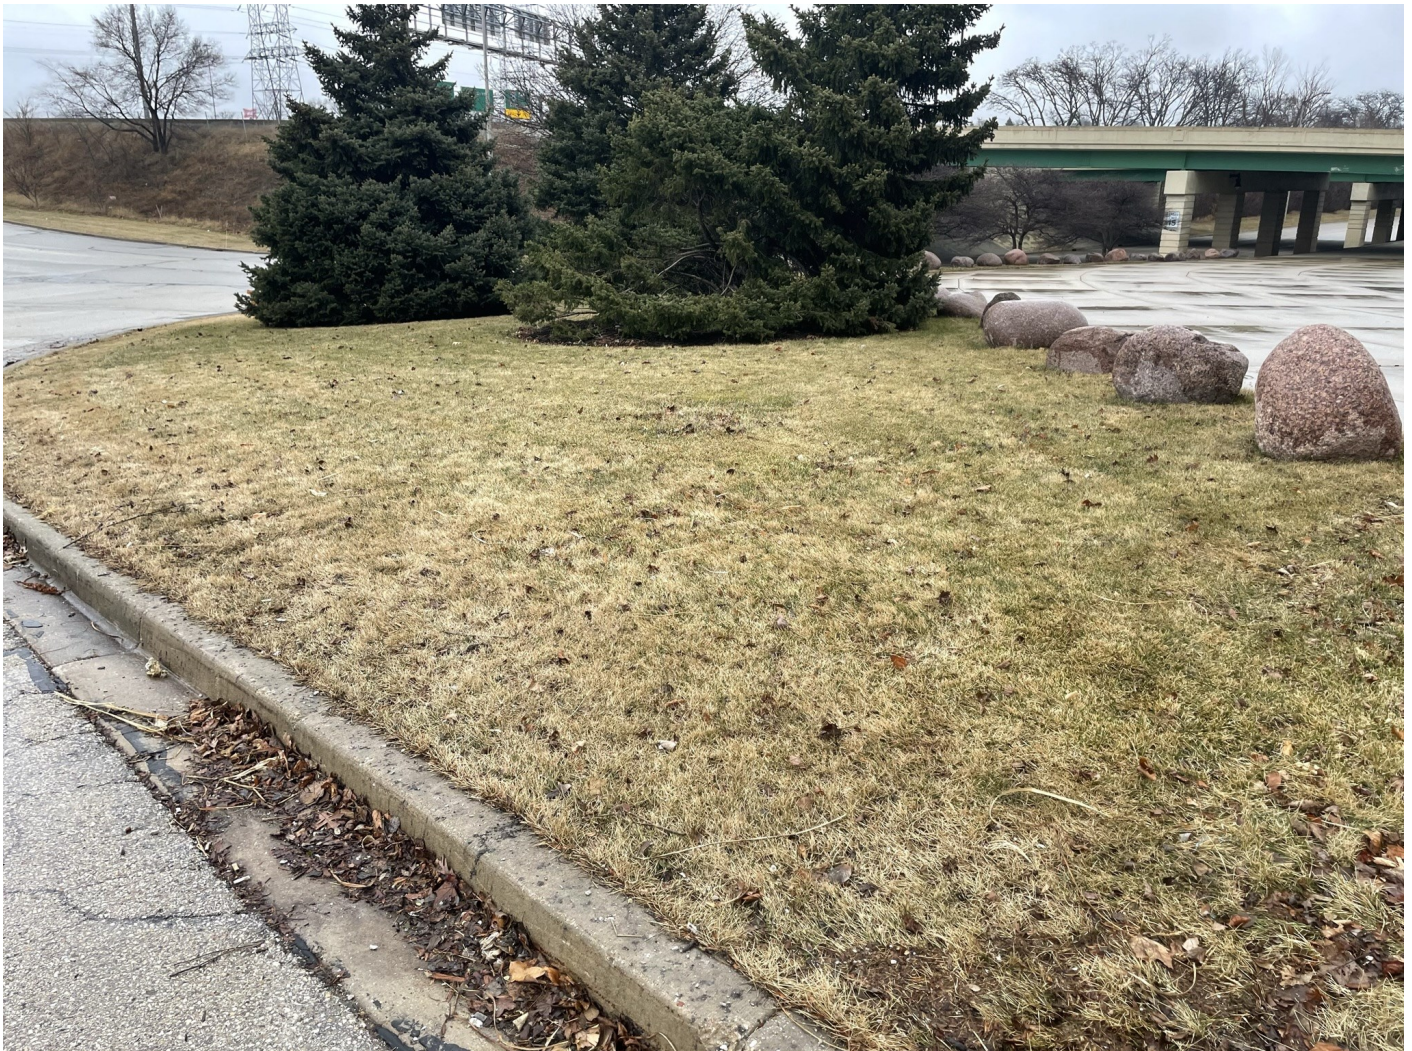
Photo 45: Brewers and Braves Lots plus Selig Drive: Greenspace landscaping with trees. Grass topsoil over 12-inches low permeability non-impacted soil. No ruts or holes in cap. Concrete curb and gutter cap shown in lower lefthand portion of photo. Photo taken facing northeast on January 18, 2023.

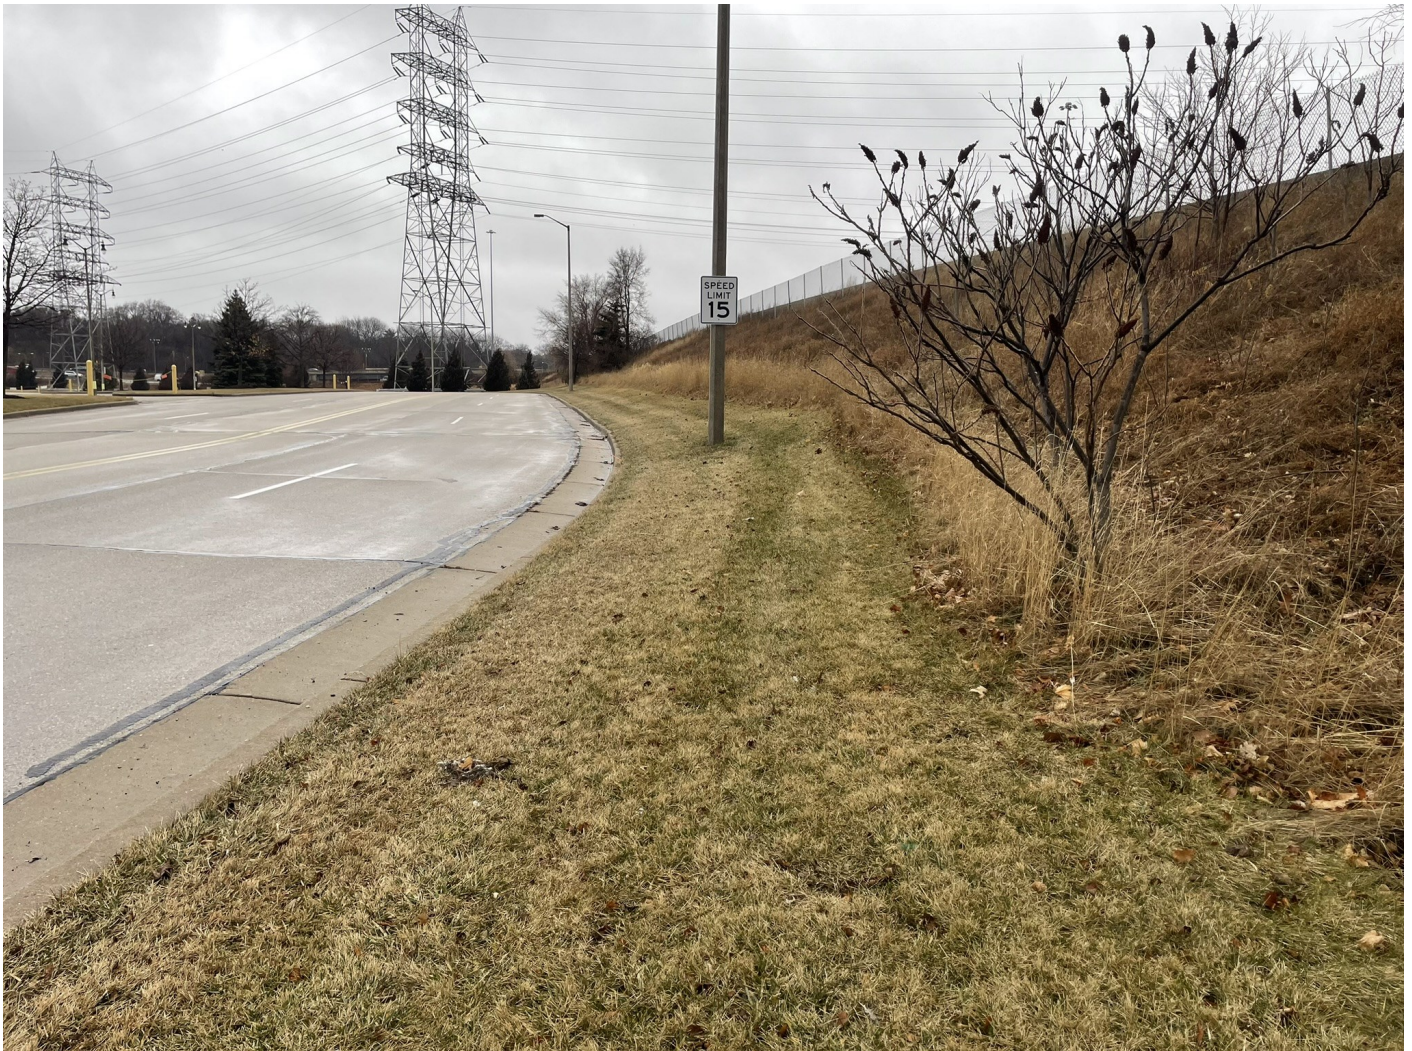
Photo 46: Brewers and Braves Lots plus Selig Drive: Greenspace landscaping along the east side of Selig Drive along Brewers and Braves Lots. Grass topsoil over 12-inches low permeability non-impacted soil. No ruts or holes in cap. Concrete curb and gutter cap, and asphalt pavement cap along roadway shown in left portion of photo. Photo taken facing northwest on January 18, 2023.

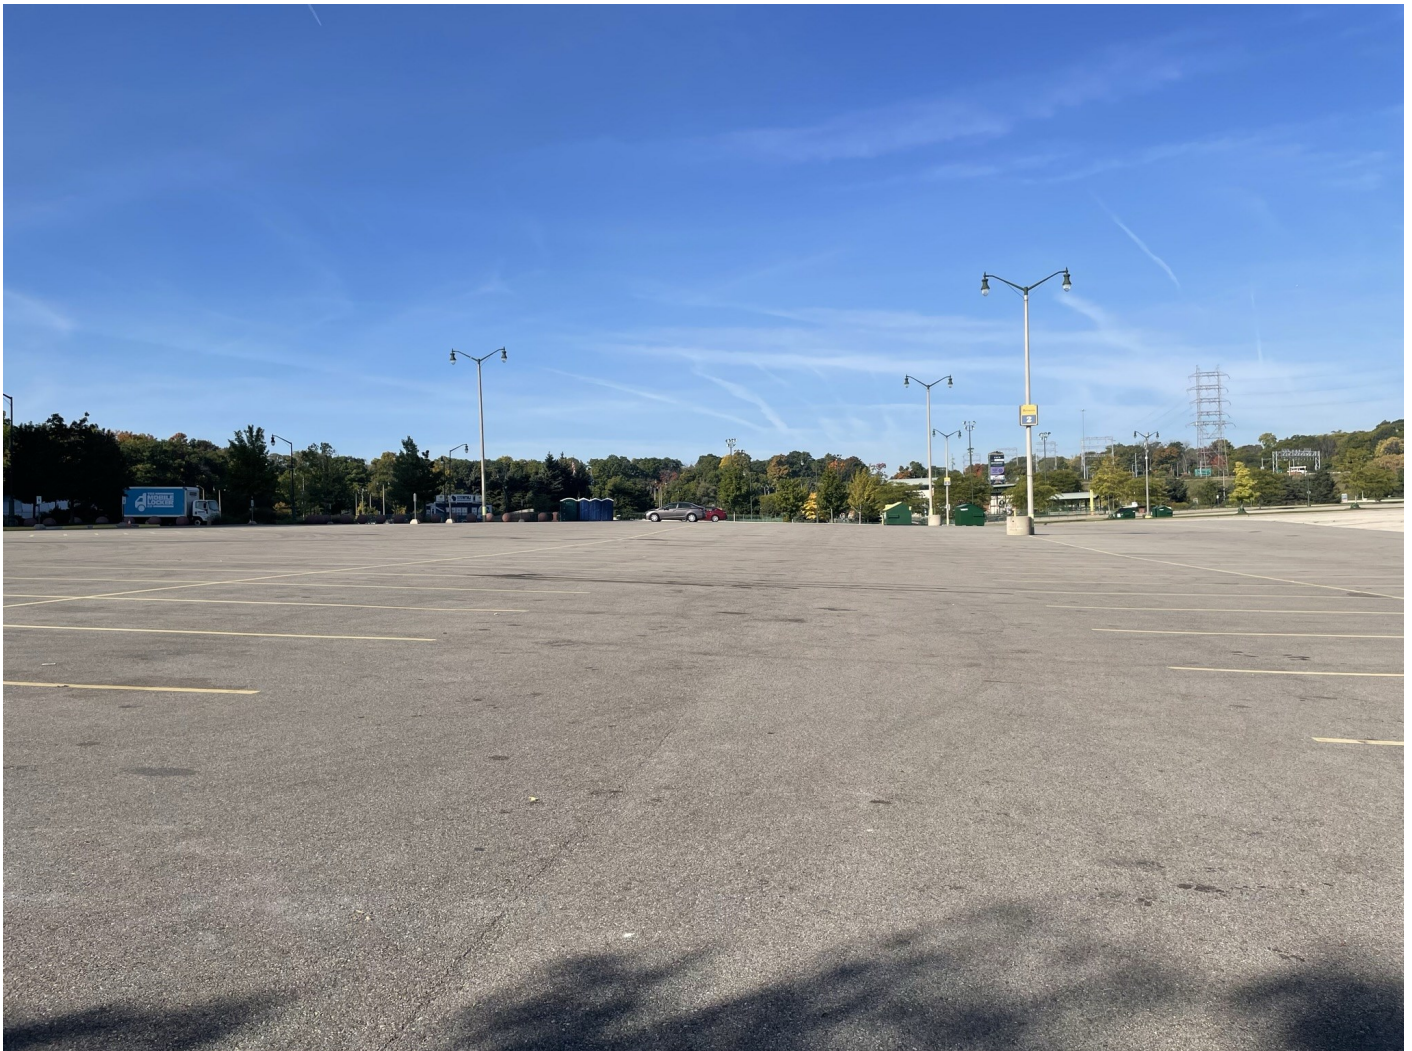
Photo 47: Brewers and Braves Lots plus Selig Drive: Brewers 2 Lot paved with asphalt surface cap: 4-inch asphalt pavement over 8-inches of crushed aggregate. No holes, major cracks, or other compromises.  
Photo taken facing west on October 4, 2022.

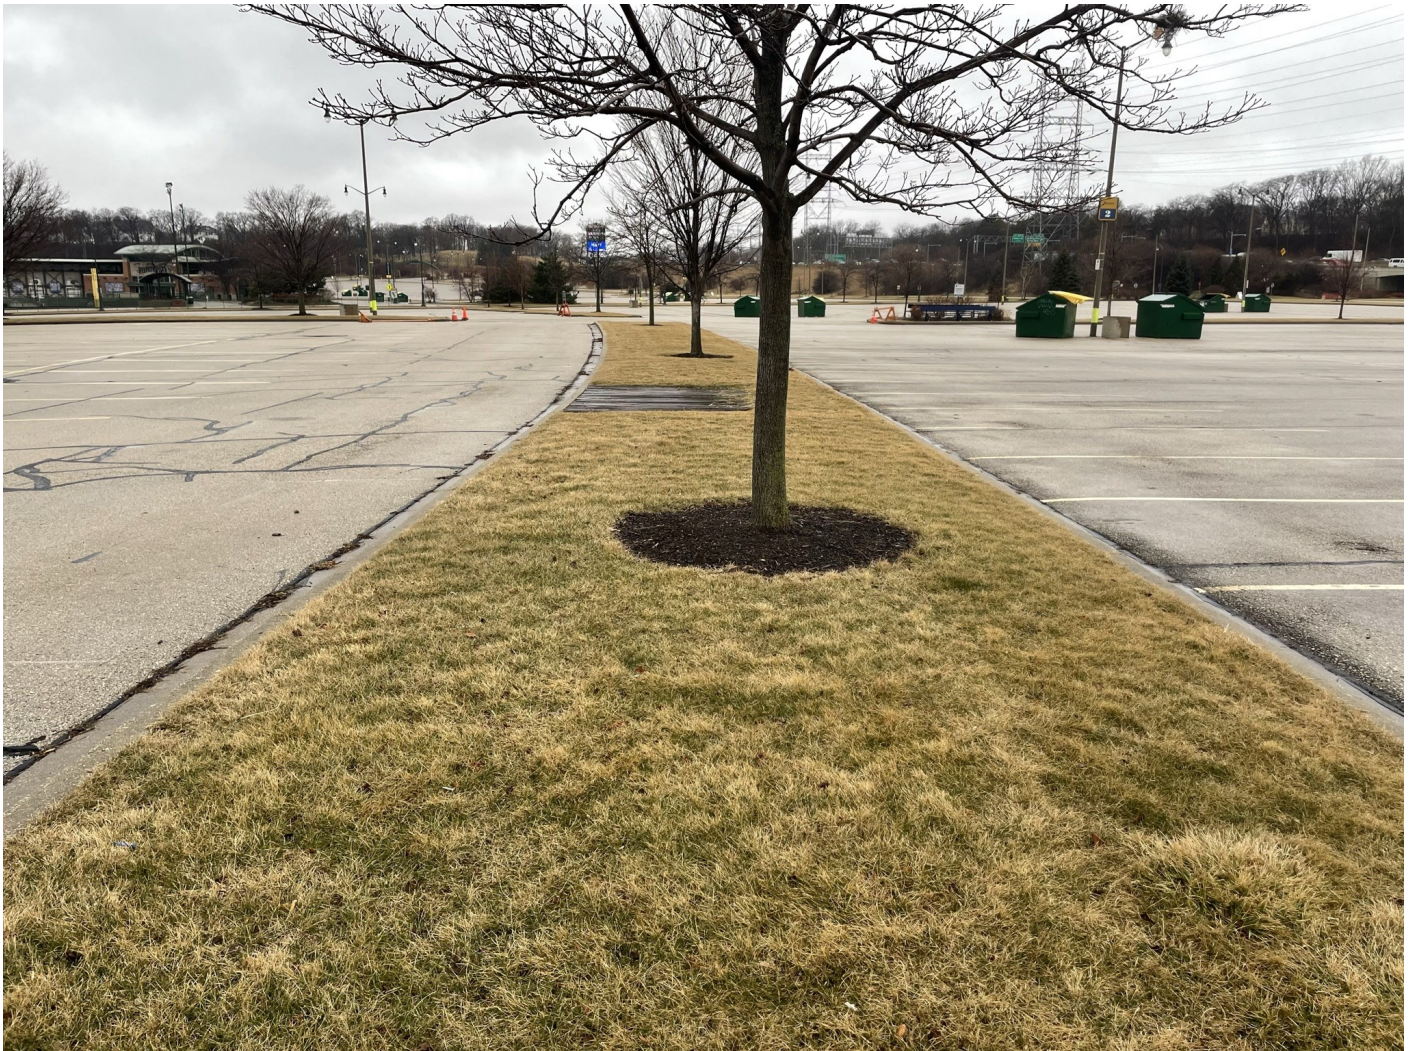
Photo 48: Brewers and Braves Lots plus Selig Drive: Brewers 2 Lot (left) and Braves 2 Lot (right) paved with asphalt surface cap: 4-inch asphalt pavement over 8-inches of crushed aggregate. No holes, major cracks, or other compromises. Landscaped median between each lot: Grass greenspace cap: grass topsoil over 12-inches of low permeability non-impacted soil. Photo taken facing west on January 18, 2023.

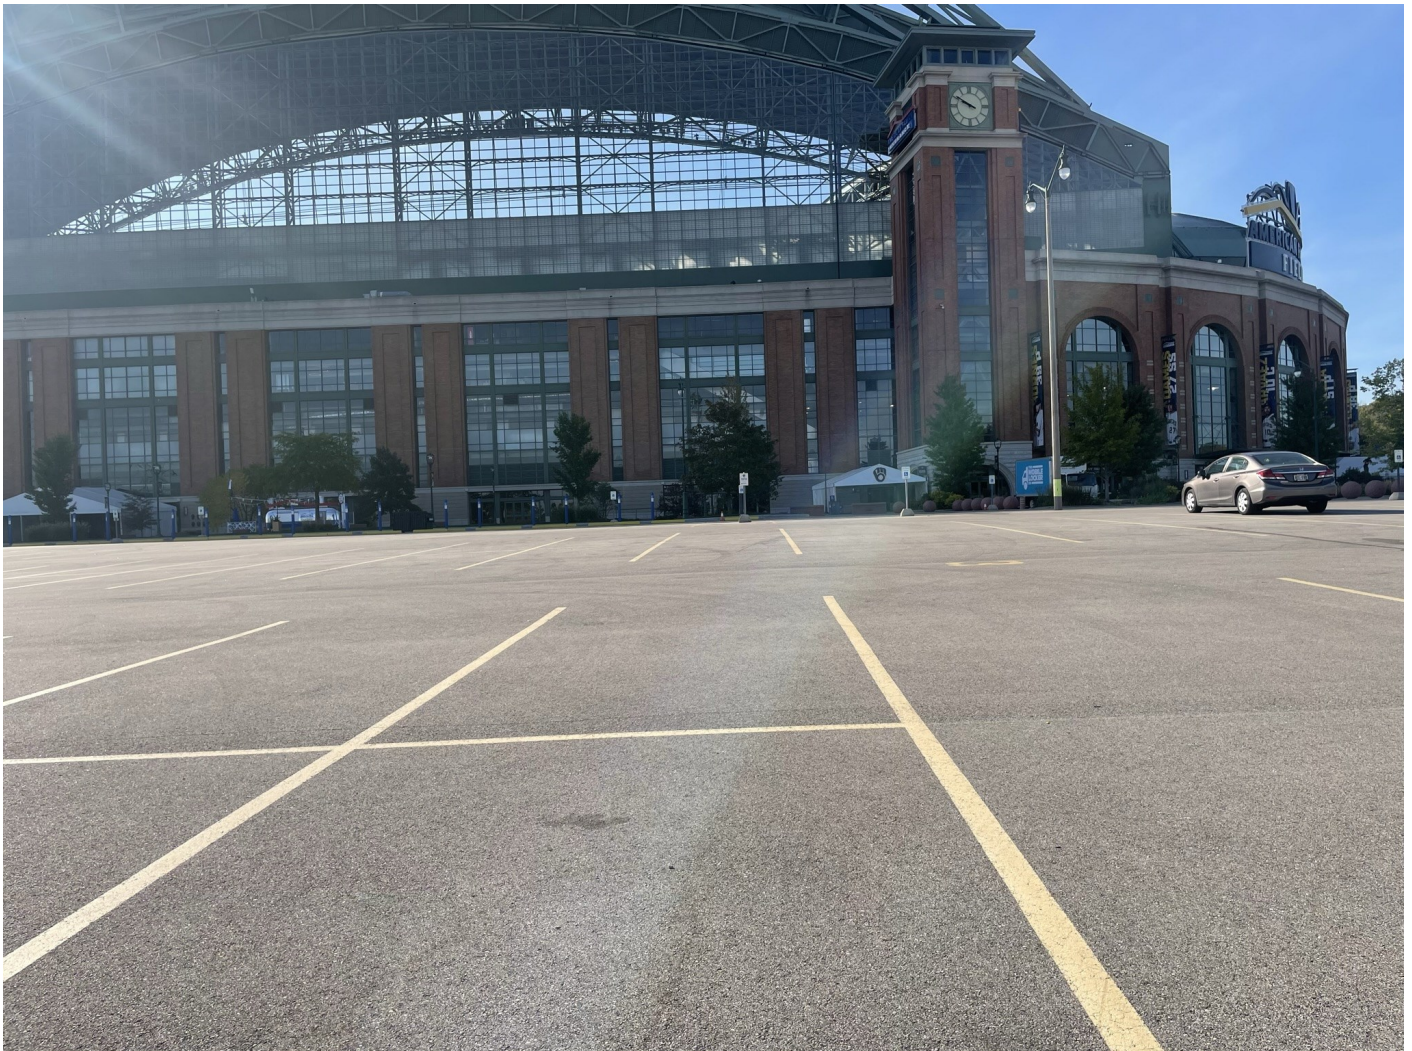
Photo 49: Brewers and Braves Lots plus Selig Drive: Brewers 2 Lot paved with asphalt surface cap: 4-inch asphalt pavement over 8-inches of crushed aggregate. No holes, major cracks, or other compromises.  
Photo taken facing south on October 4, 2022.

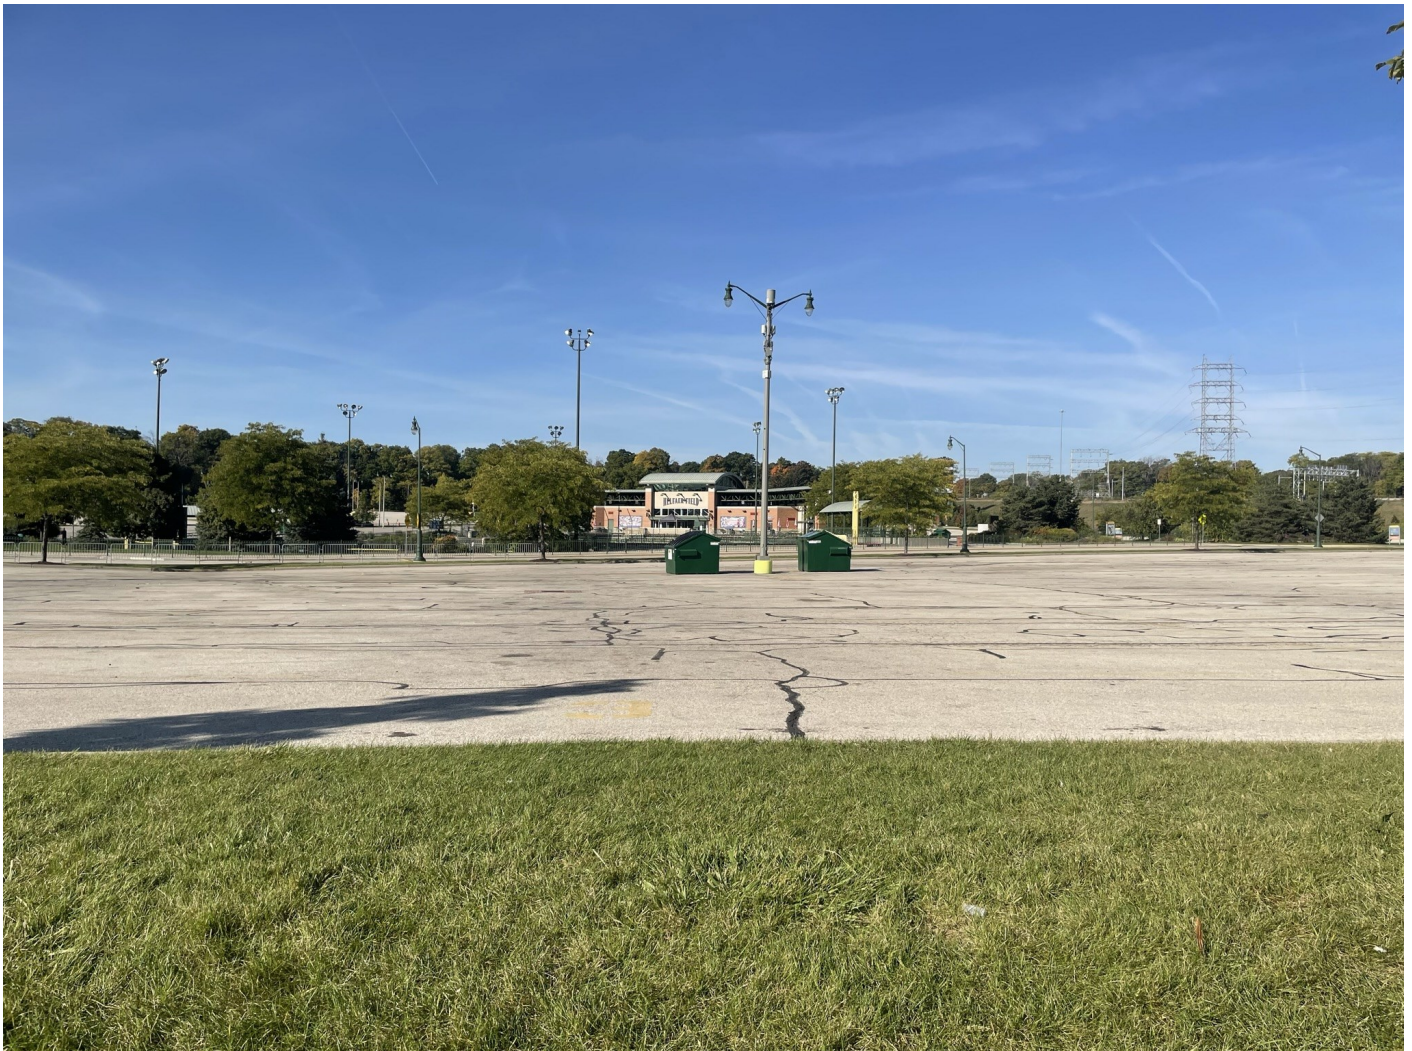
Photo 50: Brewers and Braves Lots plus Selig Drive: Brewers 1 Lot paved with asphalt surface cap: 4-inch asphalt pavement over 8-inches of crushed aggregate. Greenspace median cap shown in photo foreground. Photo taken facing west on October 4, 2022.

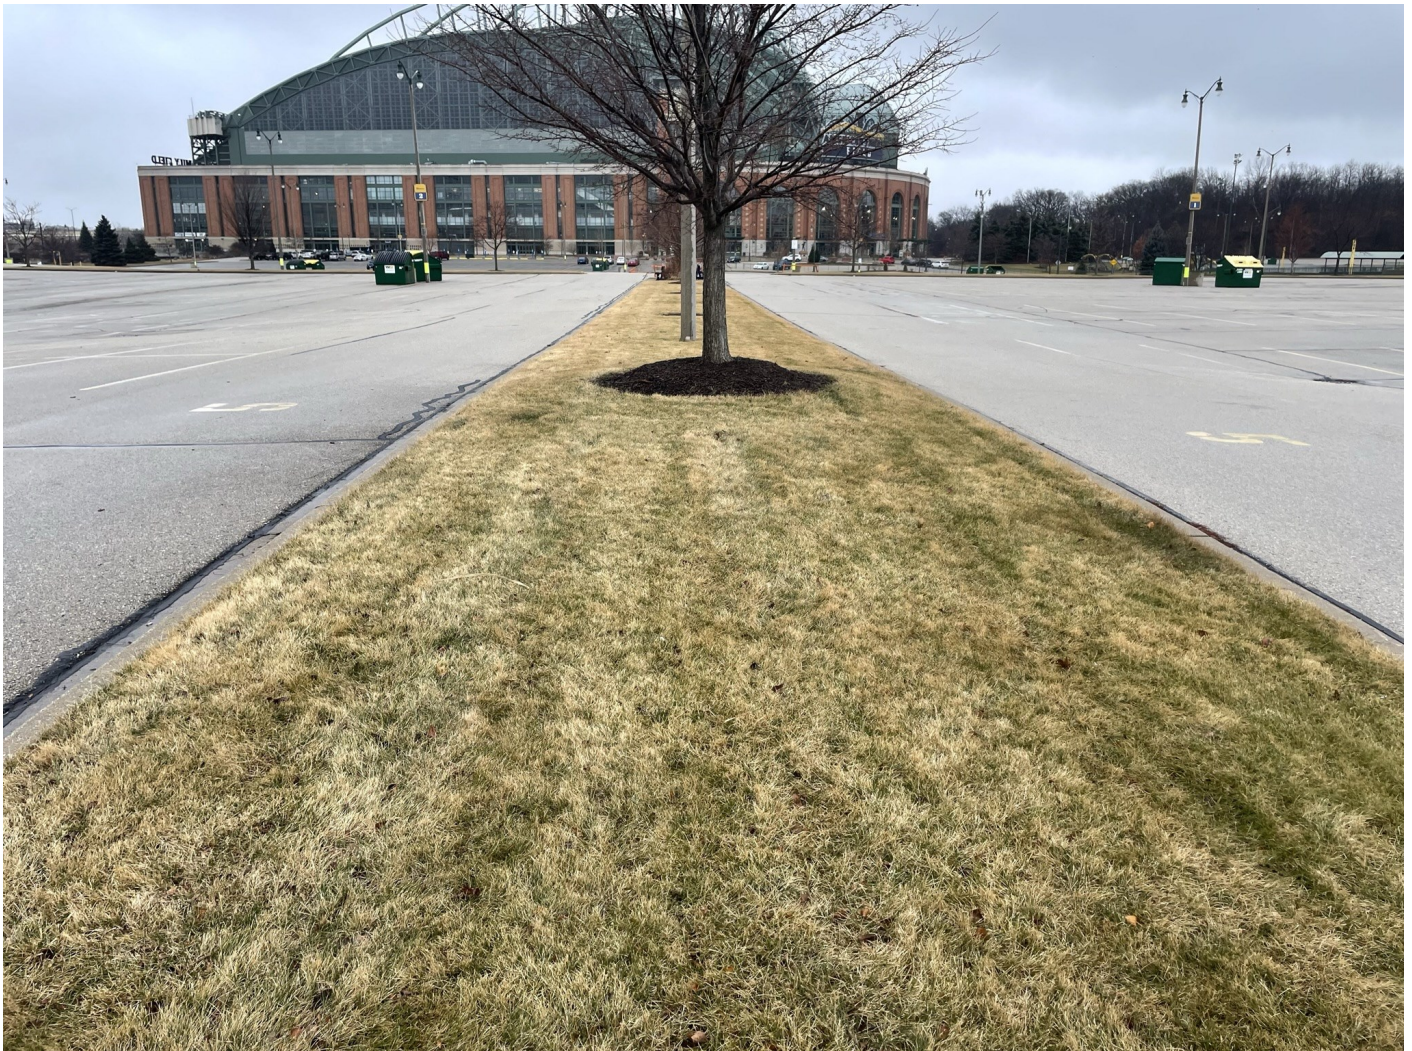
Photo 51: Brewers and Braves Lots plus Selig Drive: Braves 1 (right) and Braves 2 (left) Lots paved with asphalt surface cap: 4-inch asphalt pavement over 8-inches of crushed aggregate. Landscaped greenspace median in central portion of photo: grass topsoil over 12-inches of low permeability non-impacted soil. Photo taken facing south on January 18, 2023.

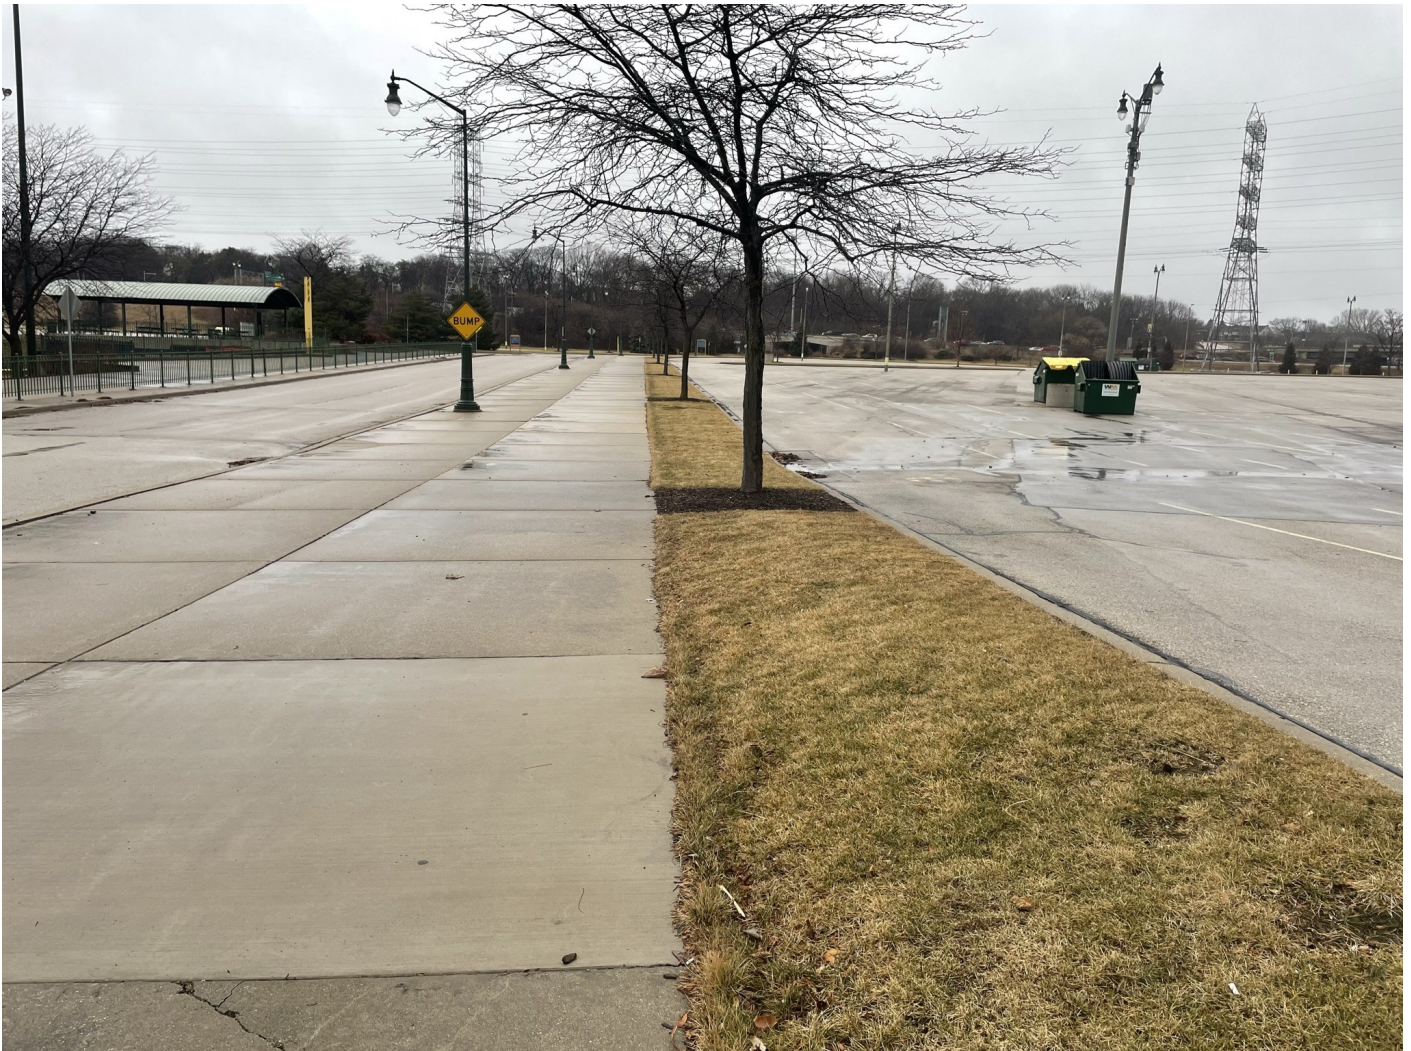
Photo 52: Brewers and Braves Lots plus Selig Drive: Asphalt cap entrance drive (left) along west side of Brewers 1 Lot. Concrete cap sidewalk along west side of Brewers 1 Lot. Greenspace cap median along west side of Brewers 1 Lot. Photo taken facing north on January 18, 2023.

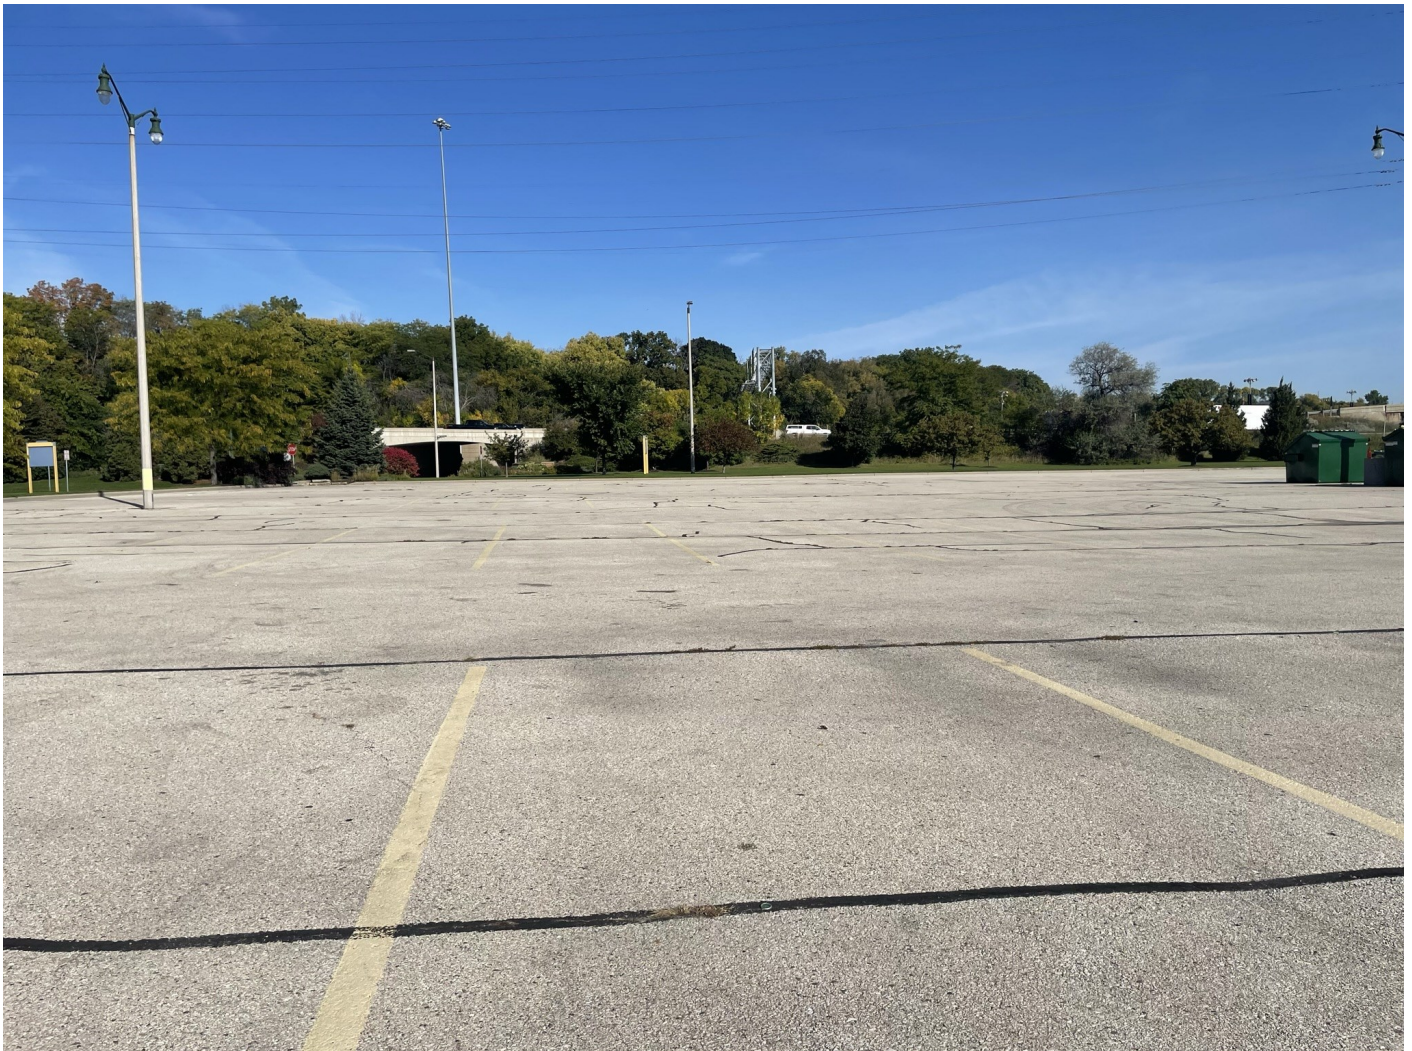
Photo 53: Brewers and Braves Lots plus Selig Drive: Braves 1 Lot paved with asphalt surface cap: 4-inch asphalt pavement over 8-inches of crushed aggregate.  
Photo taken facing north on October 4, 2022.

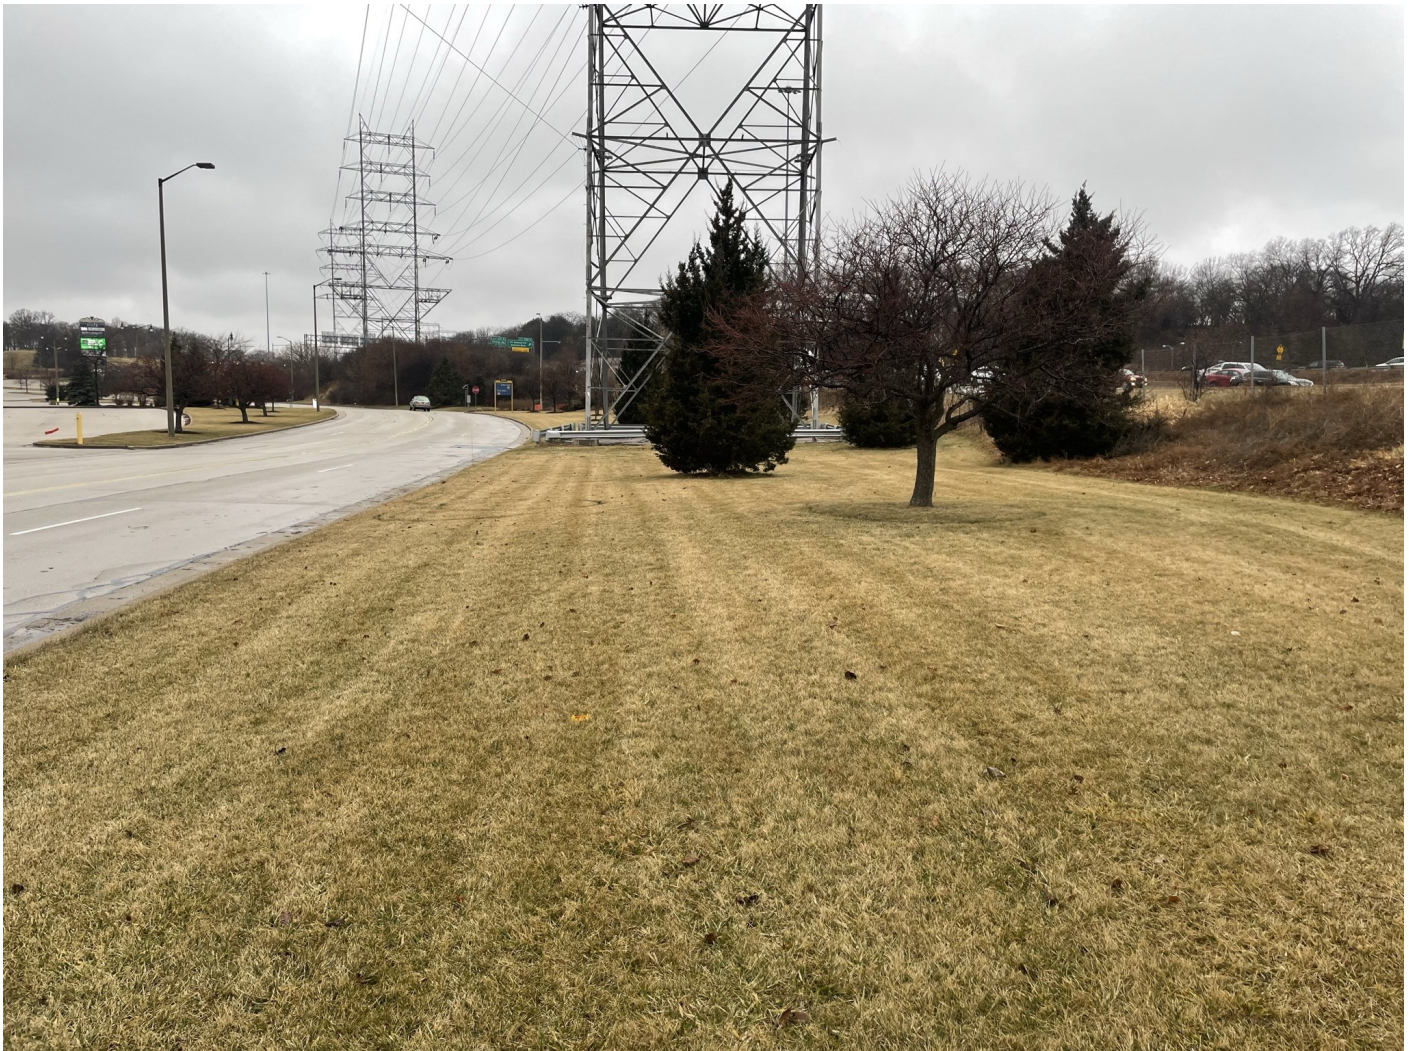
Photo 54: Brewers and Braves Lots plus Selig Drive: Greenspace landscaping along the north side of Selig Drive along Braves Lots. Grass topsoil over 12-inches low permeability non-impacted soil. No ruts or holes in cap. Concrete curb and gutter cap, and asphalt pavement cap along roadway shown in left portion of photo. Photo taken facing west on January 18, 2023.

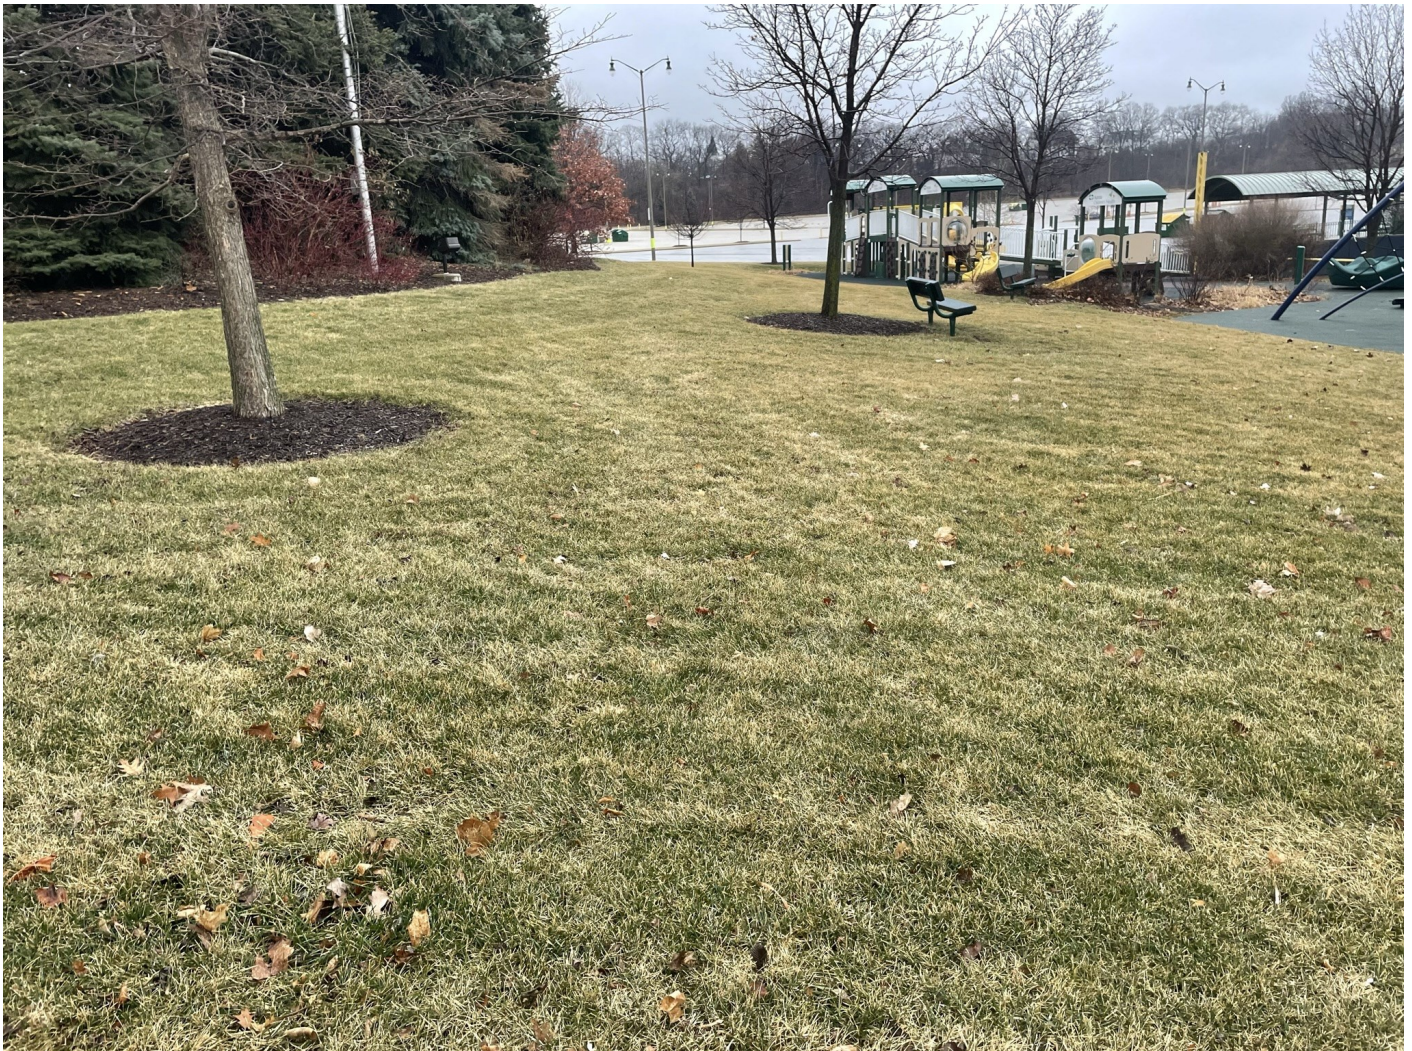
Photo 55: Helfaer Field surrounding areas: Greenspace cap and landscaping cap across playground and grassy hill area southeast of Helfaer Field: Grass or mulch covered topsoil over 12-inches of low permeability non-impacted soil. Photo taken facing west on January 18, 2023.

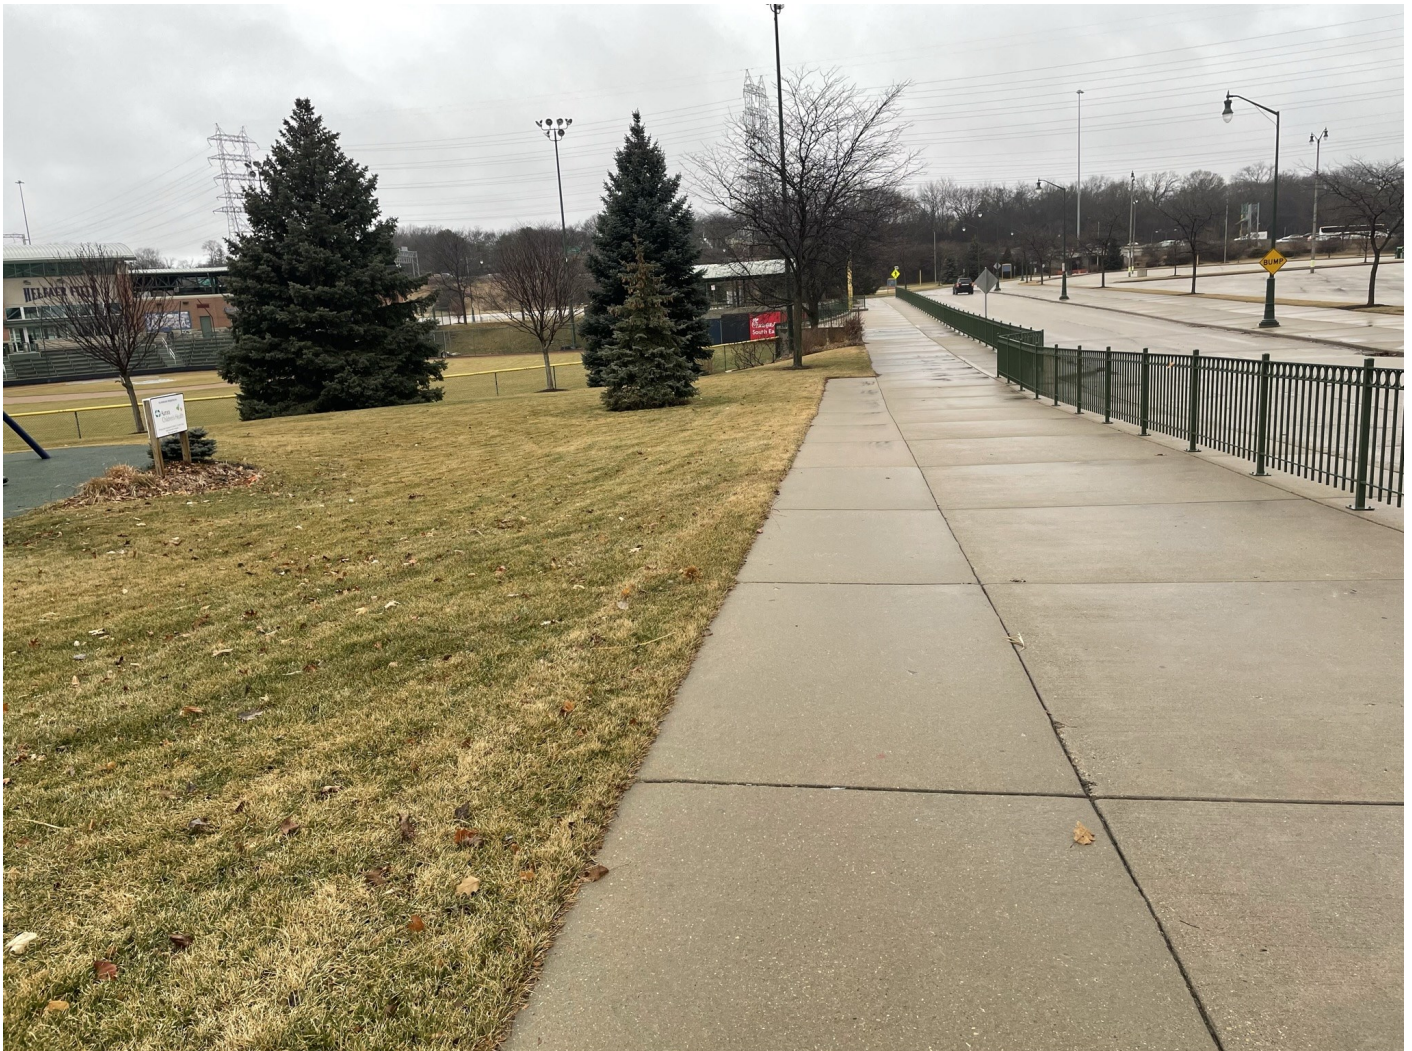
Photo 56: Helfaer Field surrounding areas: Greenspace cap and landscaping cap across playground and grassy hill area southeast of Helfaer Field (left): Grass or mulch covered topsoil over 12-inches of low permeability non-impacted soil. Concrete cap sidewalk along entrance road and east side of Helfaer Field (right): 6-inch concrete cap over 8-inches of crushed aggregate. Photo taken facing north on January 18, 2023.

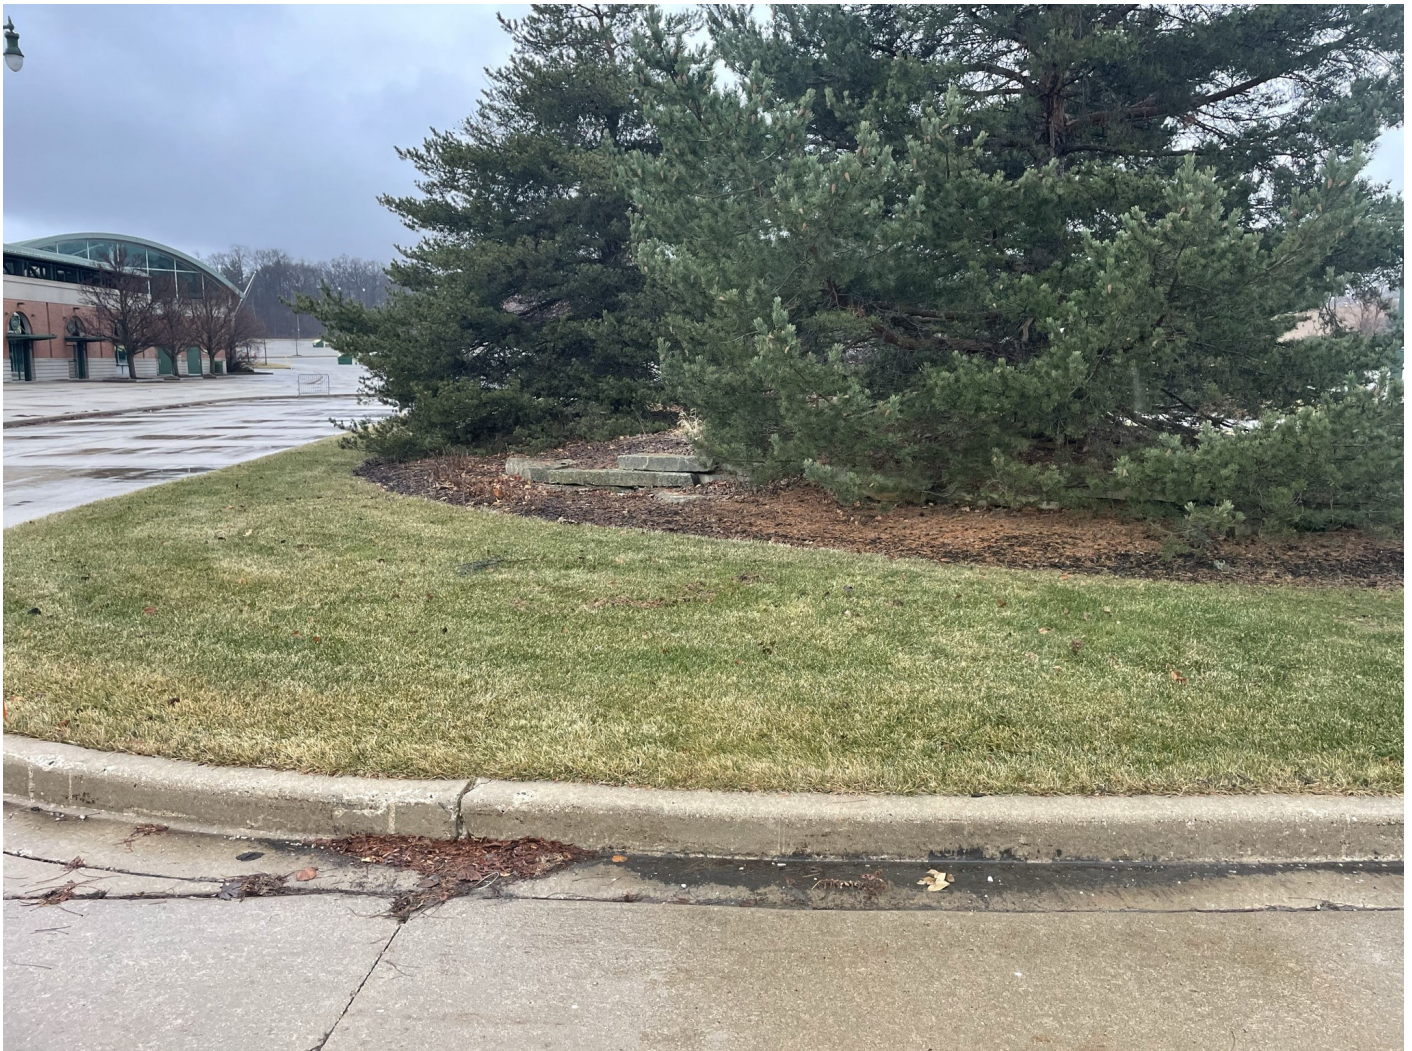
Photo 57: Helfaer Field surrounding areas: Greenspace cap and landscaping cap across within median of Helfaer Field circle drive: Grass or mulch covered topsoil over 12-inches of low permeability non-impacted soil. Photo taken facing west on January 18, 2023.
