**CAP MAINTENANCE PLAN**  
**SOUTHEAST WISCONSIN PROFESSIONAL BASEBALL PARK DISTRICT – RIVER WEST**

**FEBRUARY 2023**

**SITE PLAN MAP**  
SOUTHEAST WISCONSIN PROFESSIONAL BASEBALL PARK DISTRICT  
RIVER WEST PARCEL - BRRTS #02-41-001185  
110 S 44TH STREET, 201 & 301 S 46TH STREET  
MILWAUKEE, WISCONSIN

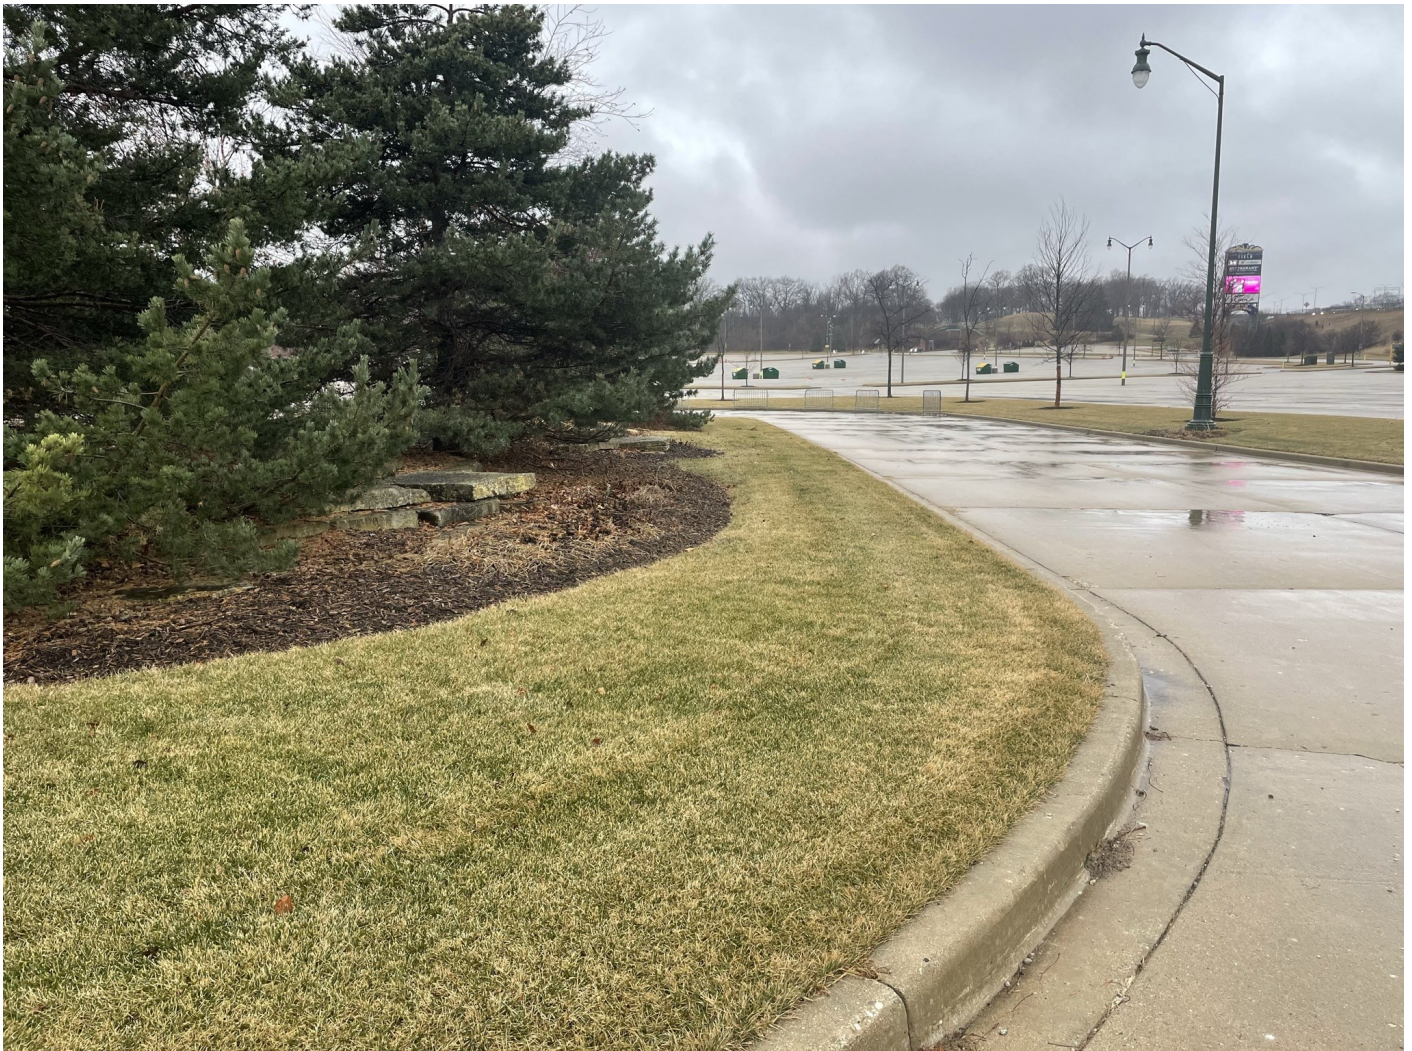
Photo 58: Helfaer Field surrounding areas: Greenspace cap and landscaping cap across within median of Helfaer Field circle drive: Grass or mulch covered topsoil over 12-inches of low permeability non-impacted soil. Concrete cap circle drive: 6-inch concrete cap overlying 8-inches crushed aggregate. Concrete curb and gutter shown in photo. Photo taken facing west on January 18, 2023.

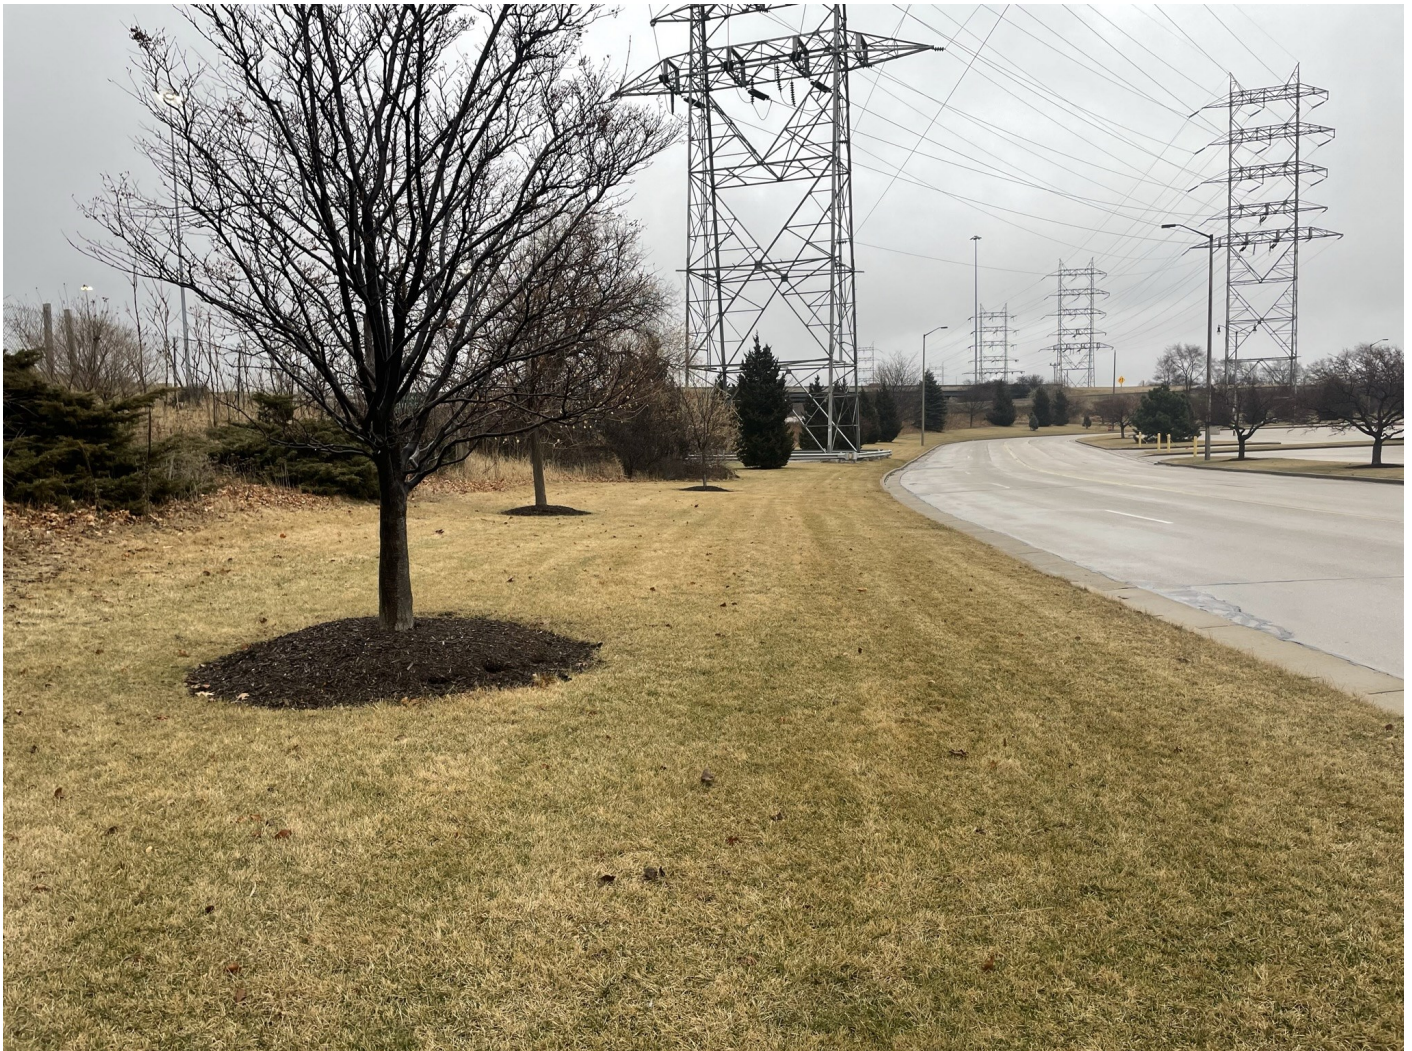
Photo 59: Cooper Lot area: Greenspace cap and landscaping cap along north side of Selig Drive north of Cooper Lot: Grass or mulch covered topsoil over 12-inches of low permeability non-impacted soil. Photo taken facing east on January 18, 2023.

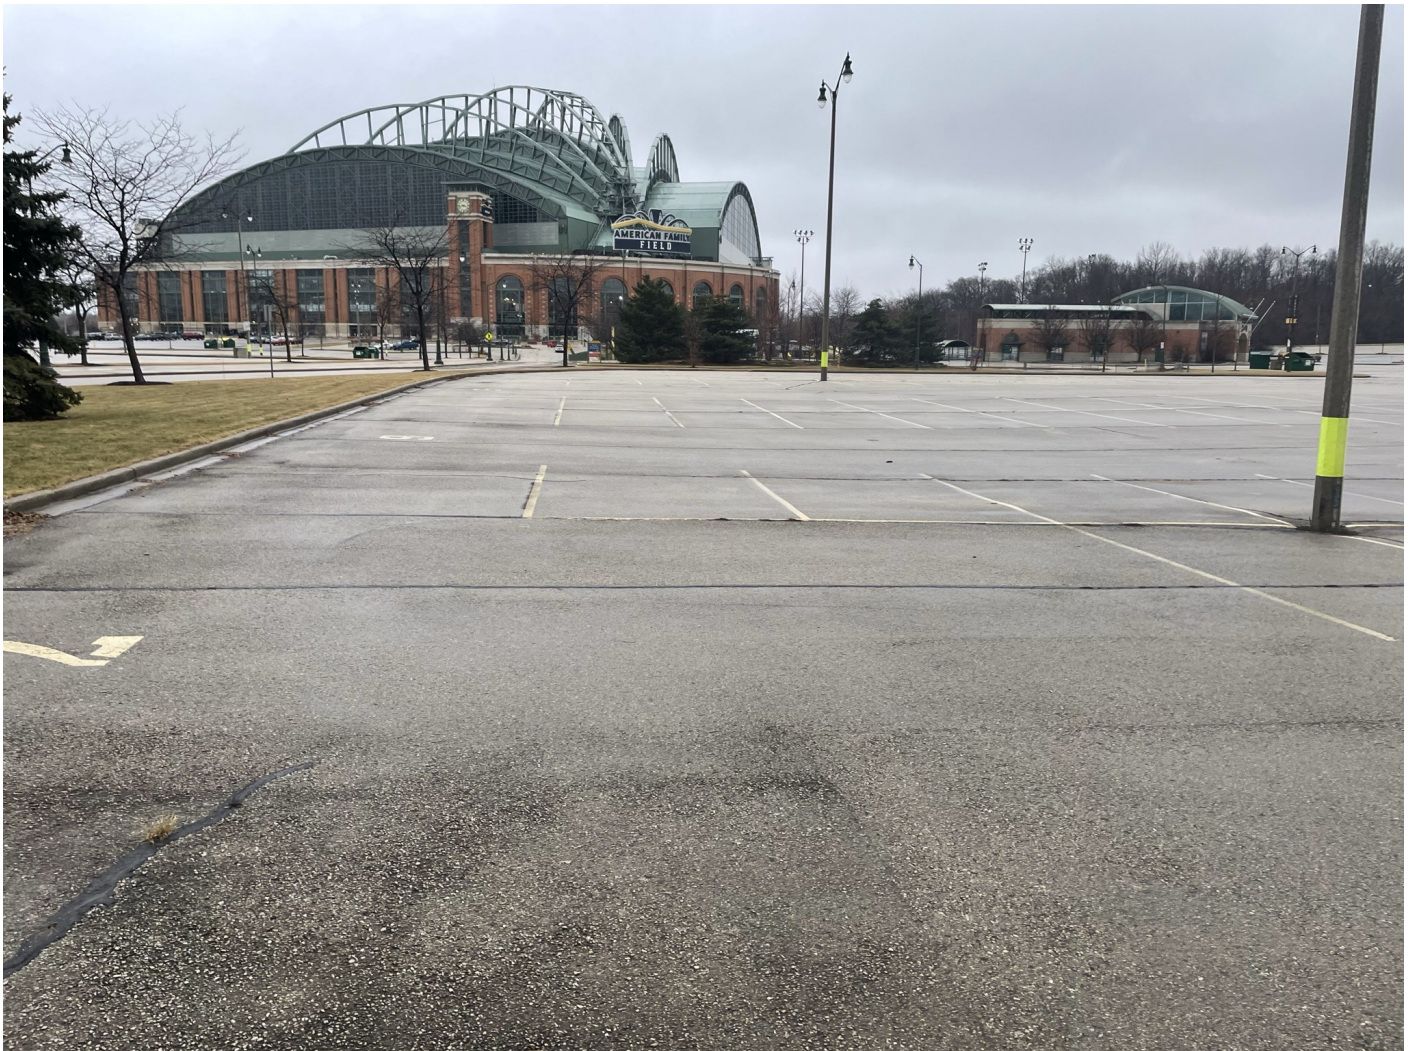
Photo 60: Cooper Lot area: Asphalt cap parking lot: 4-inch asphalt pavement cap over 8-inches of crushed aggregate base course. Photo taken facing south on January 18, 2023.

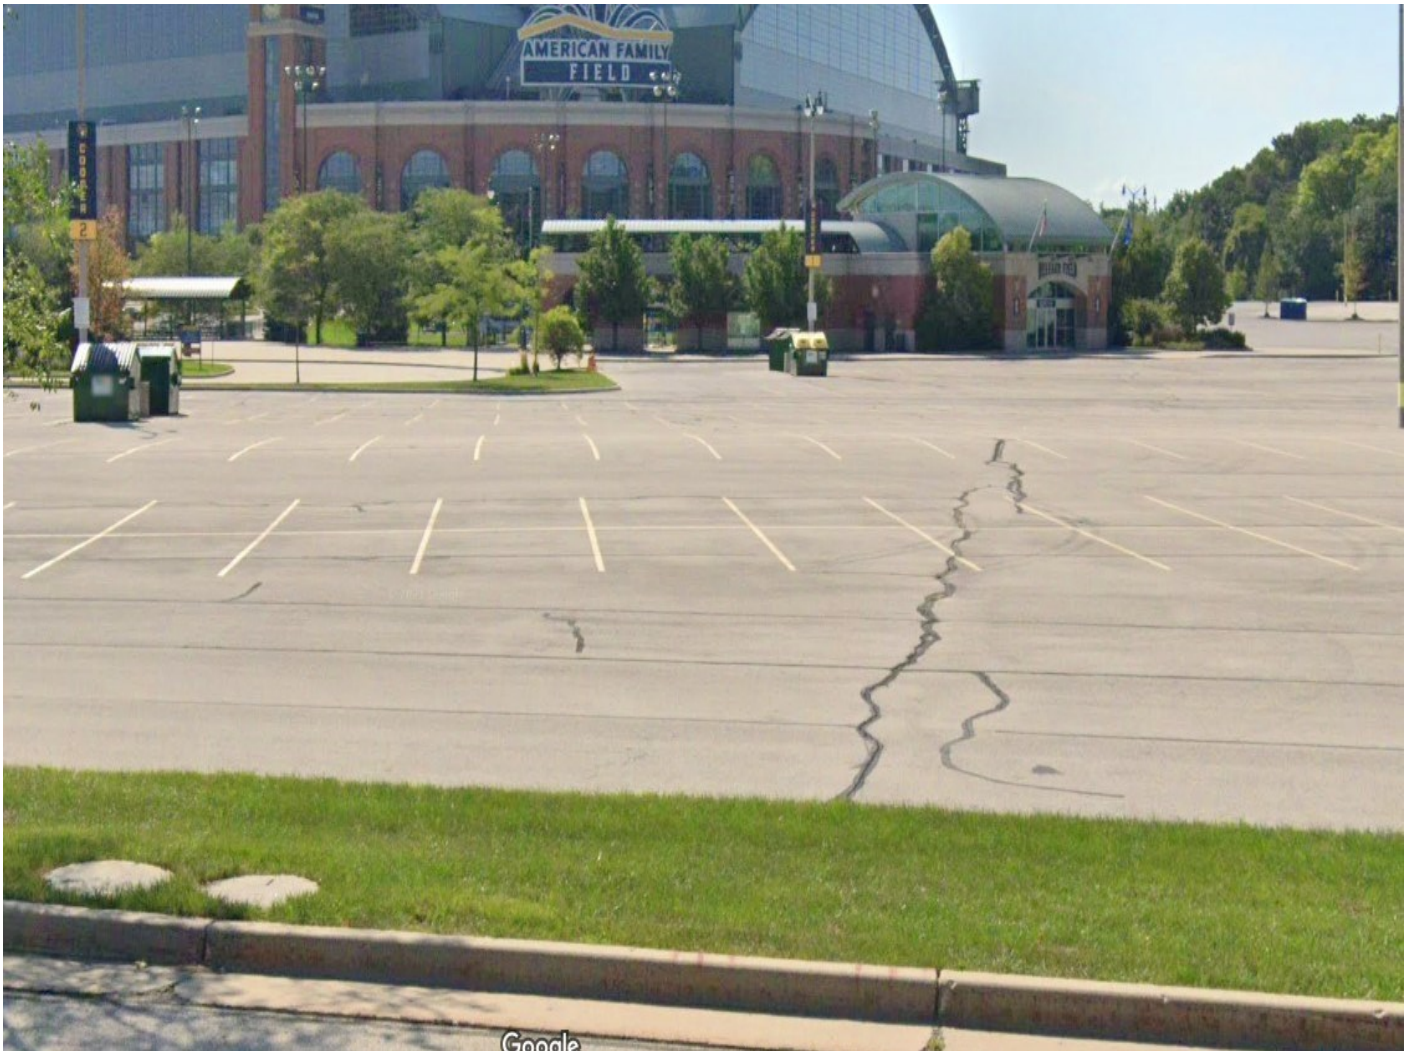
Photo 61: Cooper Lot area: Asphalt cap parking lot: 4-inch asphalt pavement cap over 8-inches of crushed aggregate base course. Greenspace median cap in photo foreground: 12-inches of low permeability non-impacted soil covered with 4-inches of vegetated topsoil.  
Photo taken facing south August 2021.

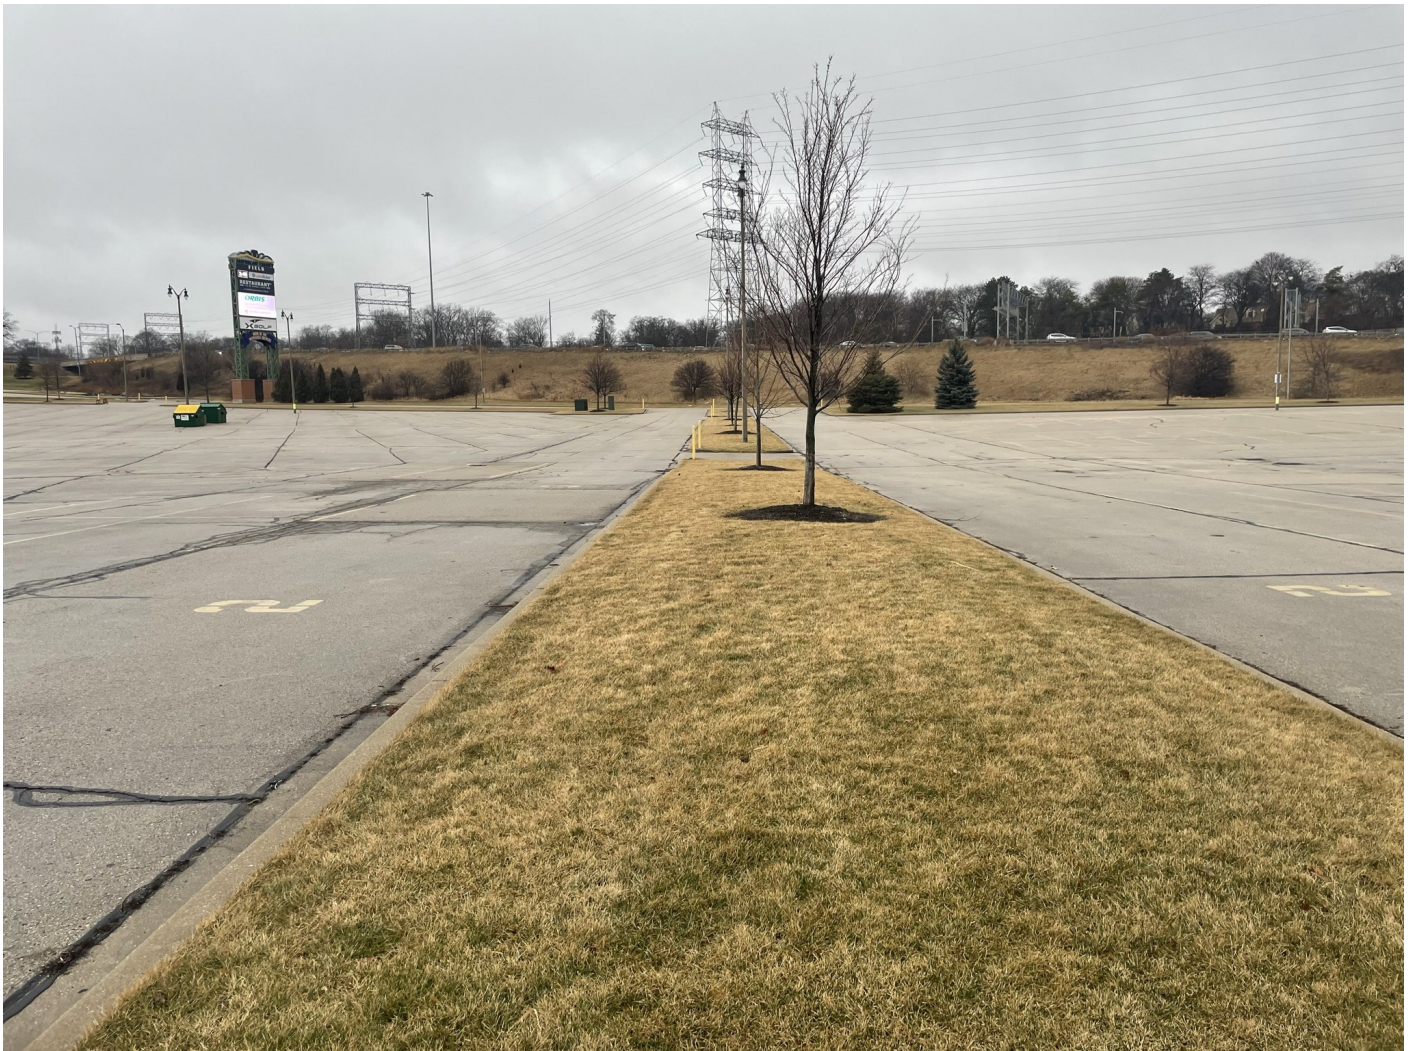
Photo 62: Cooper Lot area: Greenspace cap median between Cooper Lot and Money Lot. Asphalt capped lots on left and right side of greenspace cap median in center of photo. Photo taken facing northwest on January 18, 2023.

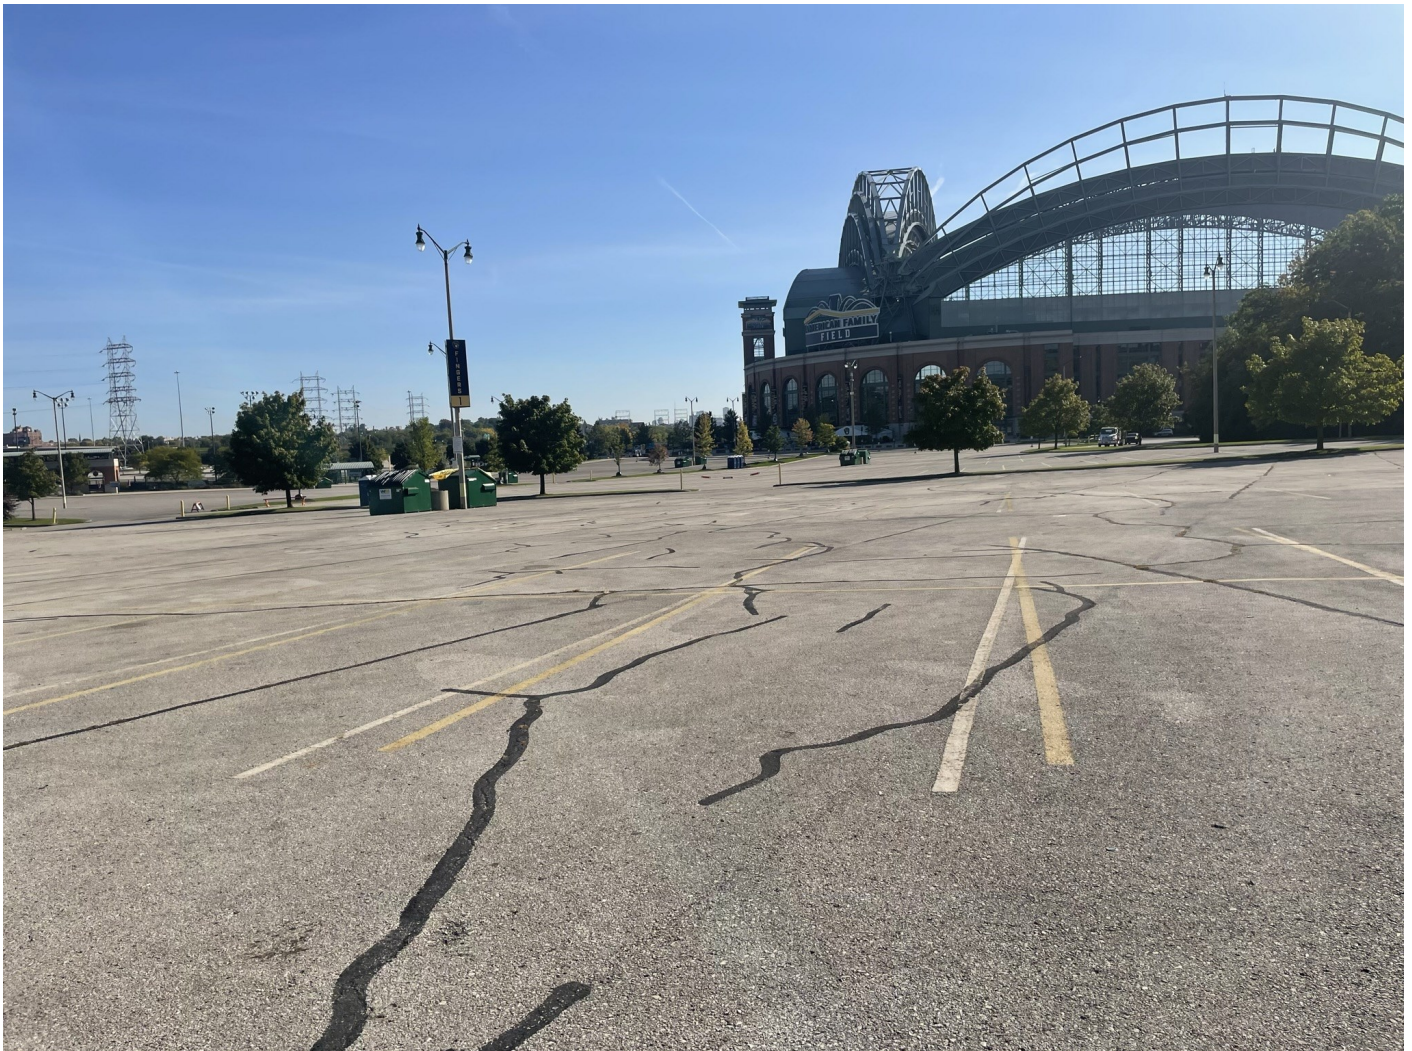
Photo 63: Money Lot: Asphalt cap surface lot: 4-inch asphalt pavement over 8-inches of crushed aggregate.  
Photo taken facing southeast on October 4, 2022.

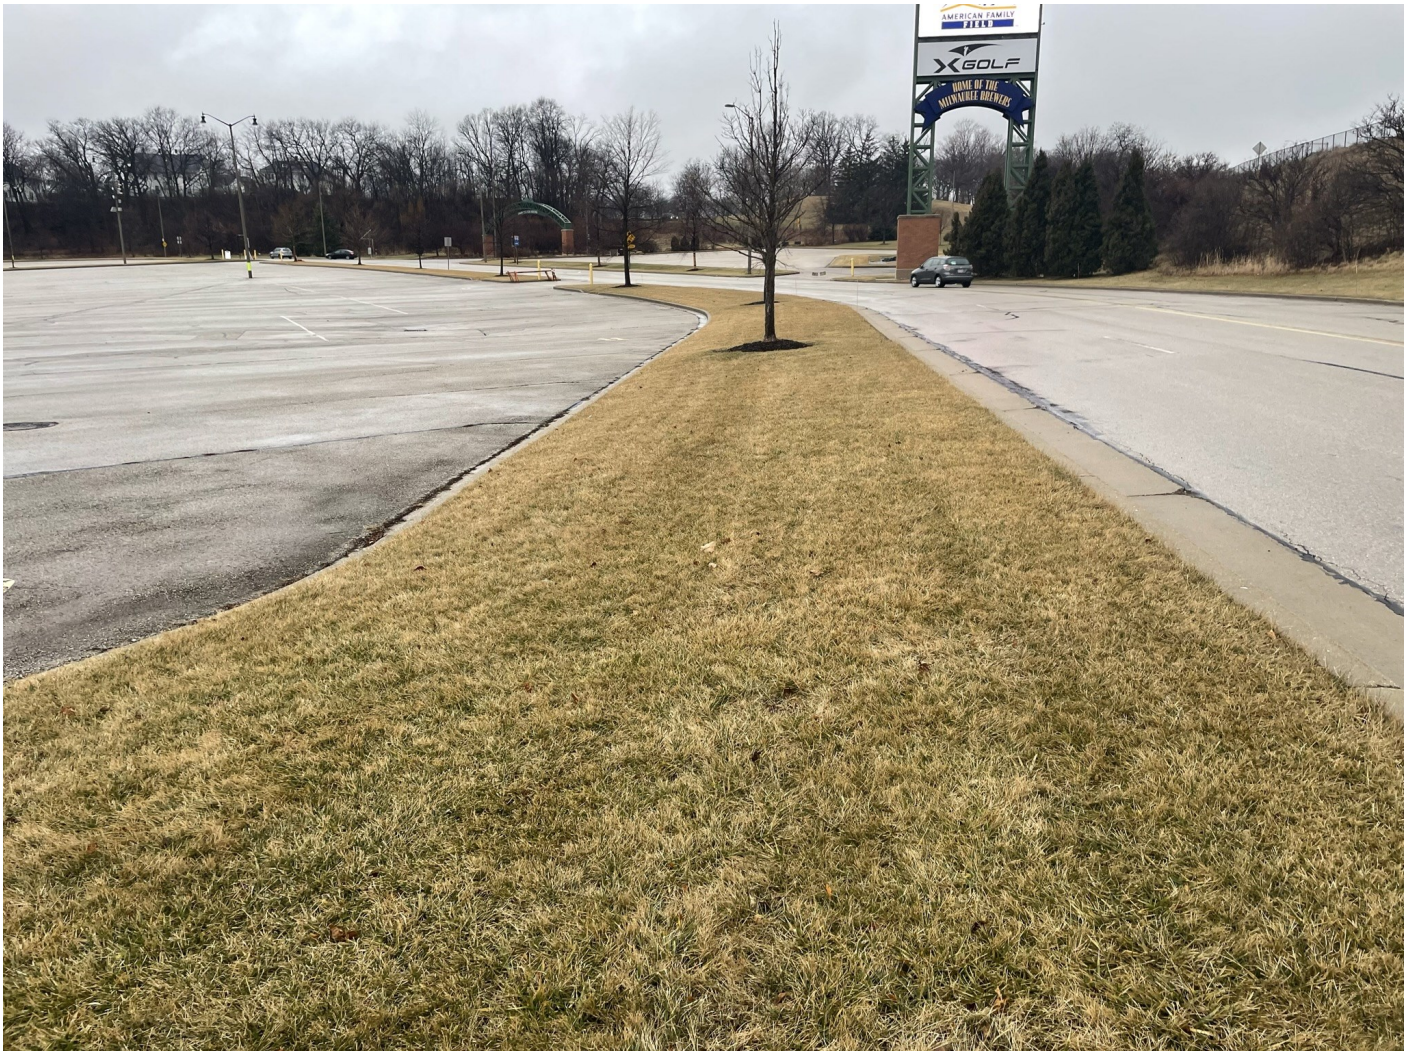
Photo 64: Money Lot: Asphalt cap surface lot: 4-inch asphalt pavement over 8-inches of crushed aggregate shown in left portion of photo. Greenspace cap median along northern edge of Money Lot, along south side of Selig Drive: 12-inches of low permeability soil covered with 4-inches of vegetated (grass) topsoil. Photo taken facing west on January 18, 2023.

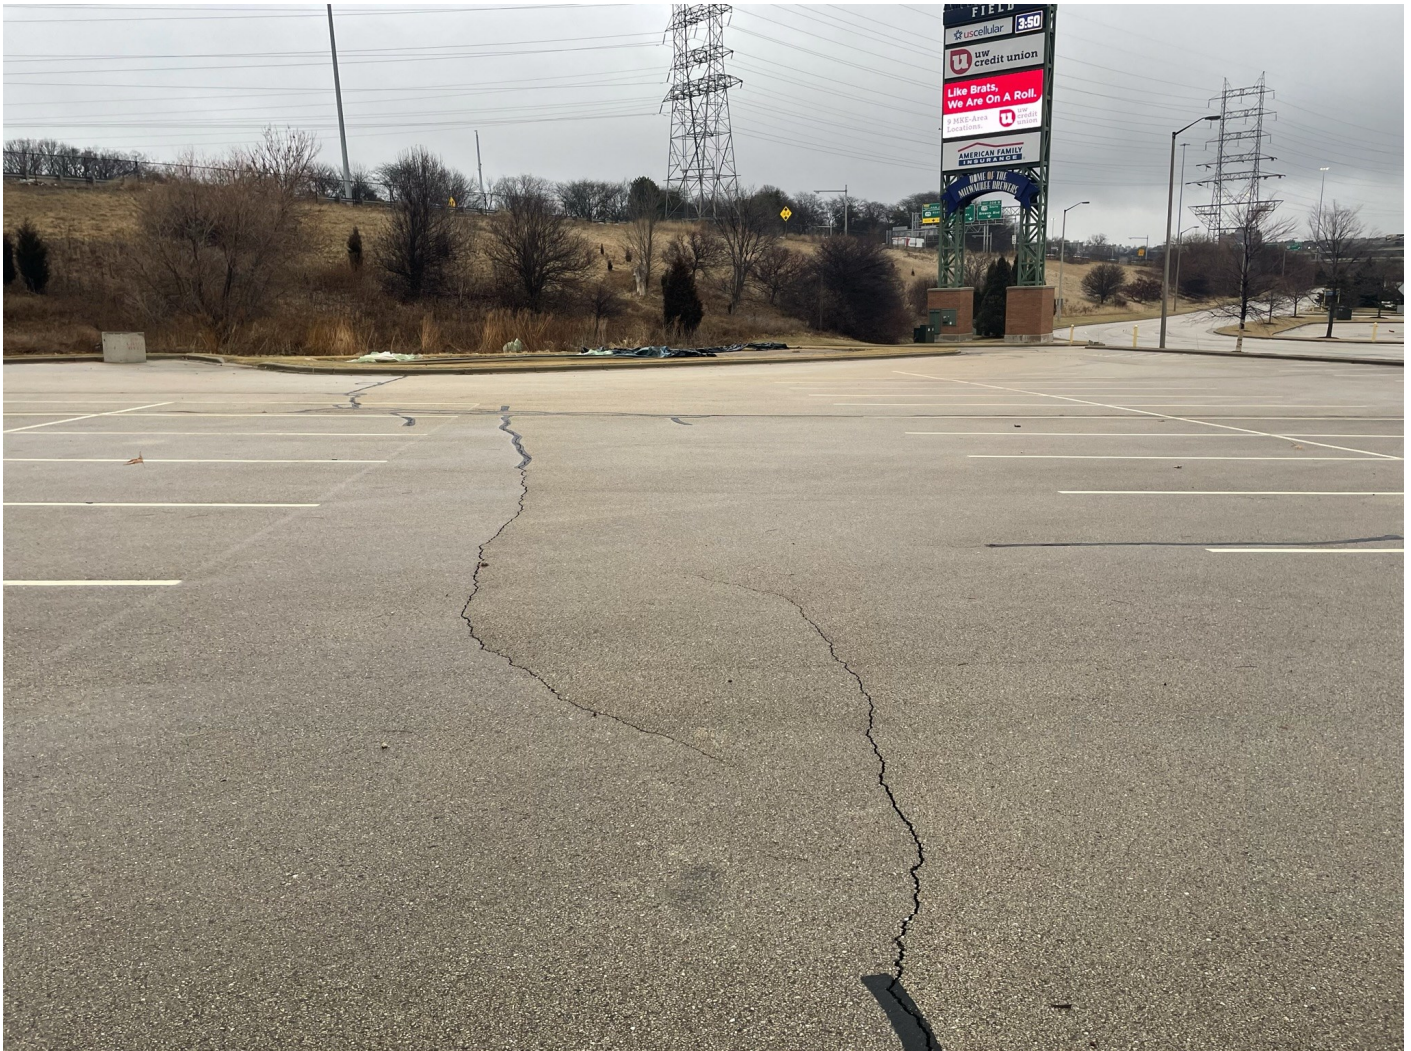
Photo 65: Money Lot - Auxiliary Lot: Asphalt cap surface lot: 4-inch asphalt pavement over 8-inches of crushed aggregate.  
Photo taken facing east on January 18, 2023.

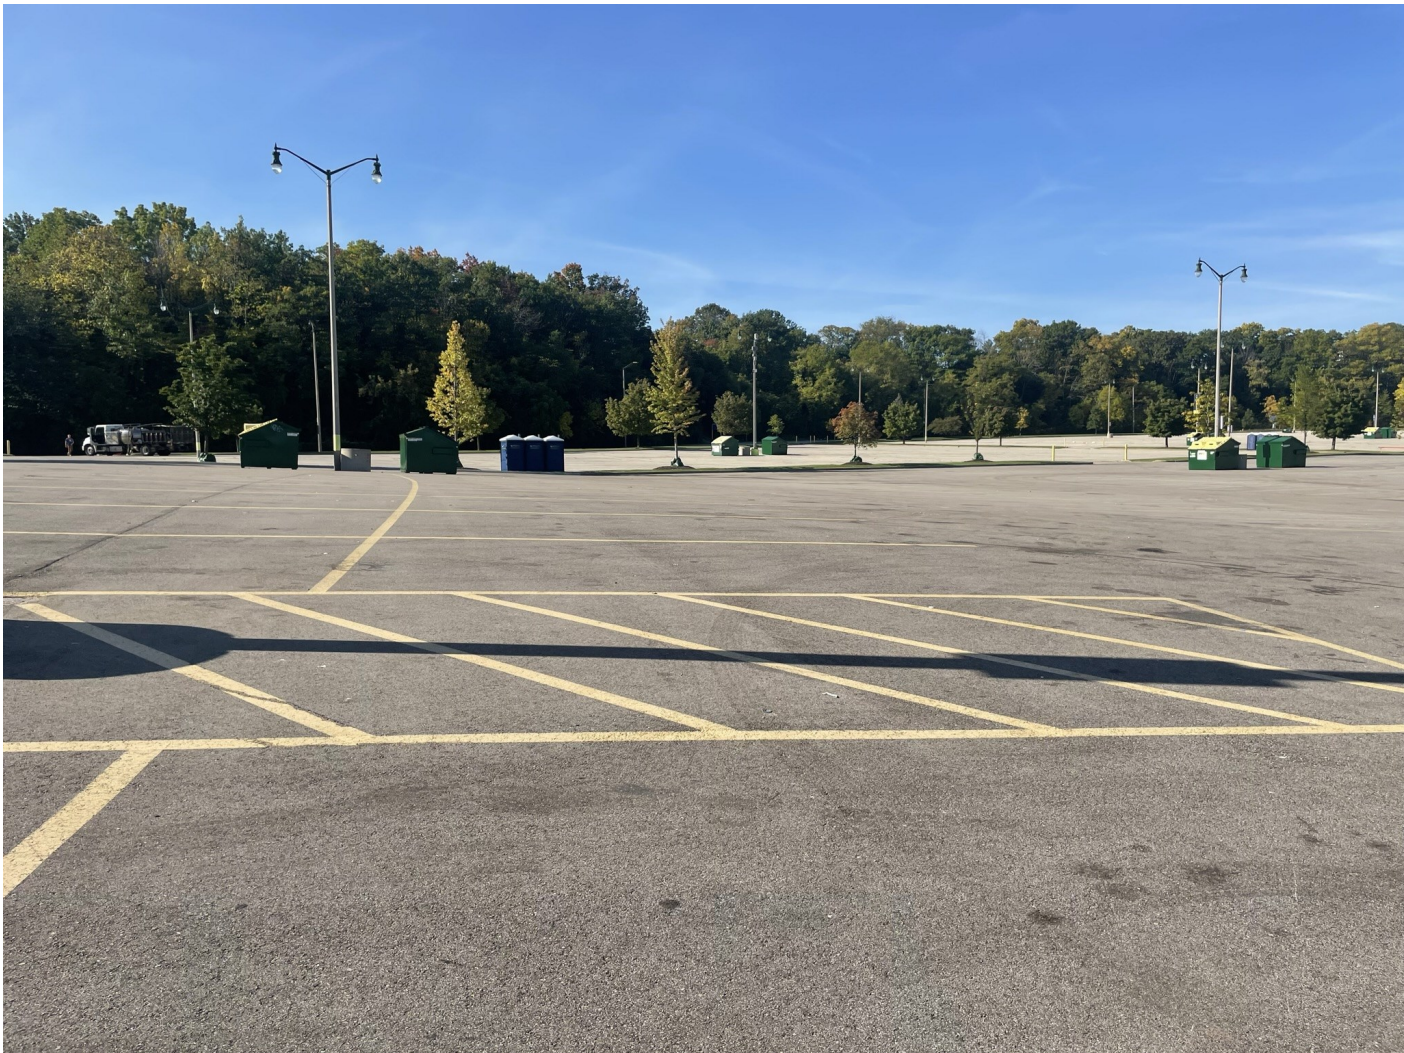
Photo 66: Aaron Lot: Asphalt cap surface lot: 4-inch asphalt pavement over 8-inches of crushed aggregate.  
Photo taken facing west on October 4, 2022.

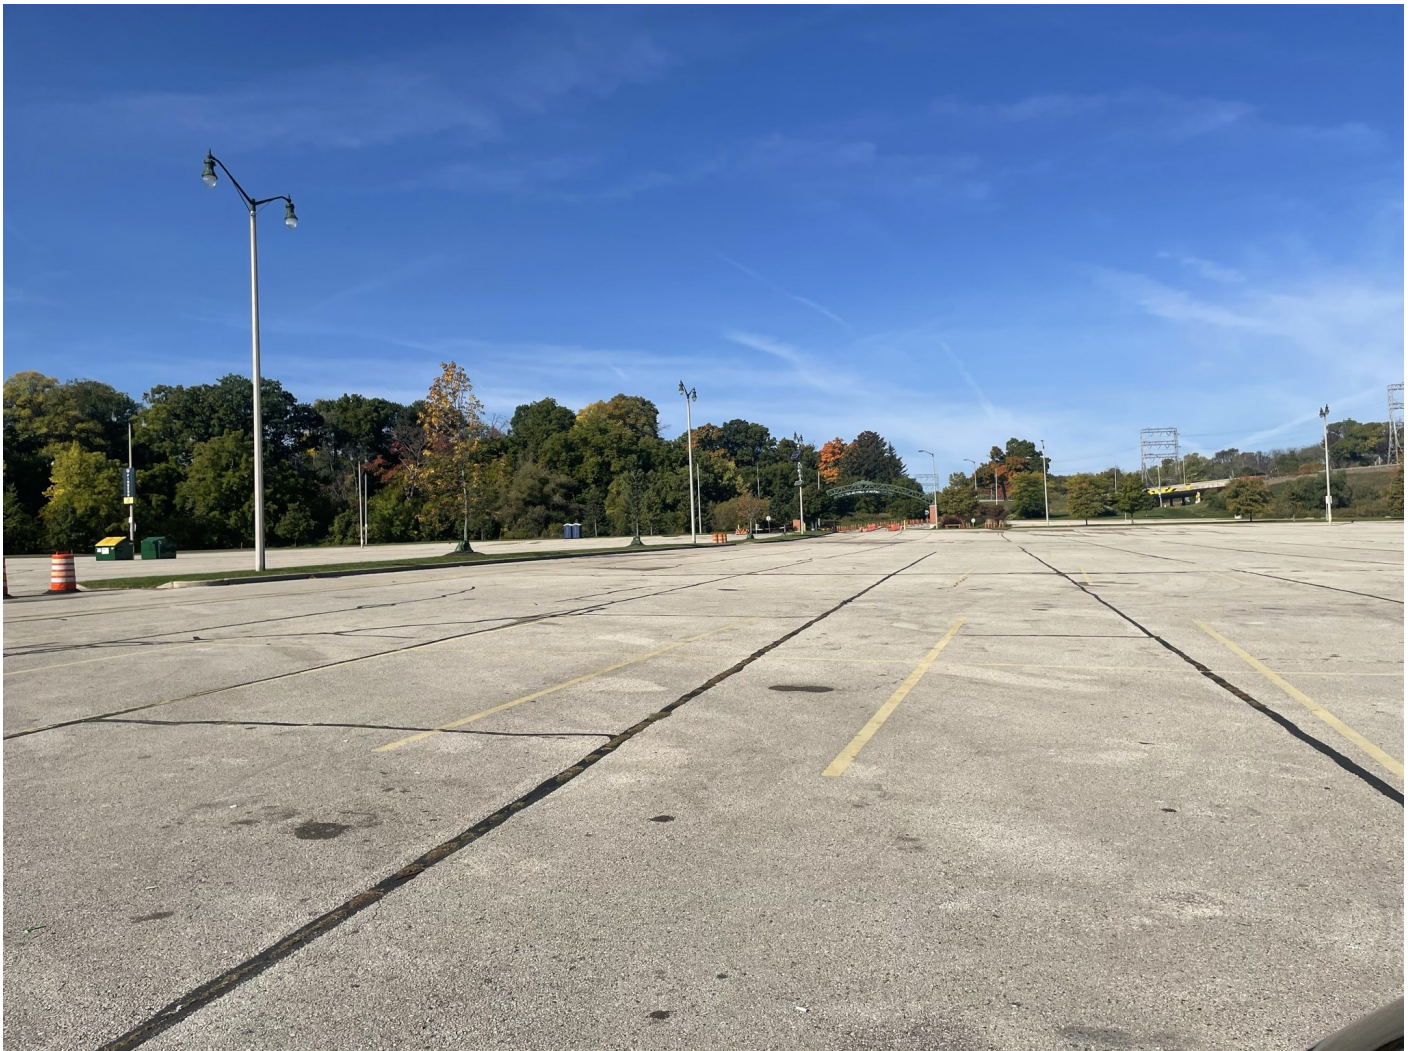
Photo 67: Money Lot: Asphalt cap surface lot: 4-inch asphalt pavement over 8-inches of crushed aggregate.  
Photo taken facing northwest on October 4, 2022.

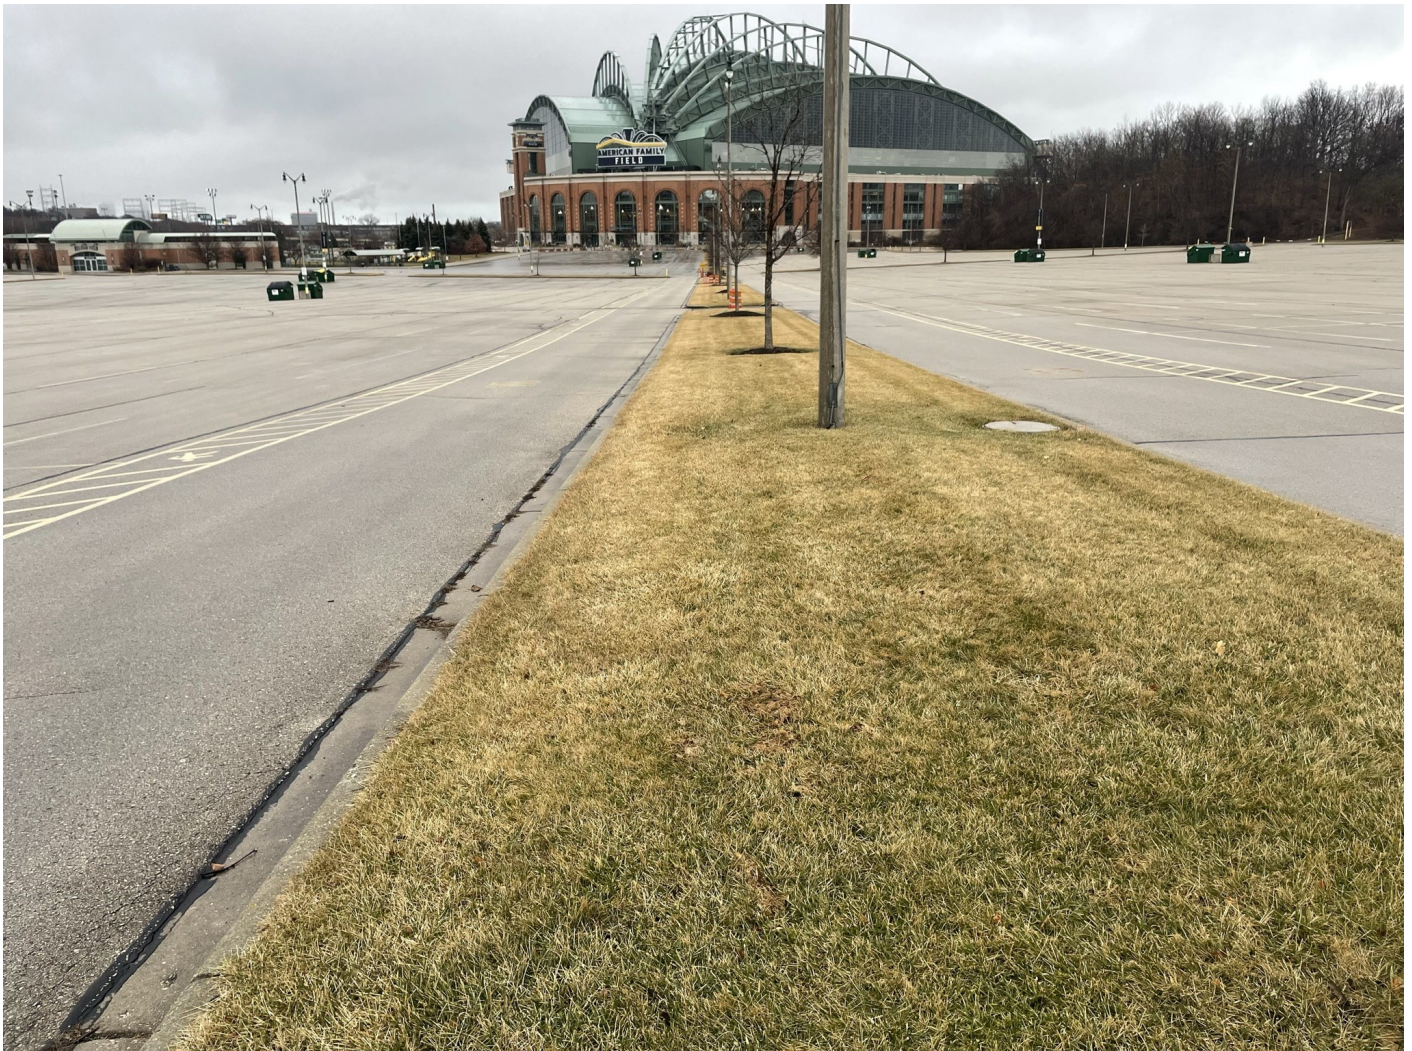
Photo 68: Money Lot: Asphalt cap Money Lot (left), asphalt cap Fingers Lot (right), greenspace cap median (center).  
Photo taken facing southeast on January 18, 2023.

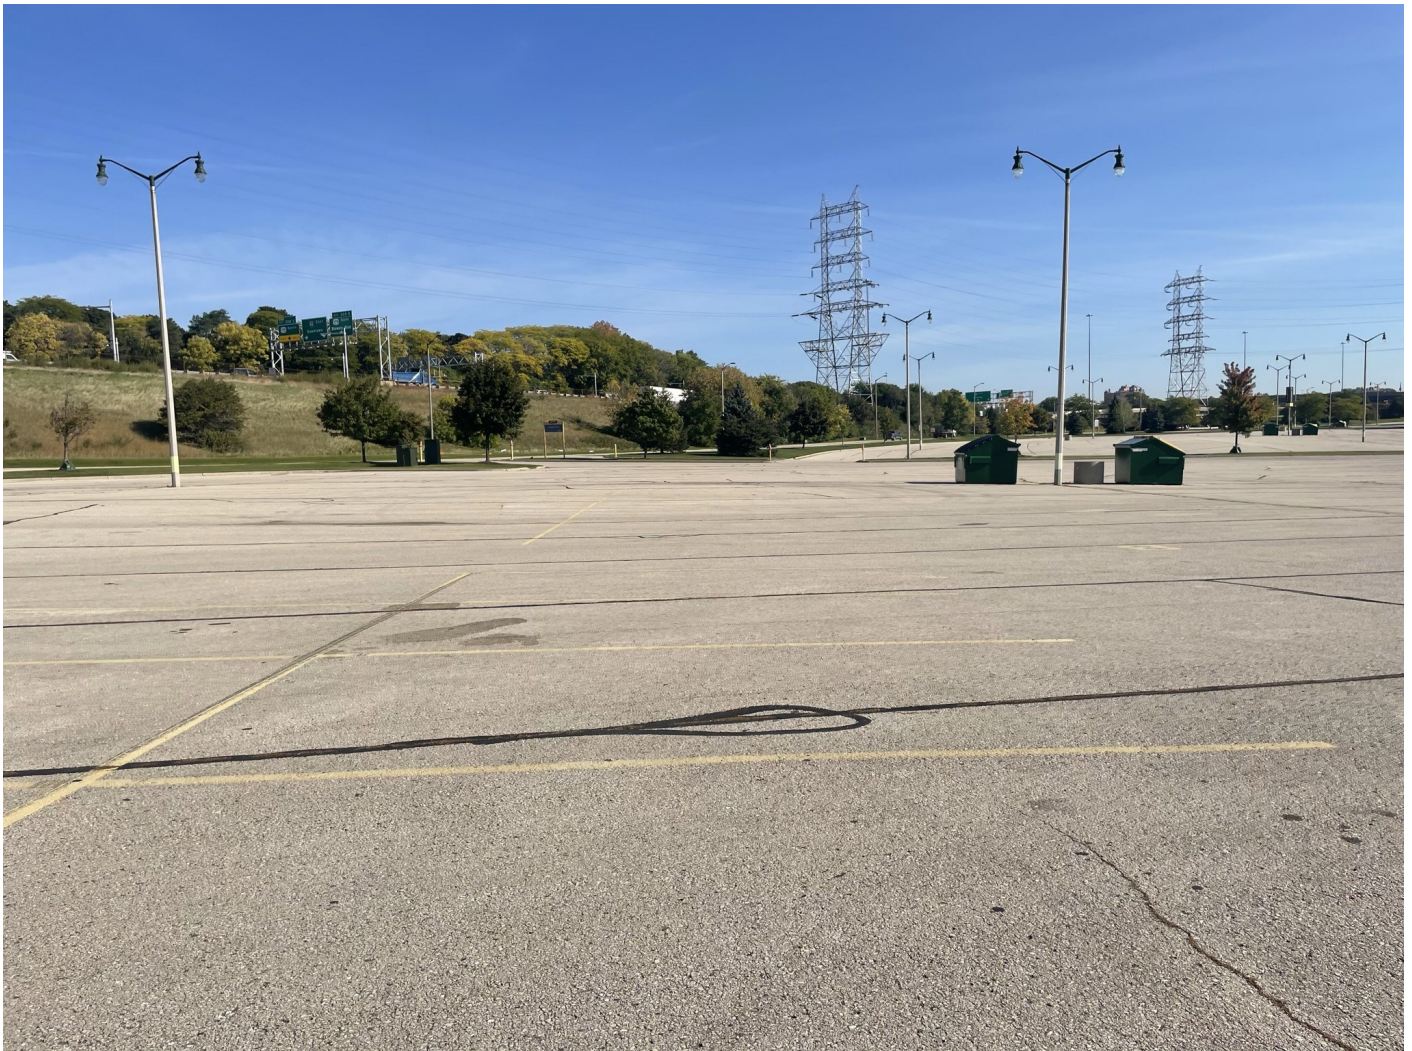
Photo 70: Fingers Lot: Asphalt cap surface lot: 4-inch asphalt pavement over 8-inches of crushed aggregate.  
Photo taken facing northeast on October 4, 2022.

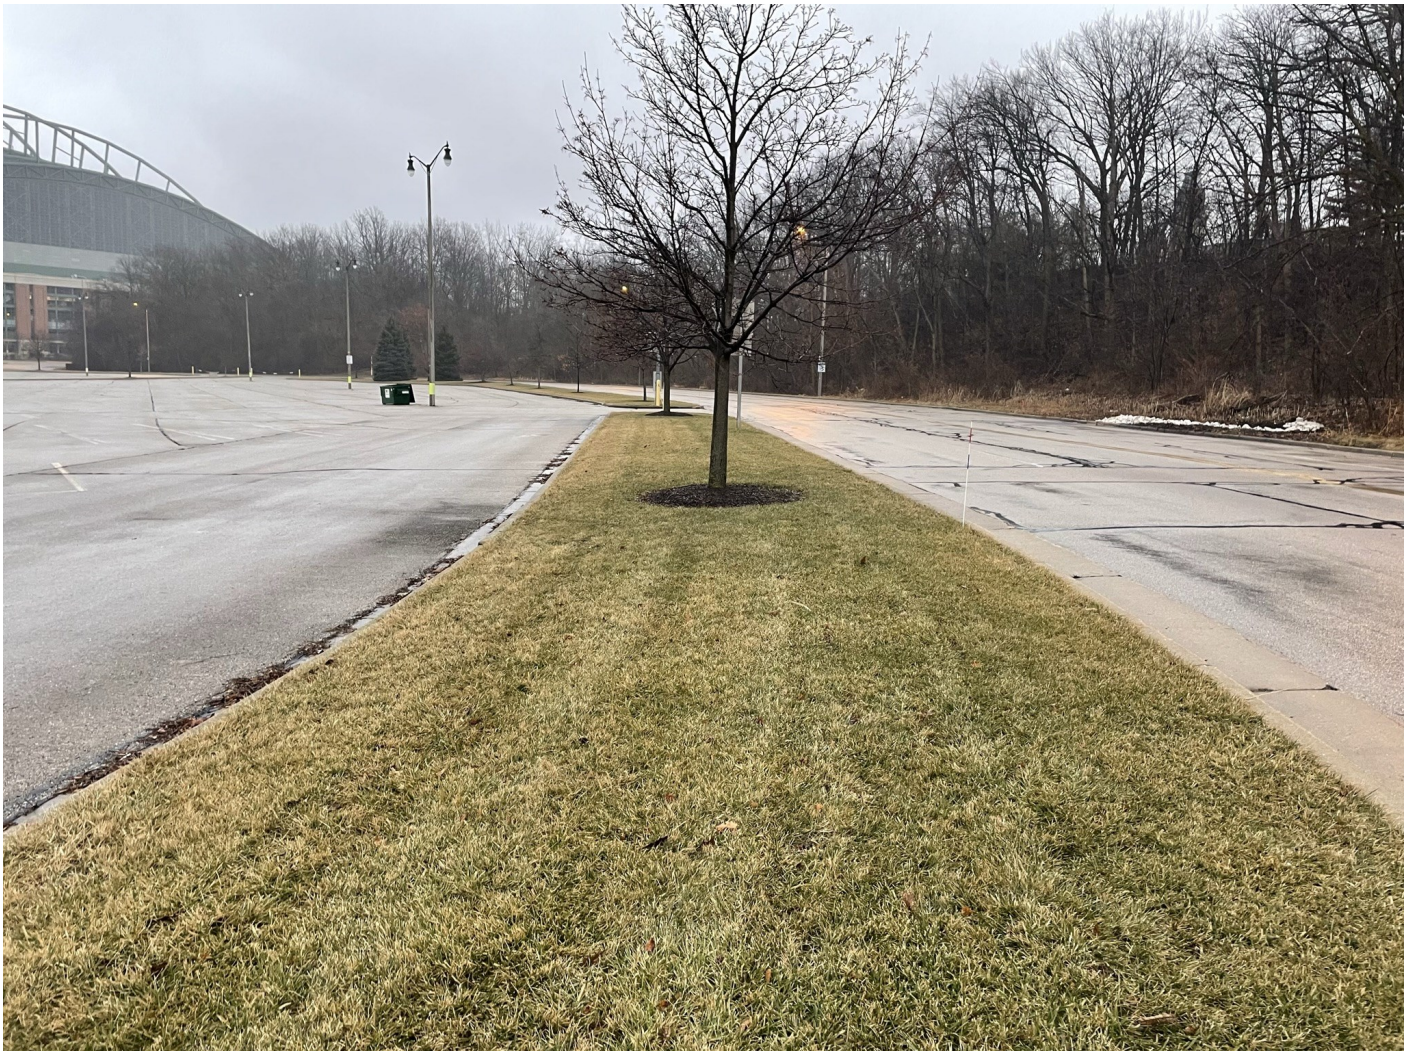
Photo 71: Fingers Lot: Greenspace cap median (center) along the northwest side of asphalt capped Fingers Lot (left), along the east side of asphalt capped Frederick Miller Way (right). Concrete cap curb and gutter running along the median perimeter. Photo taken facing southwest on January 18, 2023.

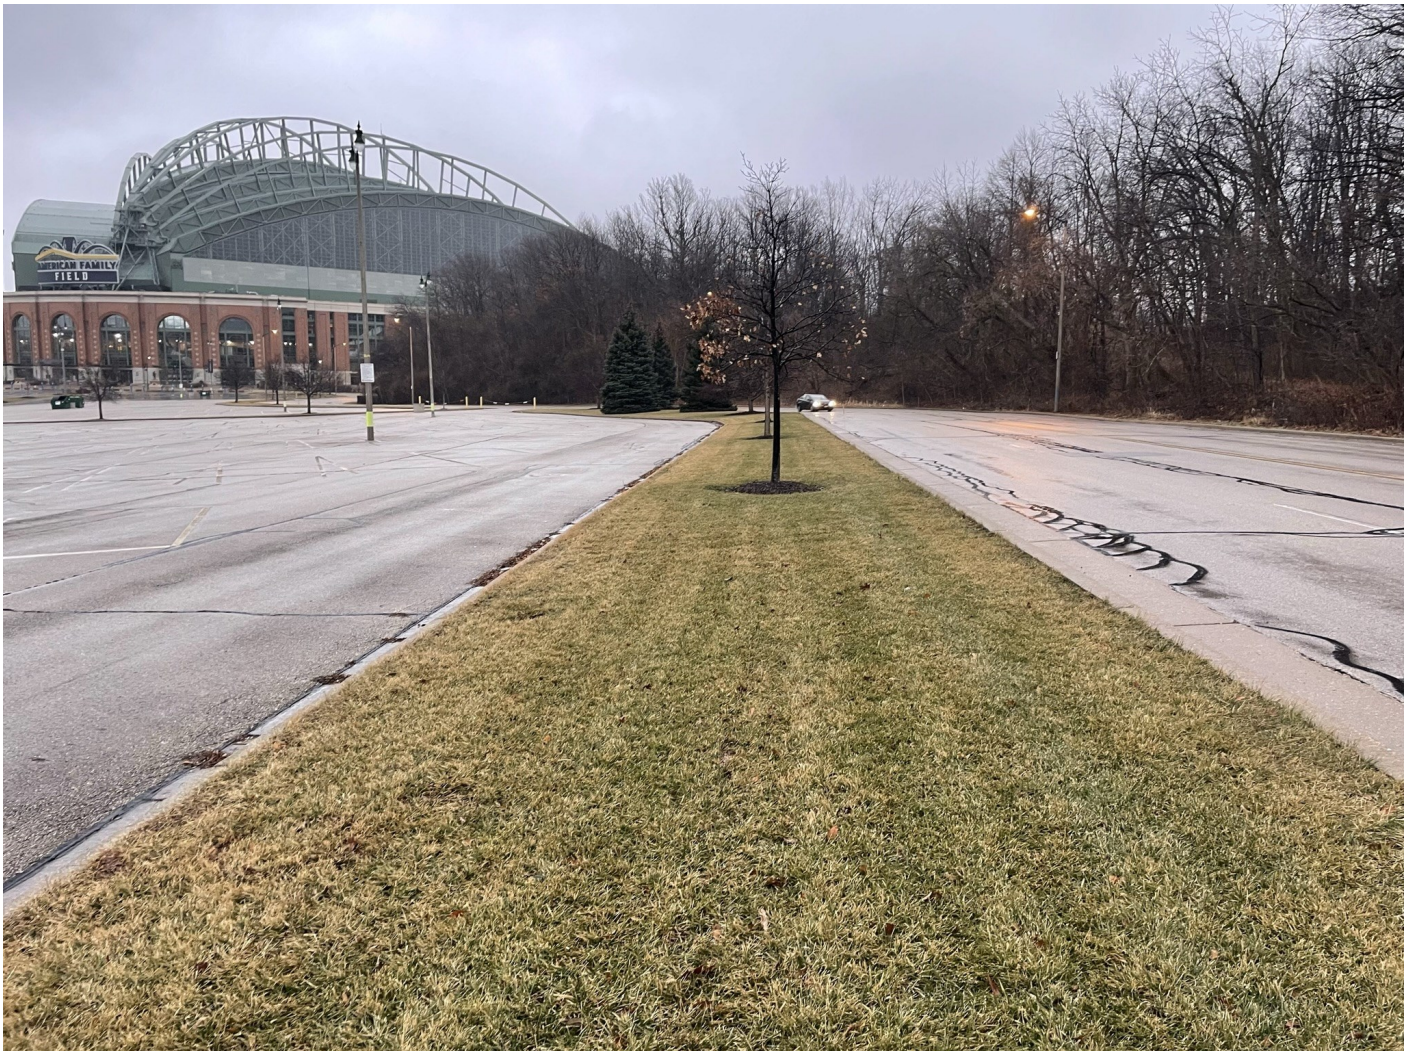
Photo 72: Fingers Lot: Greenspace cap median (center) along the northwest side of asphalt capped Fingers Lot (left), along the east side of asphalt capped Frederick Miller Way (right). Concrete cap curb and gutter running along the median perimeter. Photo taken facing southwest on January 18, 2023.

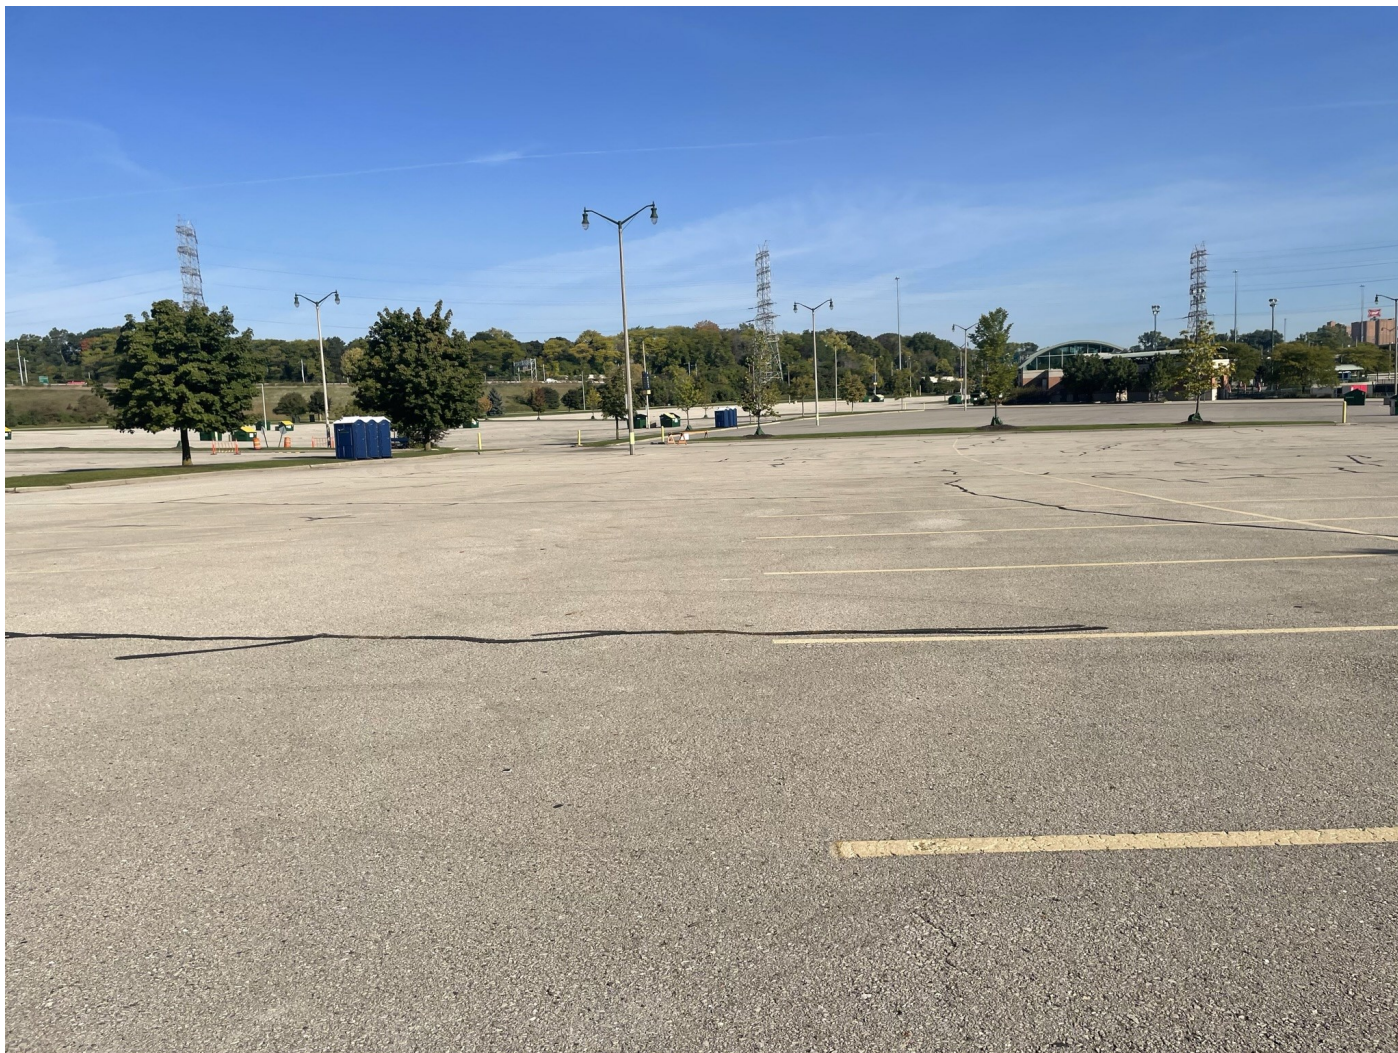
Photo 73: Thomas Lot: Asphalt cap surface lot: 4-inch asphalt pavement over 8-inches of crushed aggregate.  
Photo taken facing northeast on October 4, 2022.
