**CAP MAINTENANCE PLAN**  
**SOUTHEAST WISCONSIN PROFESSIONAL BASEBALL PARK DISTRICT – RIVER WEST**

**FEBRUARY 2023**

**SITE PLAN MAP**  
SOUTHEAST WISCONSIN PROFESSIONAL BASEBALL PARK DISTRICT  
RIVER WEST PARCEL - BRRTS #02-41-001185  
110 S 44TH STREET, 201 & 301 S 46TH STREET  
MILWAUKEE, WISCONSIN

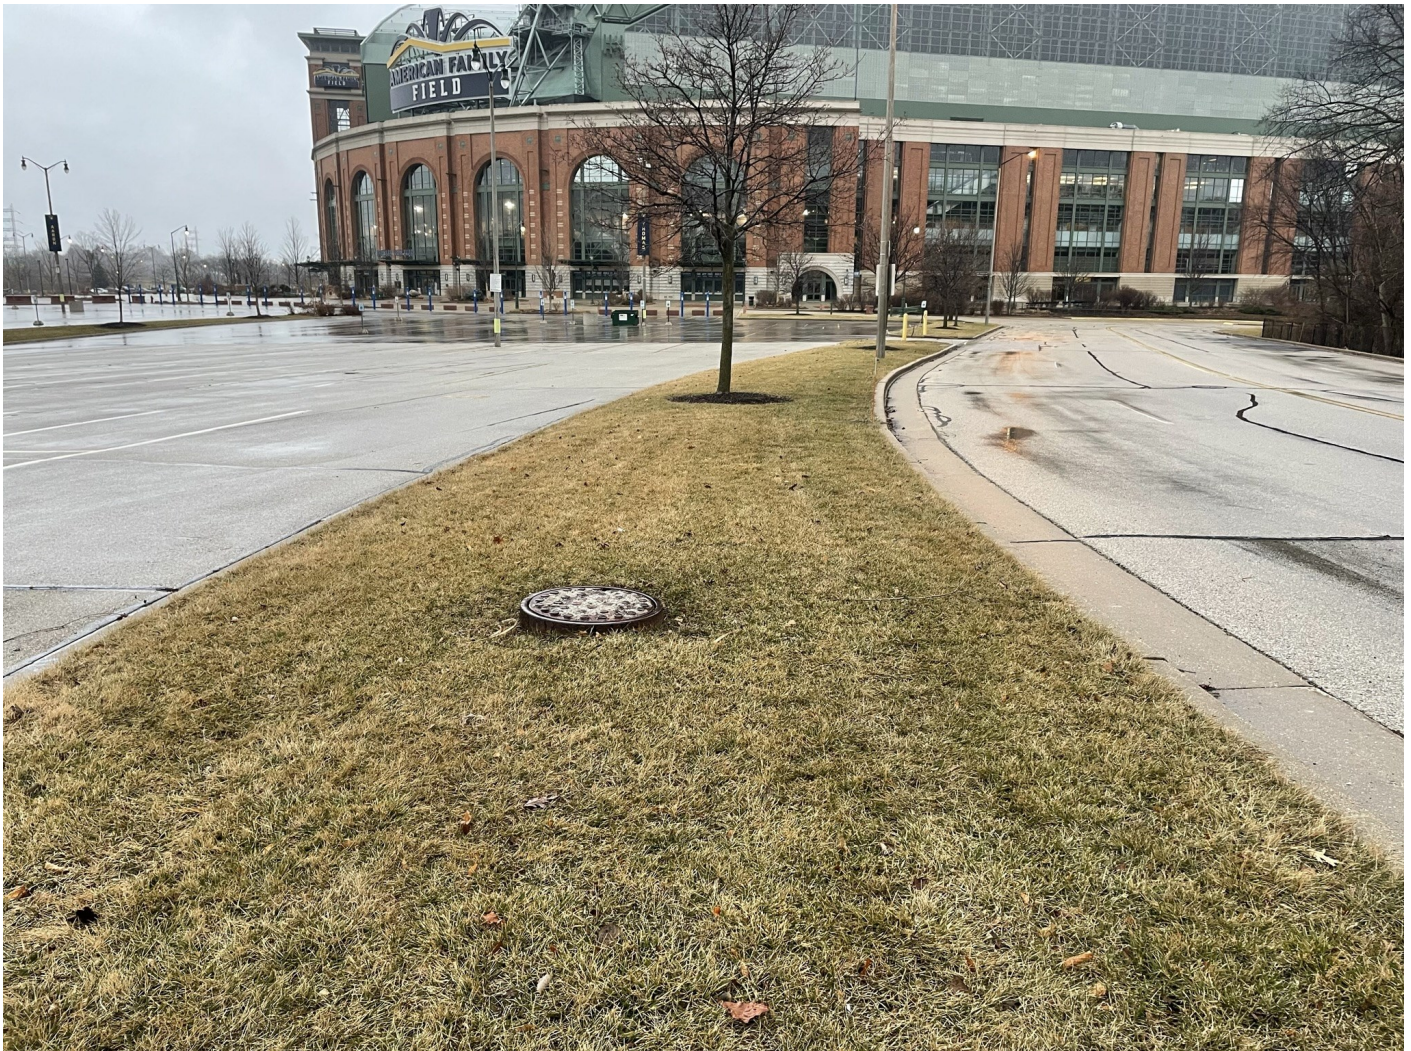
Photo 74: Thomas Lot: Greenspace cap median (center) along the west side of asphalt capped Thomas Lot (left), along the north side of asphalt capped Frederick Miller Way (right). Concrete cap curb and gutter running along the median perimeter. Photo taken facing east on January 18, 2023.

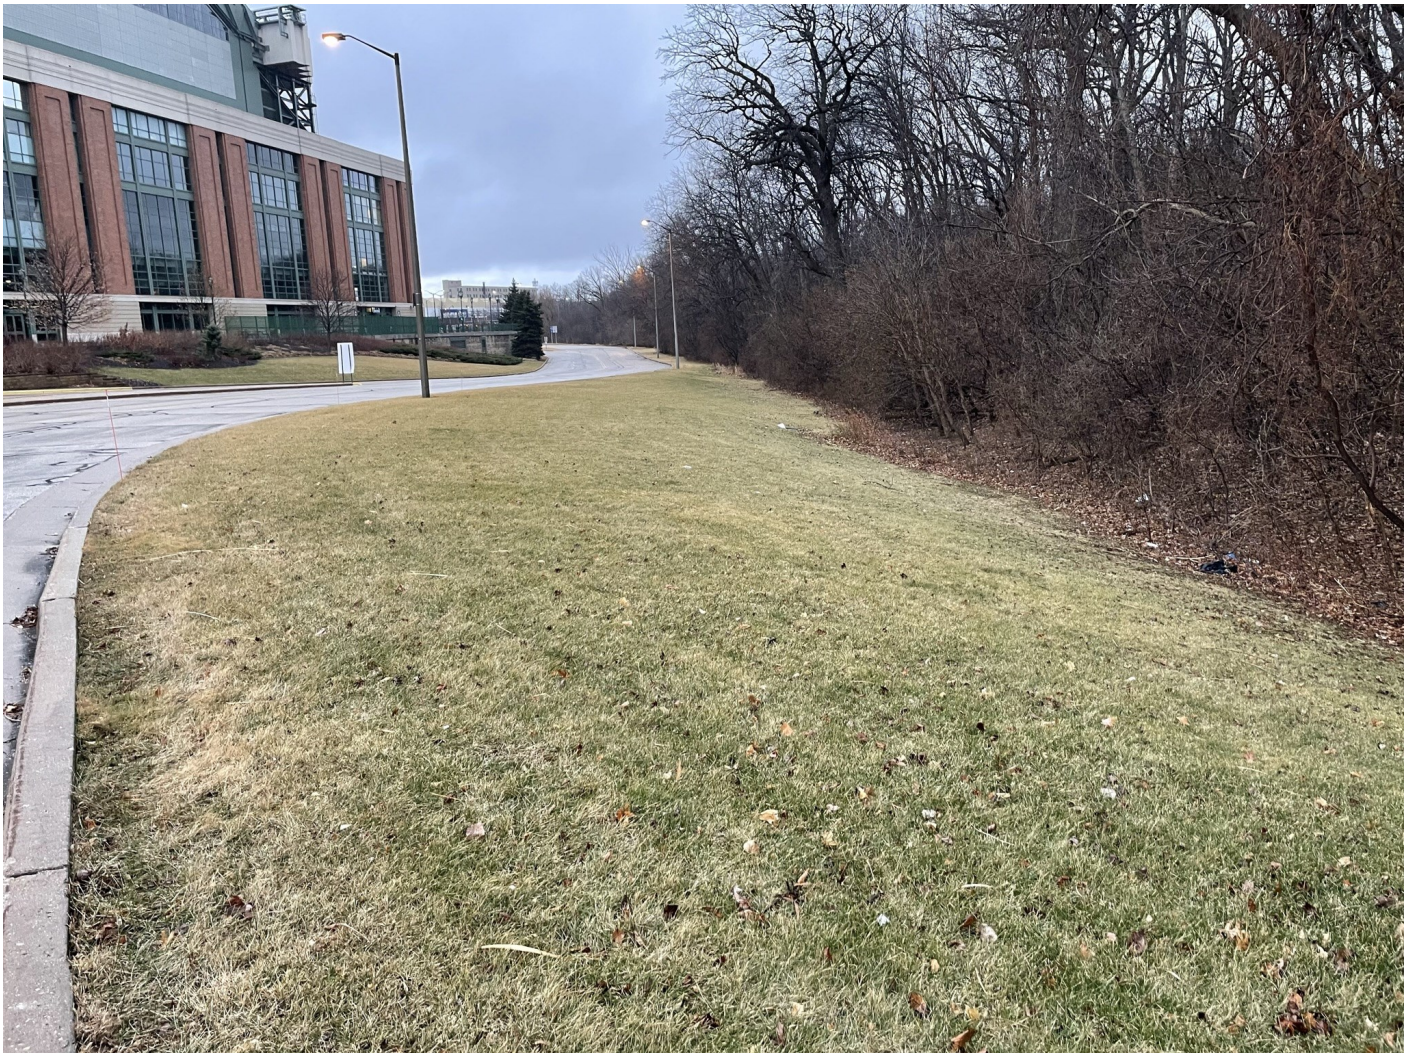
Photo 75: Thomas Lot - Frederick Miller Way: Greenspace cap along the south side of asphalt capped Frederick Miller Way (left). Concrete cap curb and gutter running along the roadway.  
Photo taken facing southeast on January 18, 2023.
