Submittal of Annual Reports and Other Compliance Documents for Municipal Separate Storm Sewer System (MS4) Permits

Project Name: 2024 Annual Report

Municipality: Southeast WI Prof Baseball Park District

Permit Number: S049921

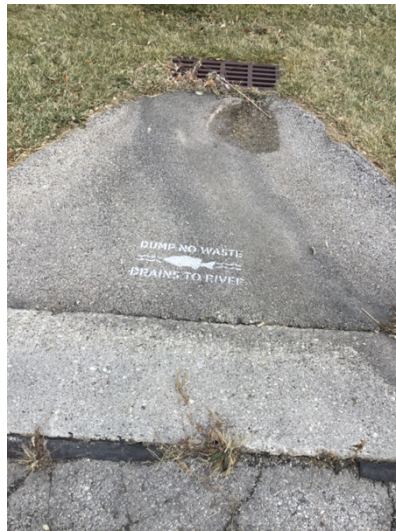
Results: There were approximately 2.6 million users of the parking lots at American Family Field during 2023 and 2.5 million during 2024 that had the opportunity to view the stenciled catch basins. This does not include the people that came for other visits to the ballpark on non-game days. Stenciled catch basins were reapplied on 18 inlets in 2023 and 34 in 2024. Below is a picture of the stenciled signage.

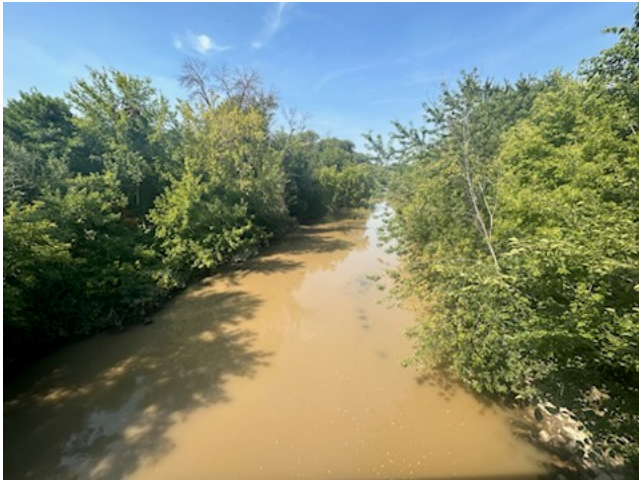
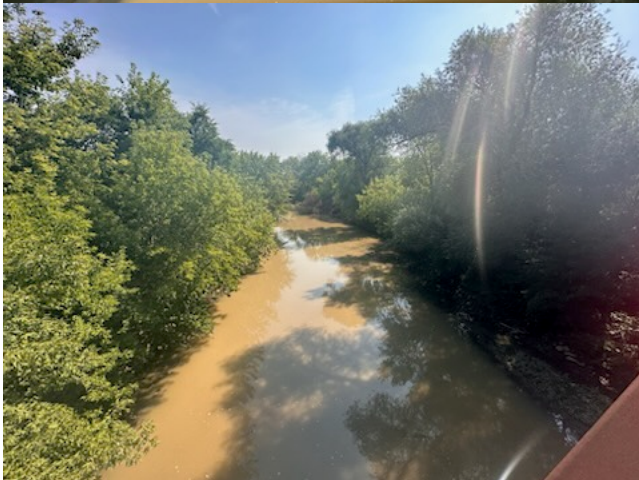
Hi Riley! One of our staff found the MN River looking gross at 37th kayak launch. I went from Tosa down and all was good until our favorite Miller Park outfall. See attached. Not sending upstream shots but have 6 or so from Bluemound upstream through 70th.

I ended up running down to the VA job site and they said the turbidity was from them. They had an excess of silt they removed from the channel they are constructing and it caused the discharge. I talked with them about having some kind of silt fence/other BMP in place to prevent this in the future. I know this has a DNR permit of some kind so I will also forward it onto the permitting program.

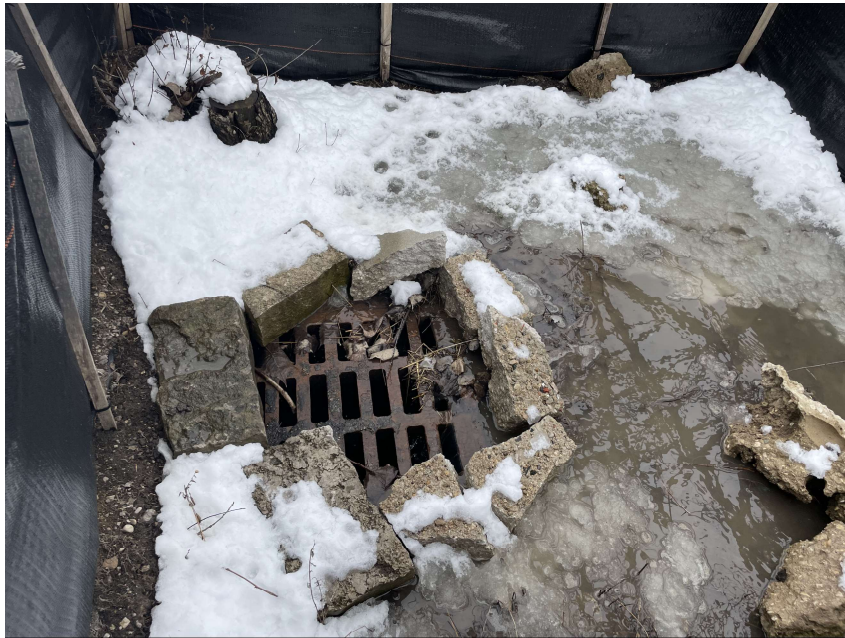
Photo #: 01

Discharge into the storm inlet on Lot 13.

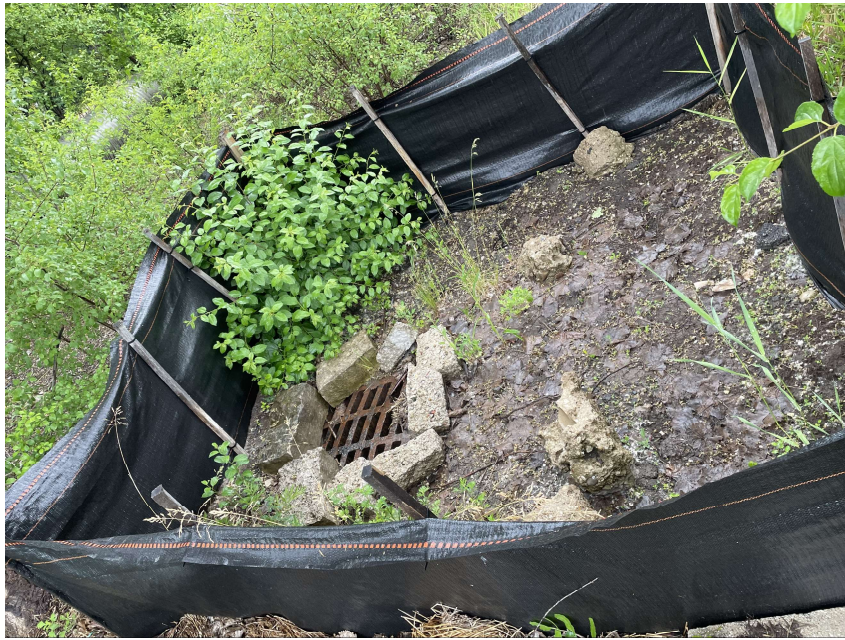
Photo #: 1

Discharge into storm inlet on Lot 13.

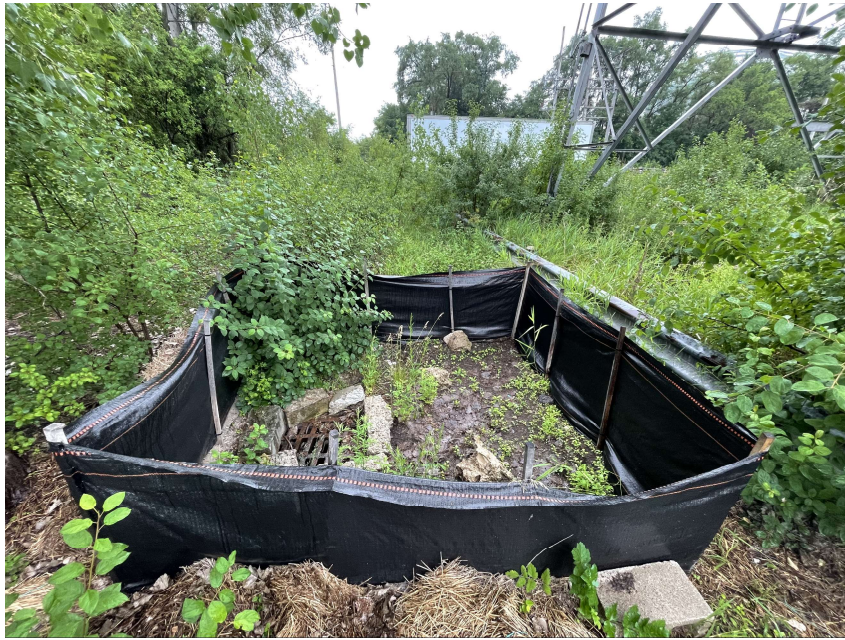
Photo #: 1

Discharge into storm inlet on Lot 13.

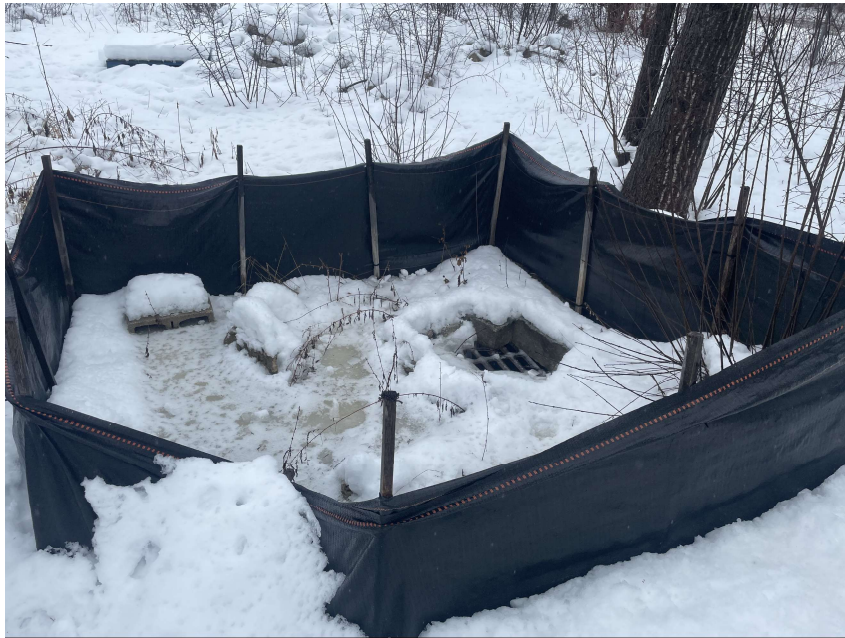
Photo #: 2

Discharge into storm inlet on Lot 13.

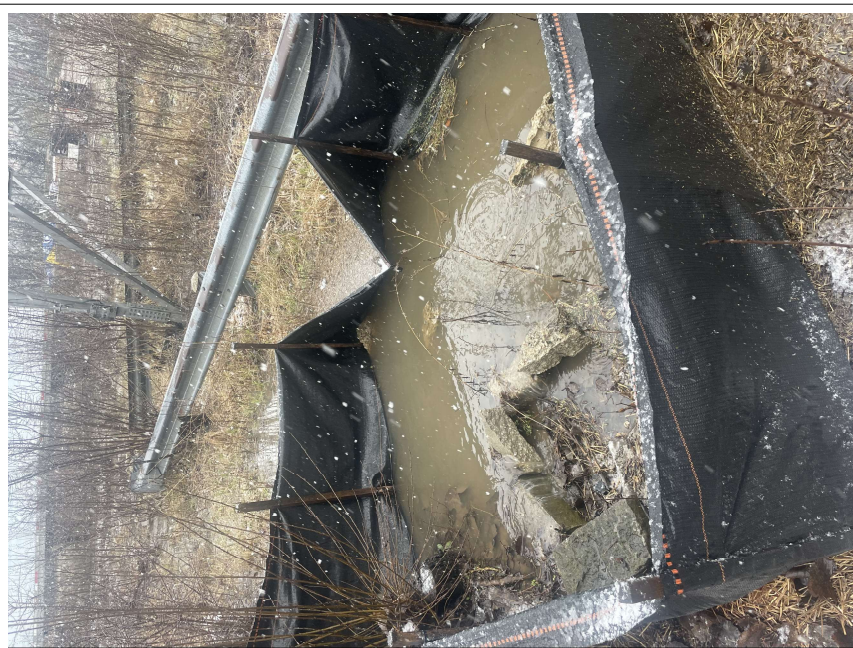
Photo #: 1
Date/Time of Photo: 2024/30/04 12:04:19
Date/Time of Photo: 04/03/2024
Photo Description: Discharge into storm inlet on Lot 13.

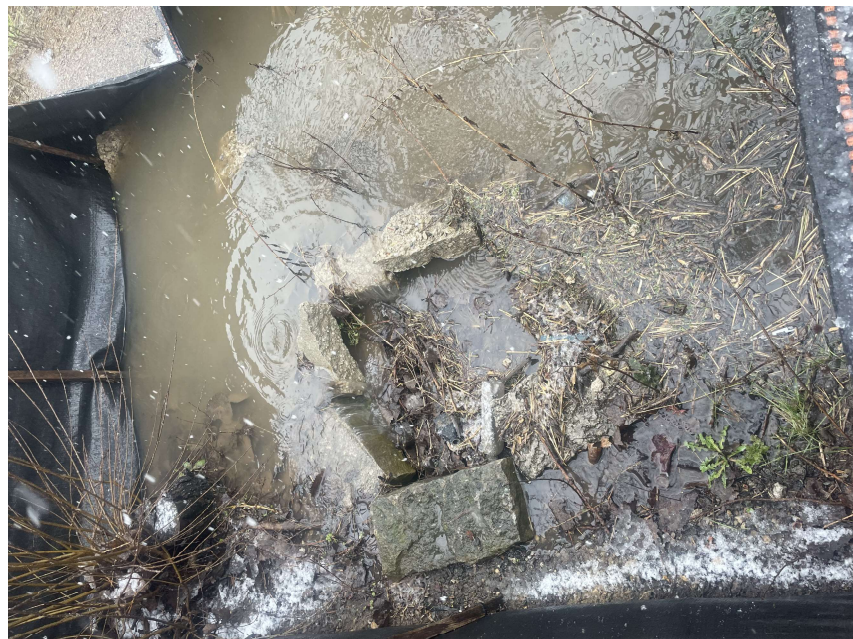
Photo #: 2
Date/Time of Photo: 2024/34/04 12:04:48
Date/Time of Photo: 04/03/2024
Photo Description: Discharge into storm inlet on Lot 13.

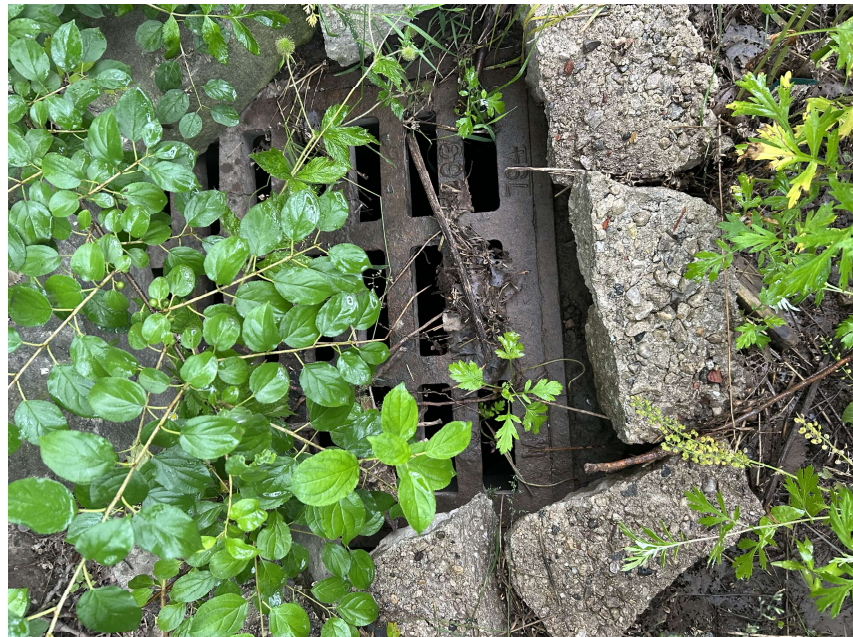
Photo #: 2
Date/Time of Photo: 2024/16/08 10:07:28
Date/Time of Photo: 7/2/2024
Photo Description: Discharge into storm inlet on Lot 13.

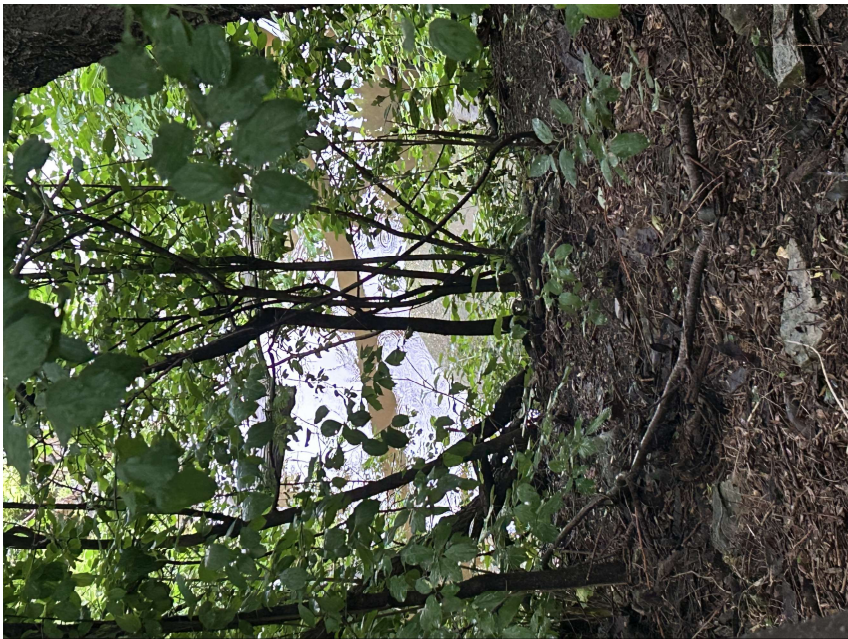
Photo #: 3
Date/Time of Photo: 2024/15/08 10:07:39
Date/Time of Photo: 7/2/2024
Photo Description: Discharge from Major Outfall 1 (MO-1).

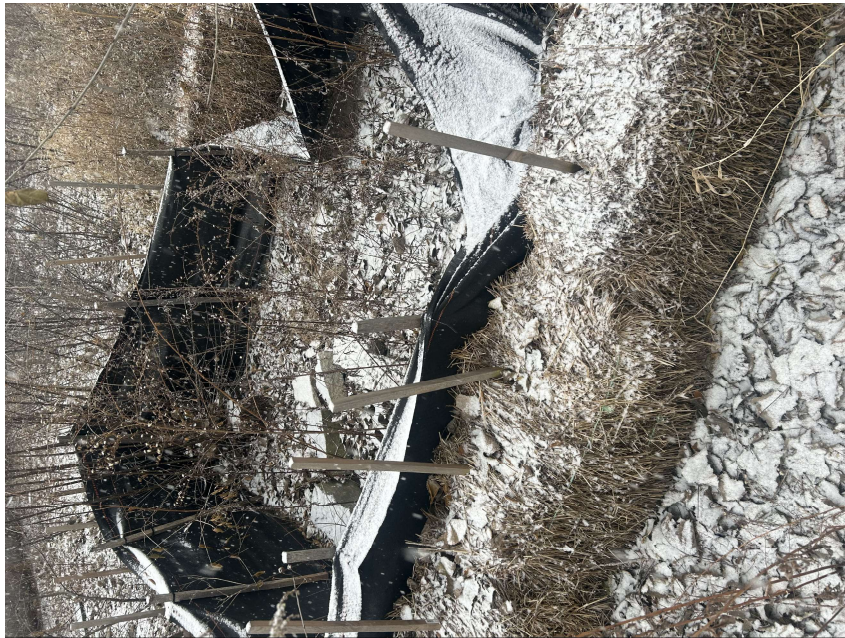
Photo #: 1

Discharge into storm inlet on Lot 13.

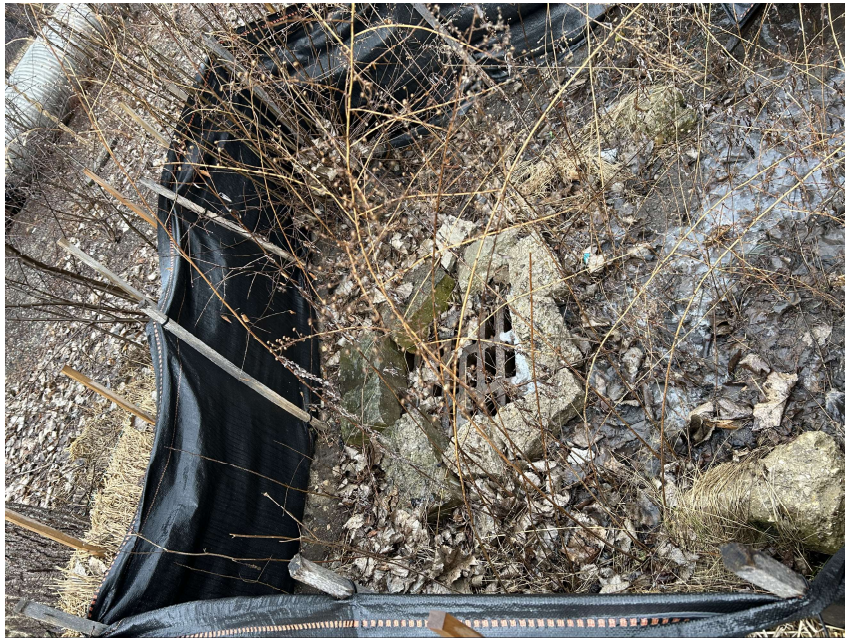
Photo #: 1

Discharge into storm inlet on Lot 13.
