ATTACHMENT D.1.

CAP MAINTENANCE PLAN SOUTHEAST WISCONSIN PROFESSIONAL BASEBALL PARK DISTRICT – RIVER EAST

FEBRUARY 2023

WDNR ACTIVITY NAME: MENOMONEE RIVER STADIUM PROJECT

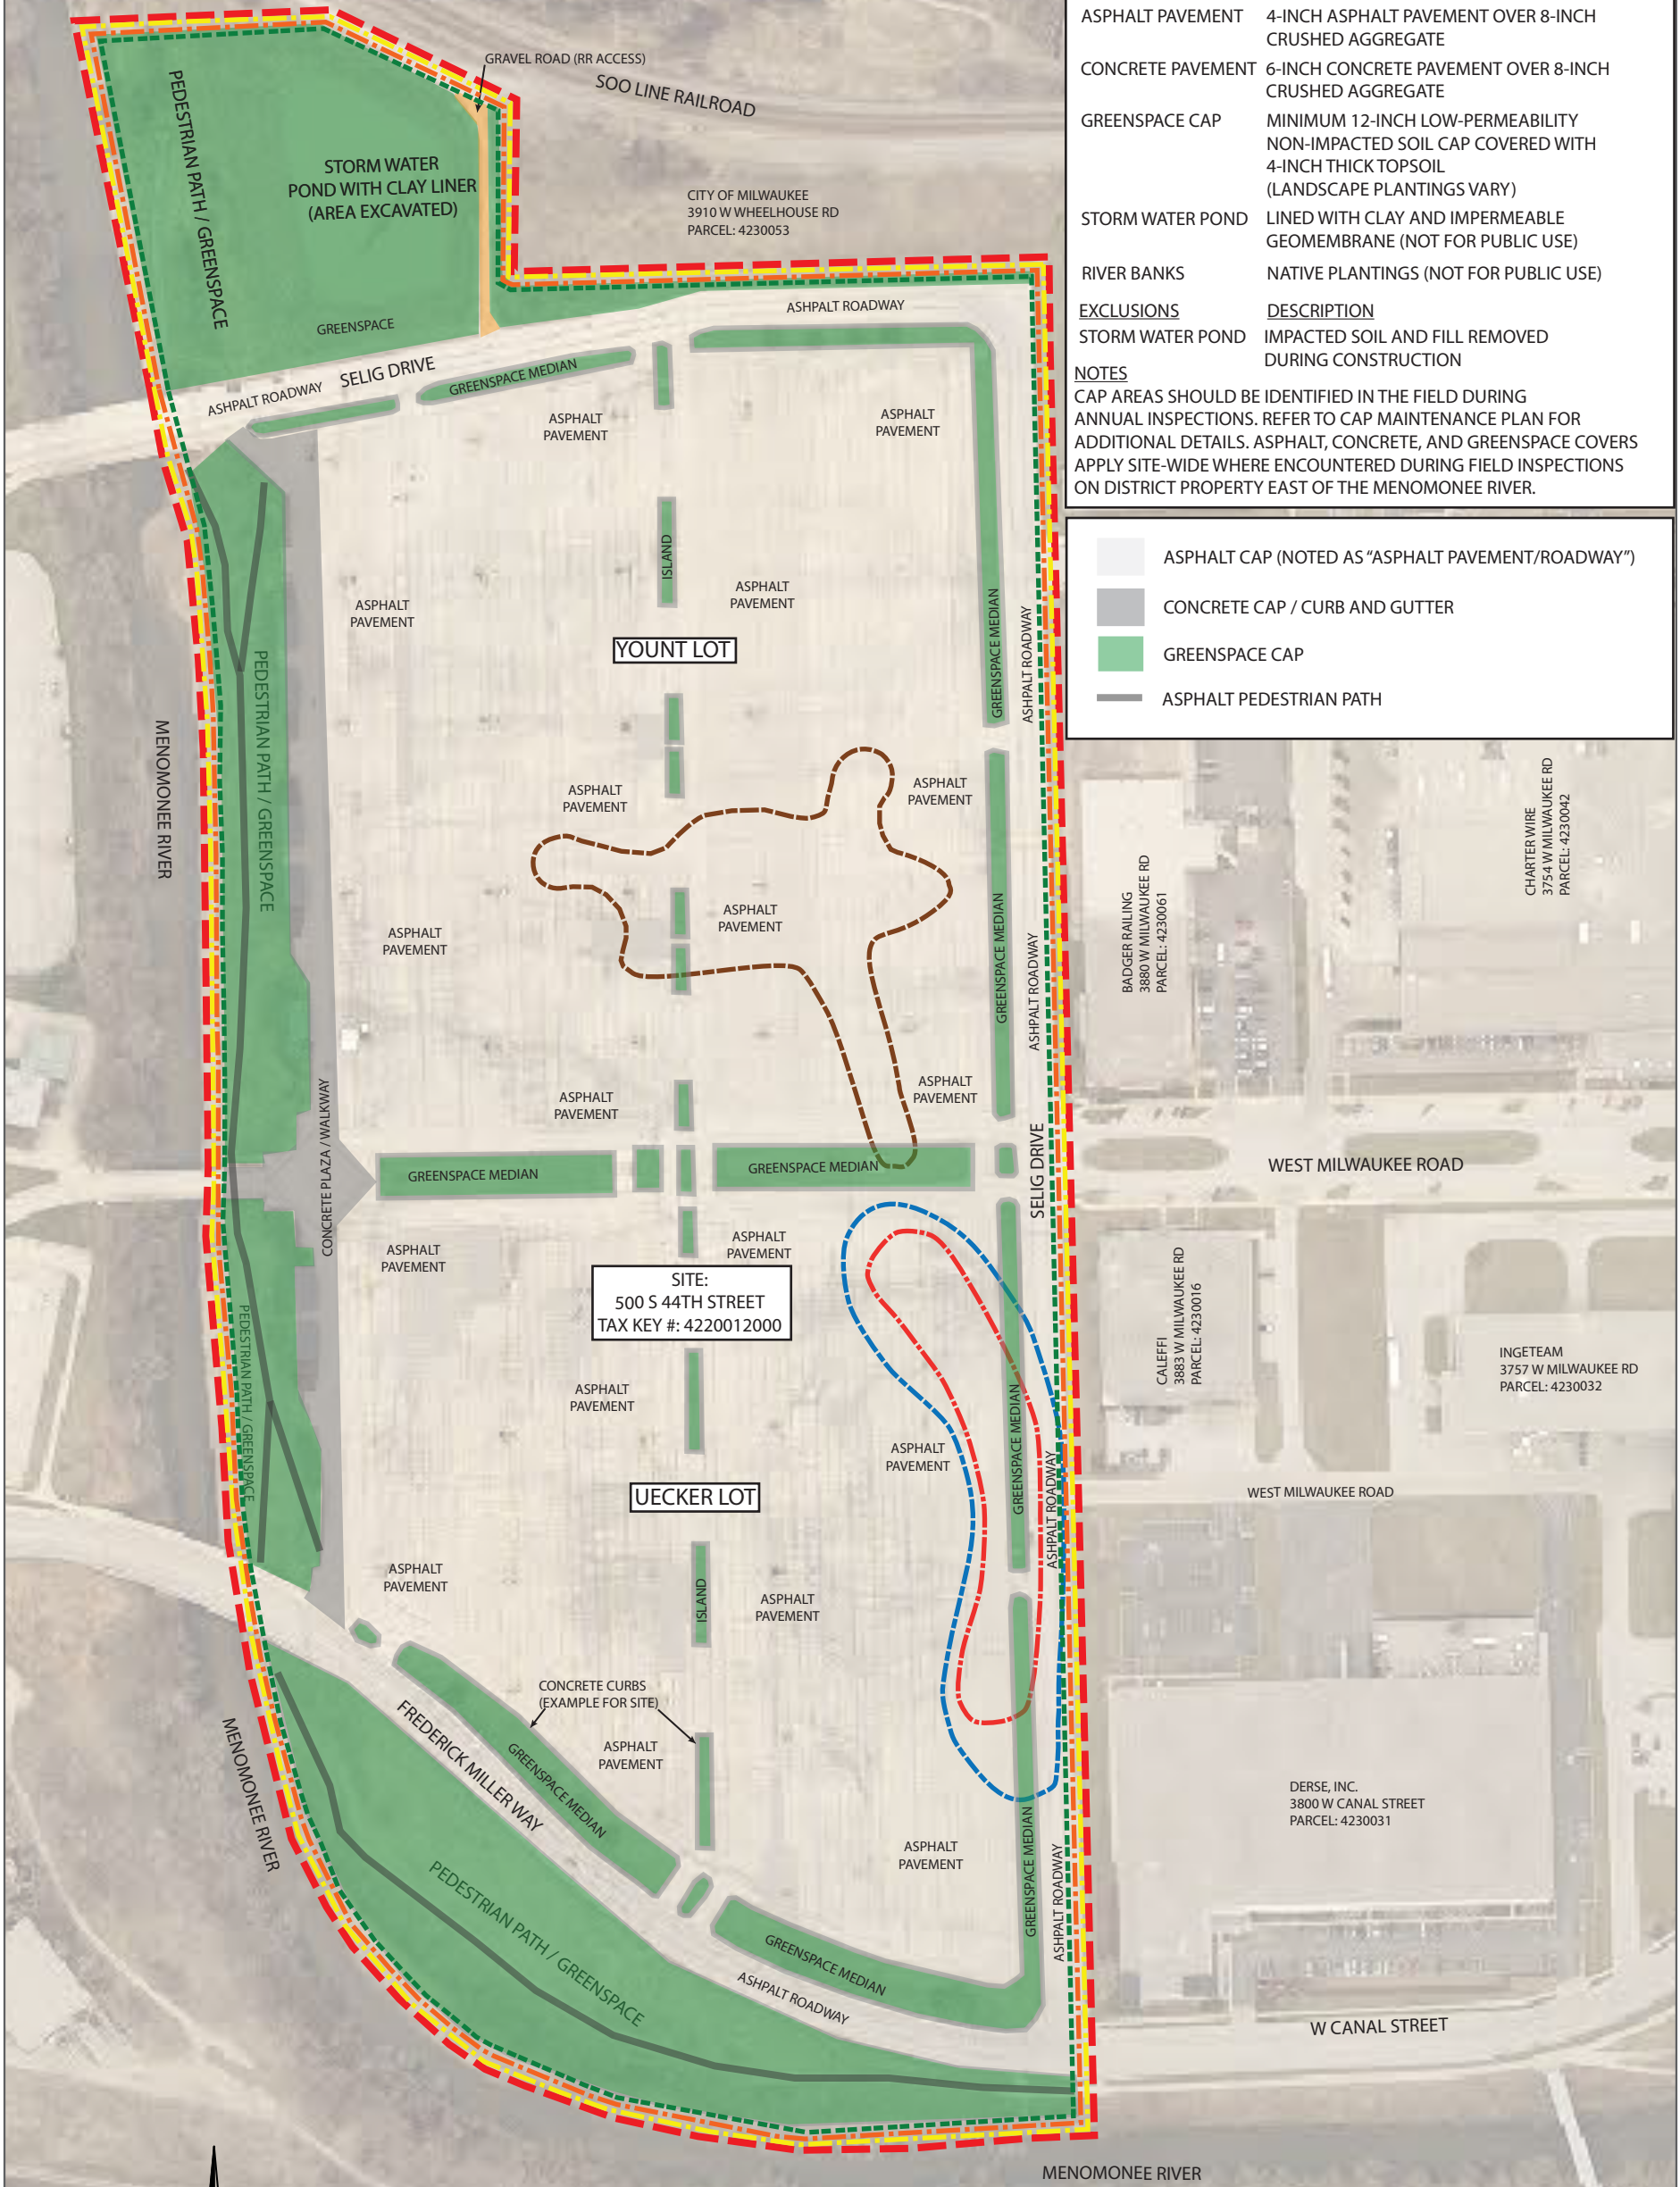
FIGURE
D.2.1

CAP AREAS SHOULD BE IDENTIFIED IN THE FIELD DURING ANNUAL INSPECTIONS. REFER TO CAP MAINTENANCE PLAN FOR ADDITIONAL DETAILS. ASPHALT, CONCRETE, AND GREENSPACE COVERS APPLY SITE-WIDE WHERE ENCOUNTERED DURING FIELD INSPECTIONS ON DISTRICT PROPERTY EAST OF THE MEMONOMEE RIVER.

- ASPHALT CAP (NOTED AS "ASPHALT PAVEMENT/ROADWAY")
- CONCRETE CAP / CURB AND GUTTER
- GREENSPACE CAP
- ASPHALT PEDESTRIAN PATH

CAP LOCATION MAP
 SOUTHEAST WISCONSIN PROFESSIONAL BASEBALL PARK DISTRICT
 RIVER EAST
 500 S 44TH STREET
 MILWAUKEE, WISCONSIN

The property address and tax key are shown in **Figure D.2.1 – Cap Location Map**. Additional land description and parcel information is provided within the Assessor's Plat of Miller Park (**Attachment 1**).

Annual Inspection. The caps overlying the contaminated soil, groundwater, and petroleum free product as depicted in **Attachment D.2.1** and **D.2.2** will be inspected once a year in the late fall when there is no snow or ice cover, for deterioration, cracks and other potential problems that can cause exposure to or additional infiltration into underlying soils. The inspections will be performed by the property owner or their designated representative. The inspections will be performed to evaluate damage due to settling, exposure to the weather, wear, age related degradation, and other factors. Areas where soils have become or are likely to become exposed will be documented.

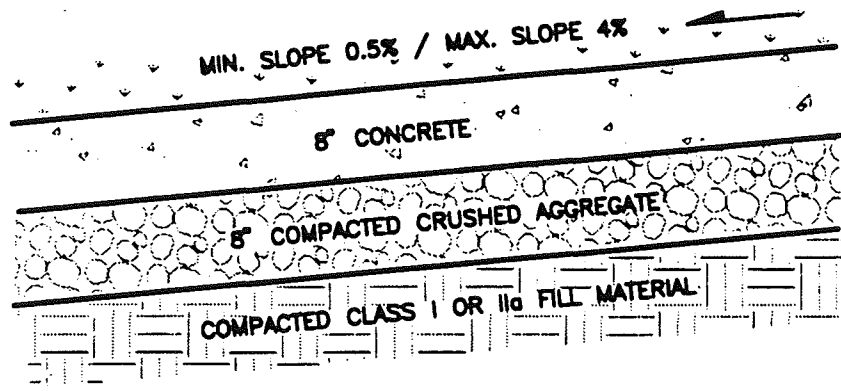
TYPICAL PLAZA SECTION DETAIL
(PRELIMINARY AND CONCEPTUAL ONLY)

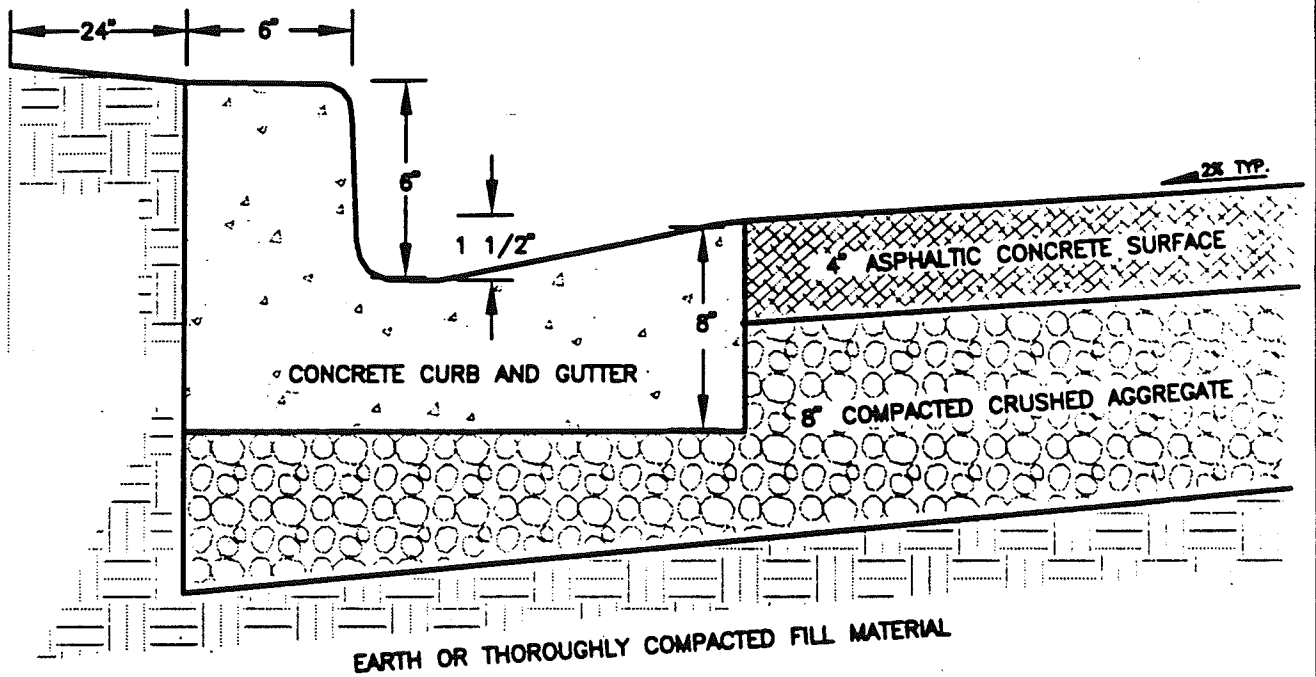
TYPICAL STREET SECTION DETAIL
(PRELIMINARY AND CONCEPTUAL ONLY)

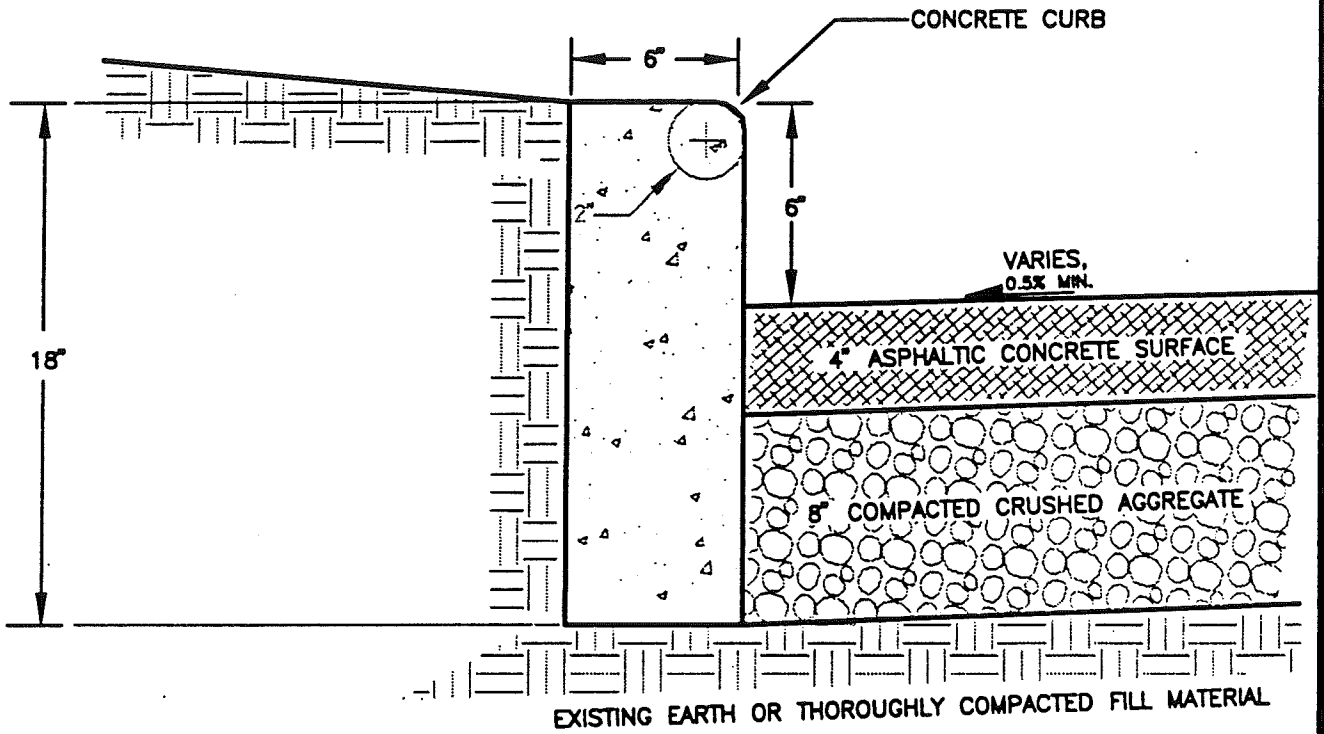
TYPICAL PARKING SECTION DETAIL
(PRELIMINARY AND CONCEPTUAL ONLY)

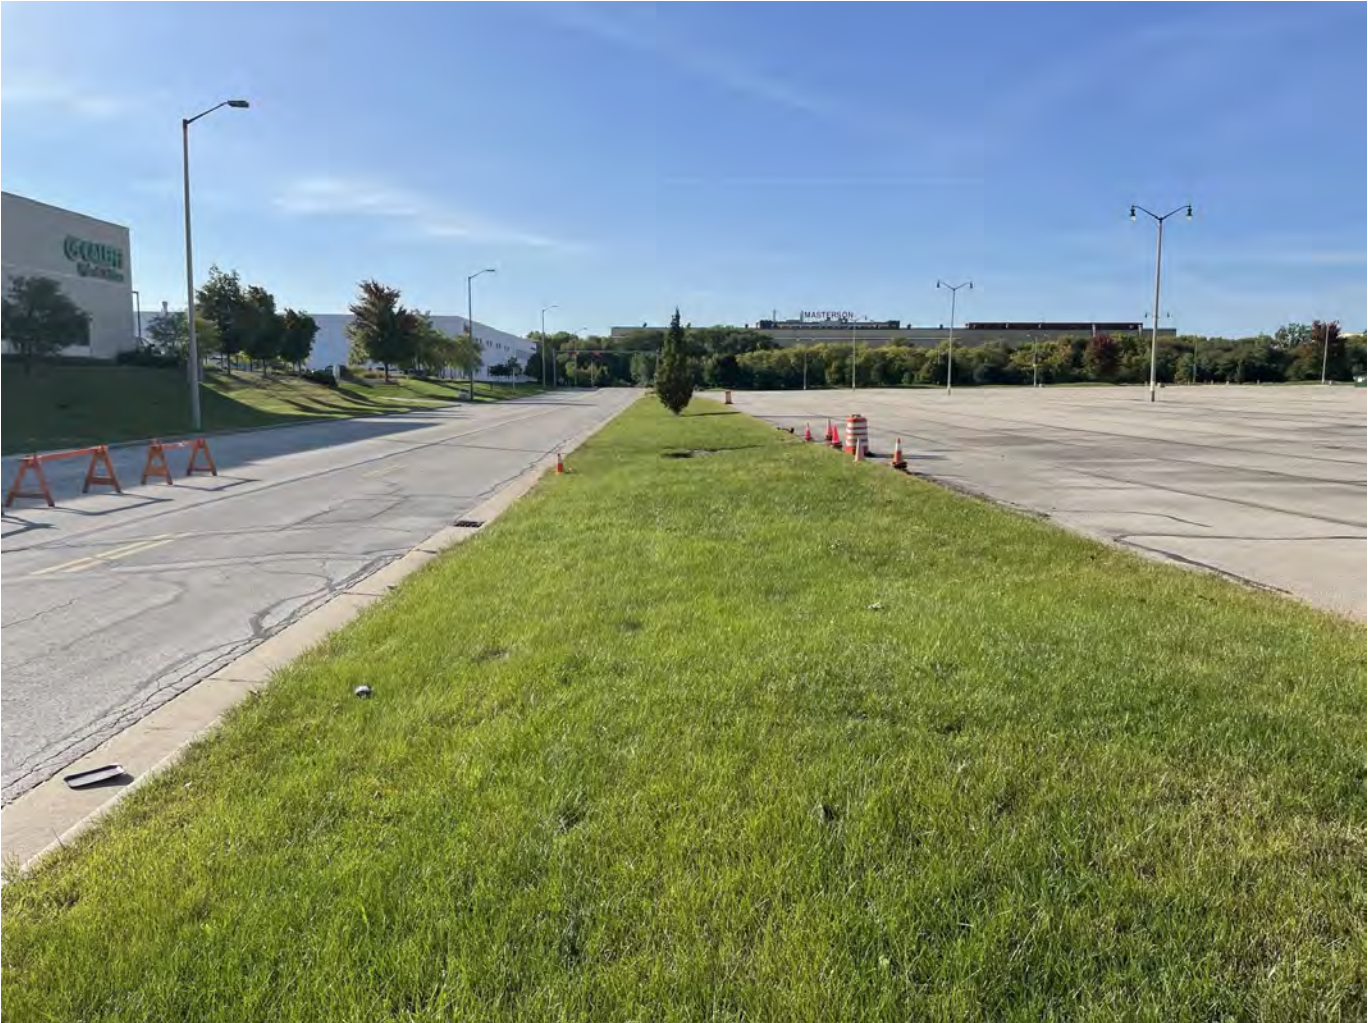
Photo 1: Yount Lot: Greenspace cap along parking lot median: 12-inches of low permeability non-impacted soil covered with 4-inches of vegetated (grass as shown) topsoil. Asphalt capped Selig Drive shown on left side of photo. Asphalt capped Yount Lot shown on ride side of photo.
Photo taken facing south on October 4, 2022.

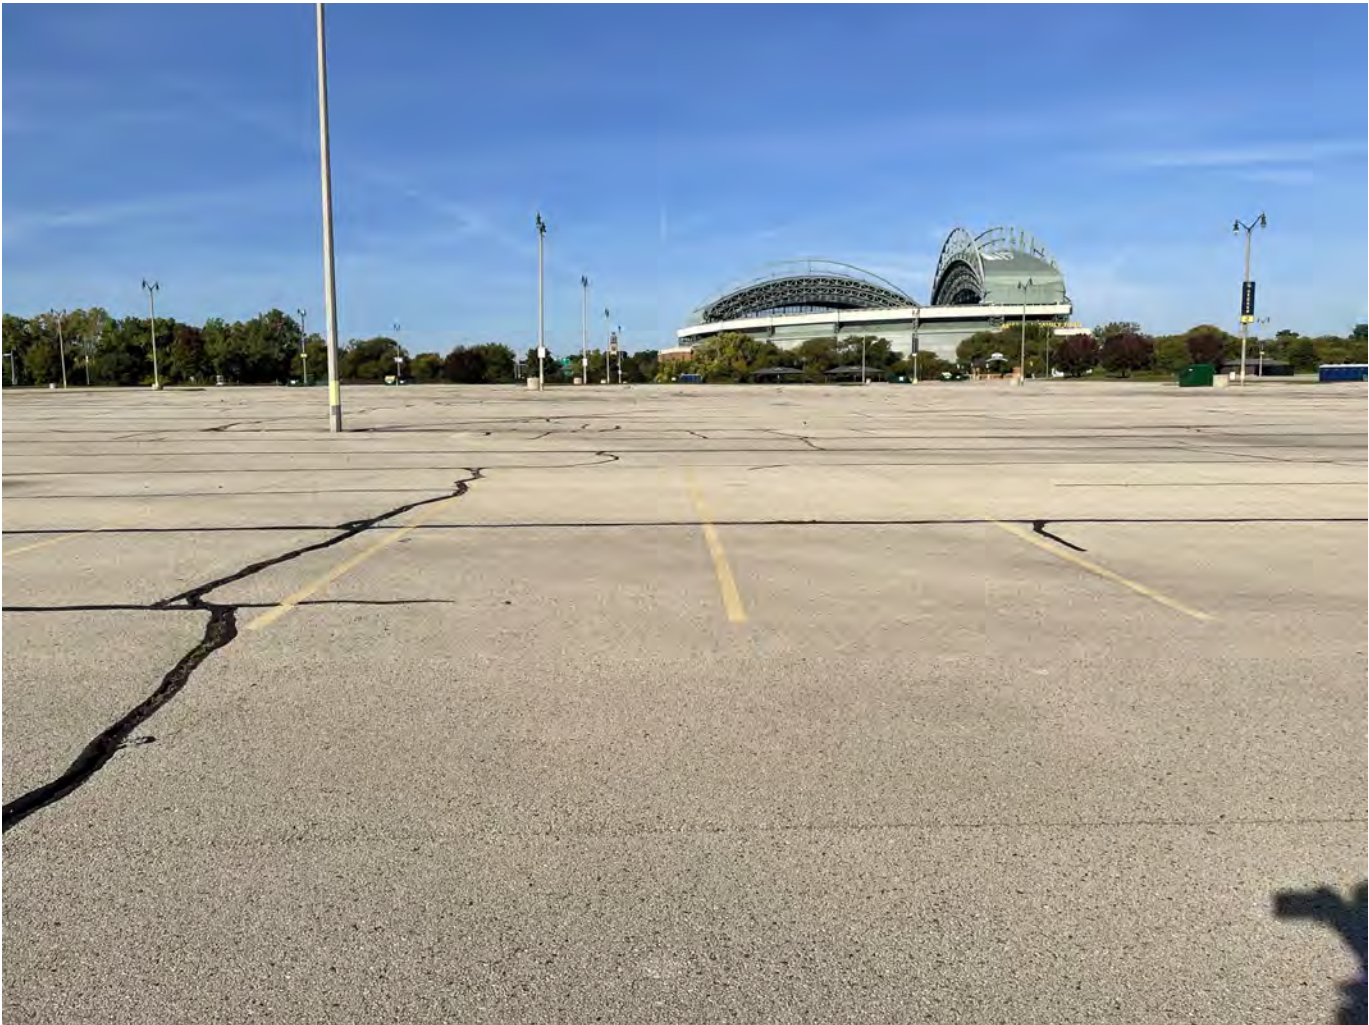
Photo 2: Yount Lot: Asphalt cap over Yount Lot: 4-inch asphalt pavement overlying 8-inches of crushed aggregate base course. Photo depicts current conditions for comparison during future inspections.
Photo taken facing west on October 4, 2022.

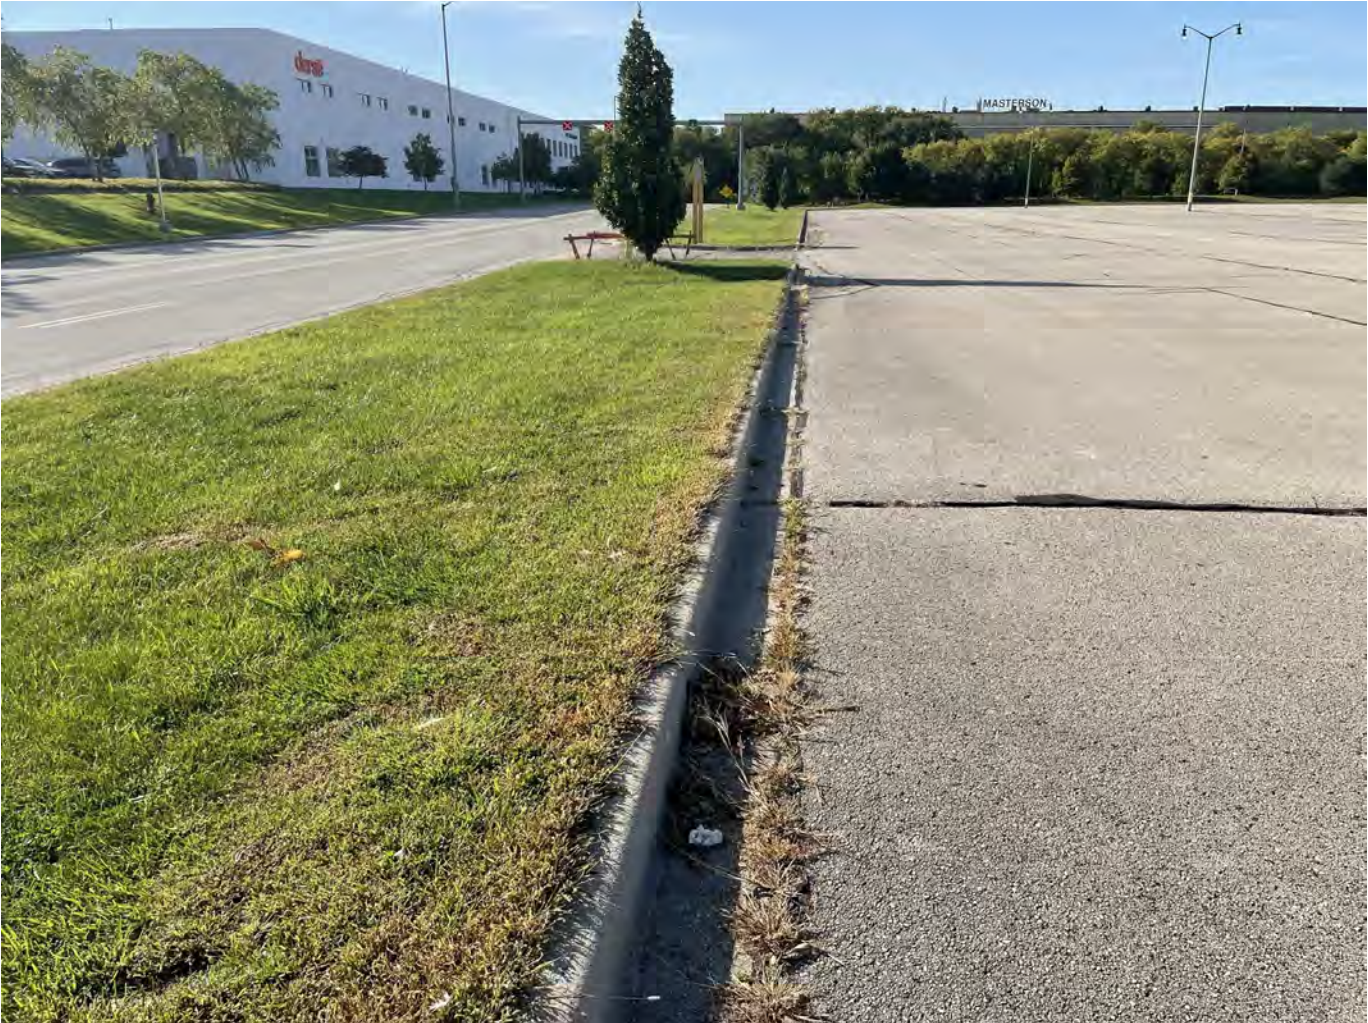
Photo 3: Yount Lot: Asphalt cap over Yount Lot (right side of photo): 4-inch asphalt pavement overlying 8-inches of crushed aggregate base course. Greenspace cap over parking lot median: 12-inches of low-permeability non-impacted soil covered with 4-inches of vegetated topsoil. Concrete curb and gutter along median perimeter and edge of asphalt pavement. Photo taken facing south on October 4, 2022.

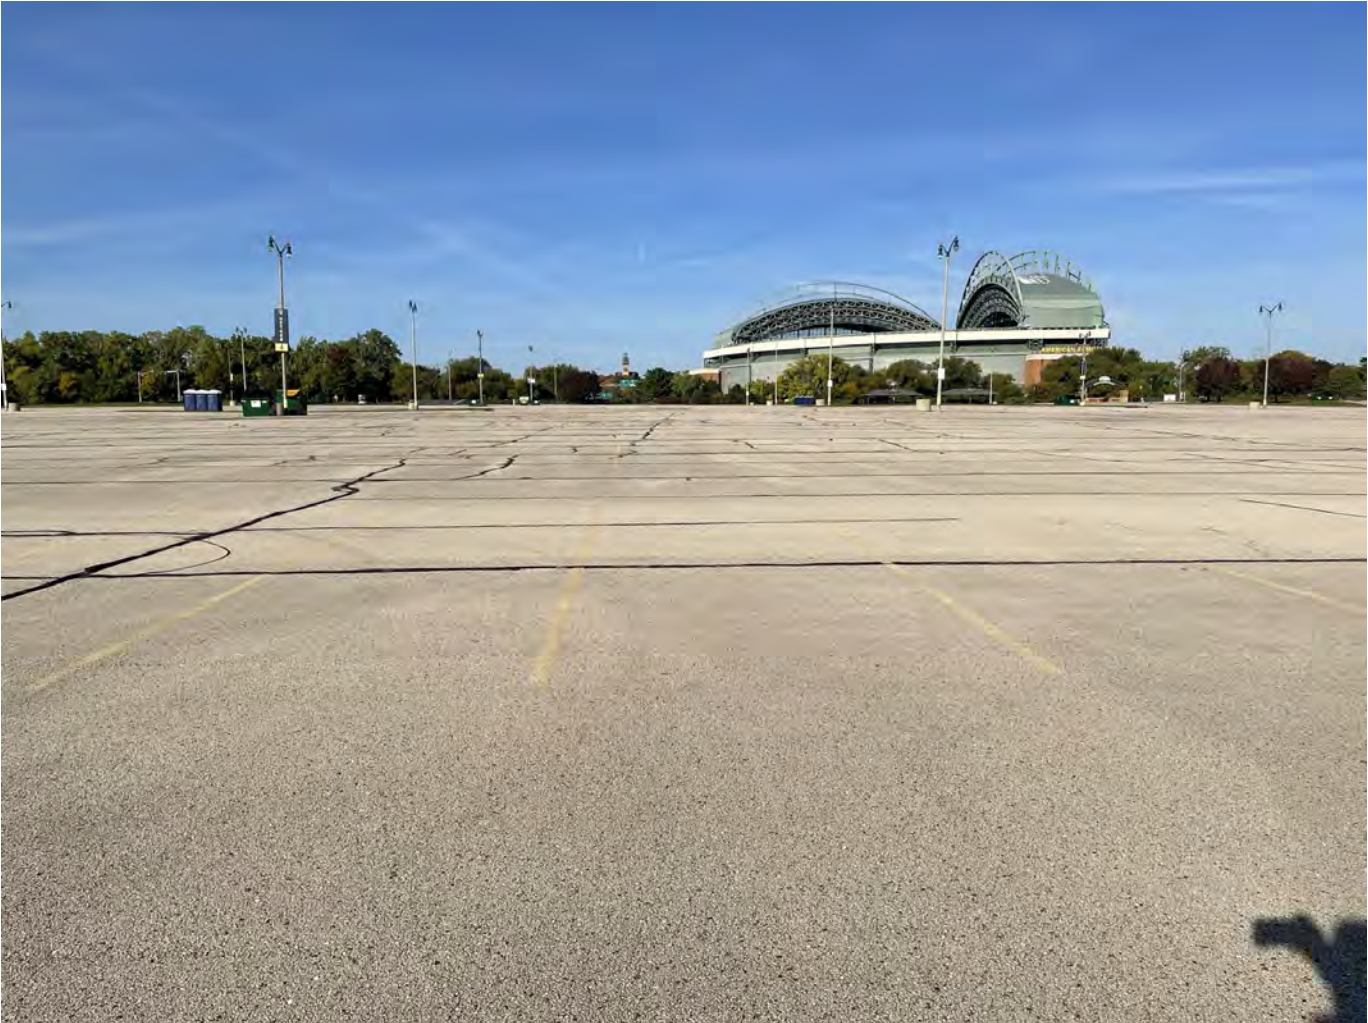
Photo 4: Yount Lot: Asphalt cap over Yount Lot: 4-inch asphalt pavement overlying 8-inches of crushed aggregate base course.
Photo taken facing west on October 4, 2022.

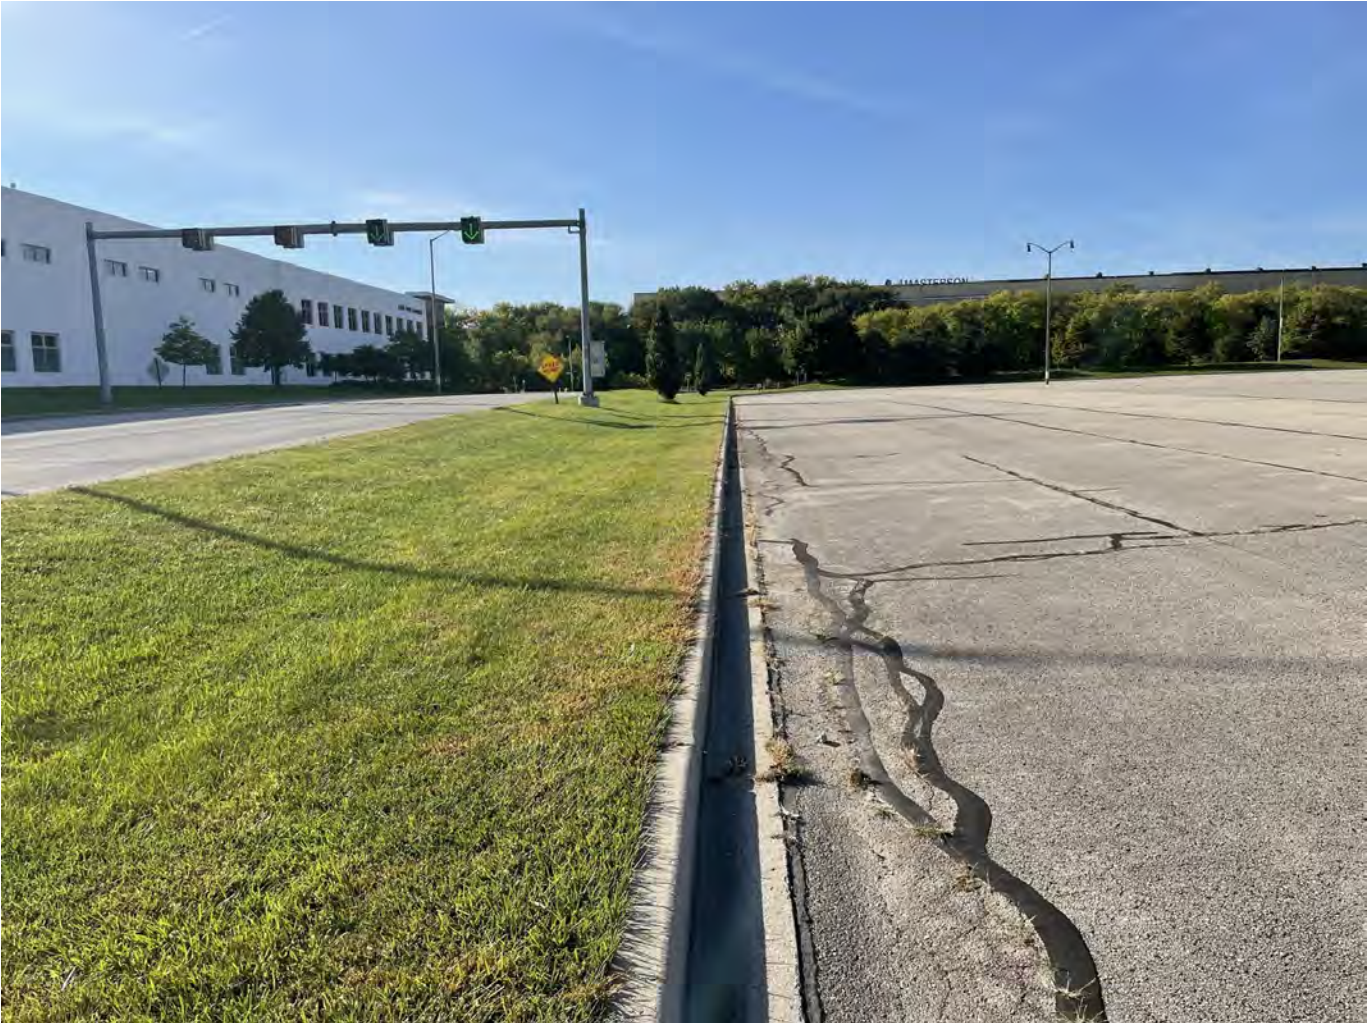
Photo 5: Uecker Lot: Asphalt cap over Uecker Lot (right side of photo): 4-inch asphalt pavement overlying 8-inches of crushed aggregate base course. Greenspace cap over parking lot median: 12-inches of low-permeability non-impacted soil covered with 4-inches of vegetated topsoil. Concrete curb and gutter along median perimeter and edge of asphalt pavement. Photo taken facing south on October 4, 2022.

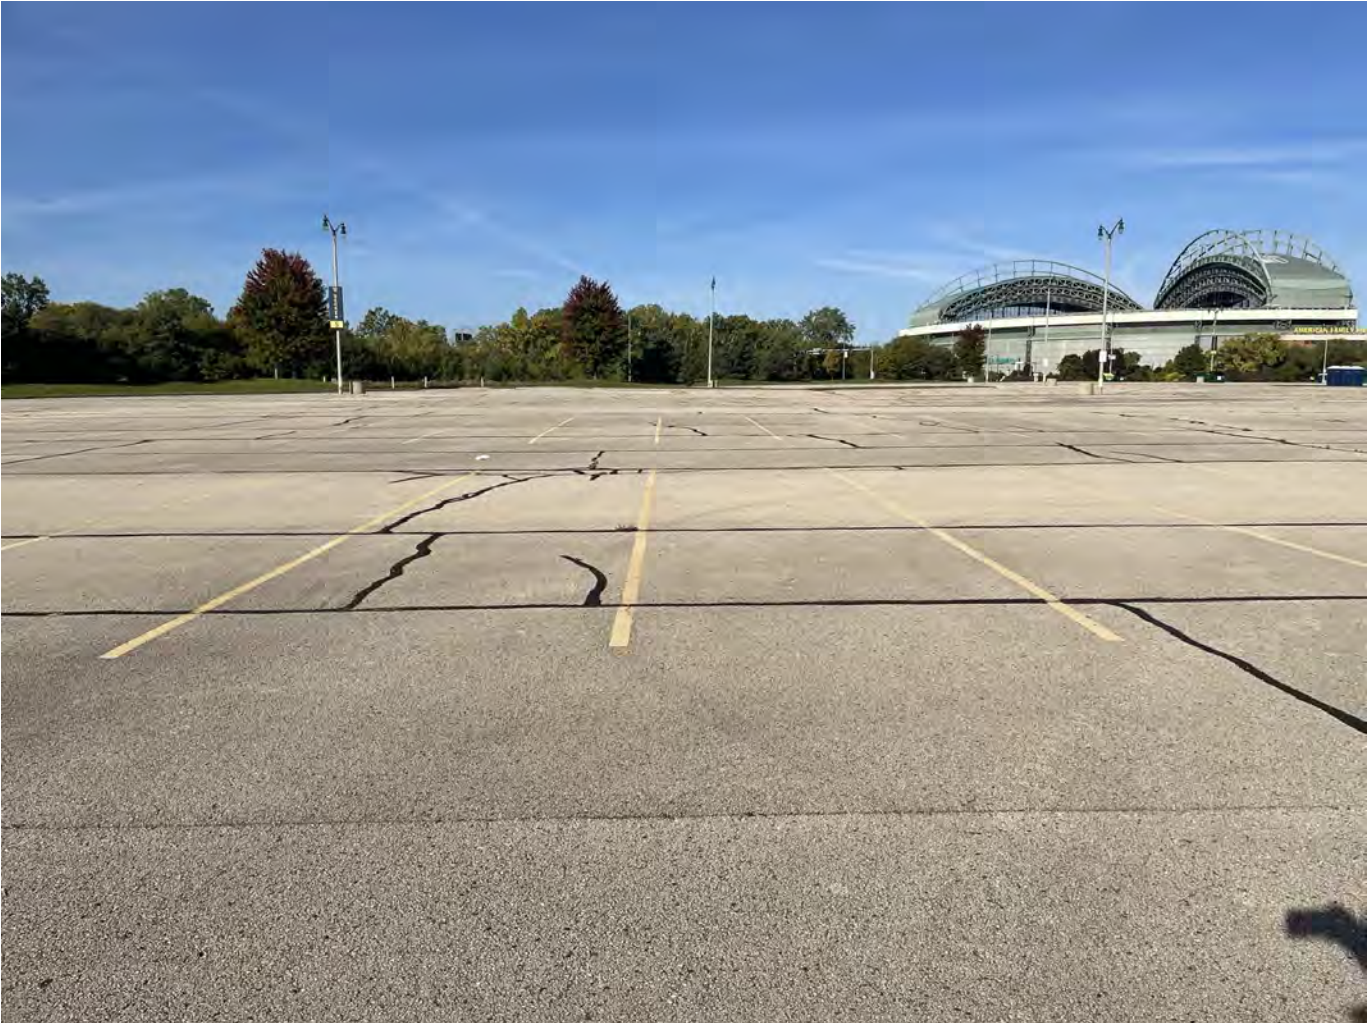
Photo 7: Uecker Lot: Asphalt cap over Uecker Lot: 4-inch asphalt pavement overlying 8-inches of crushed aggregate base course.
Photo taken facing west on October 4, 2022.

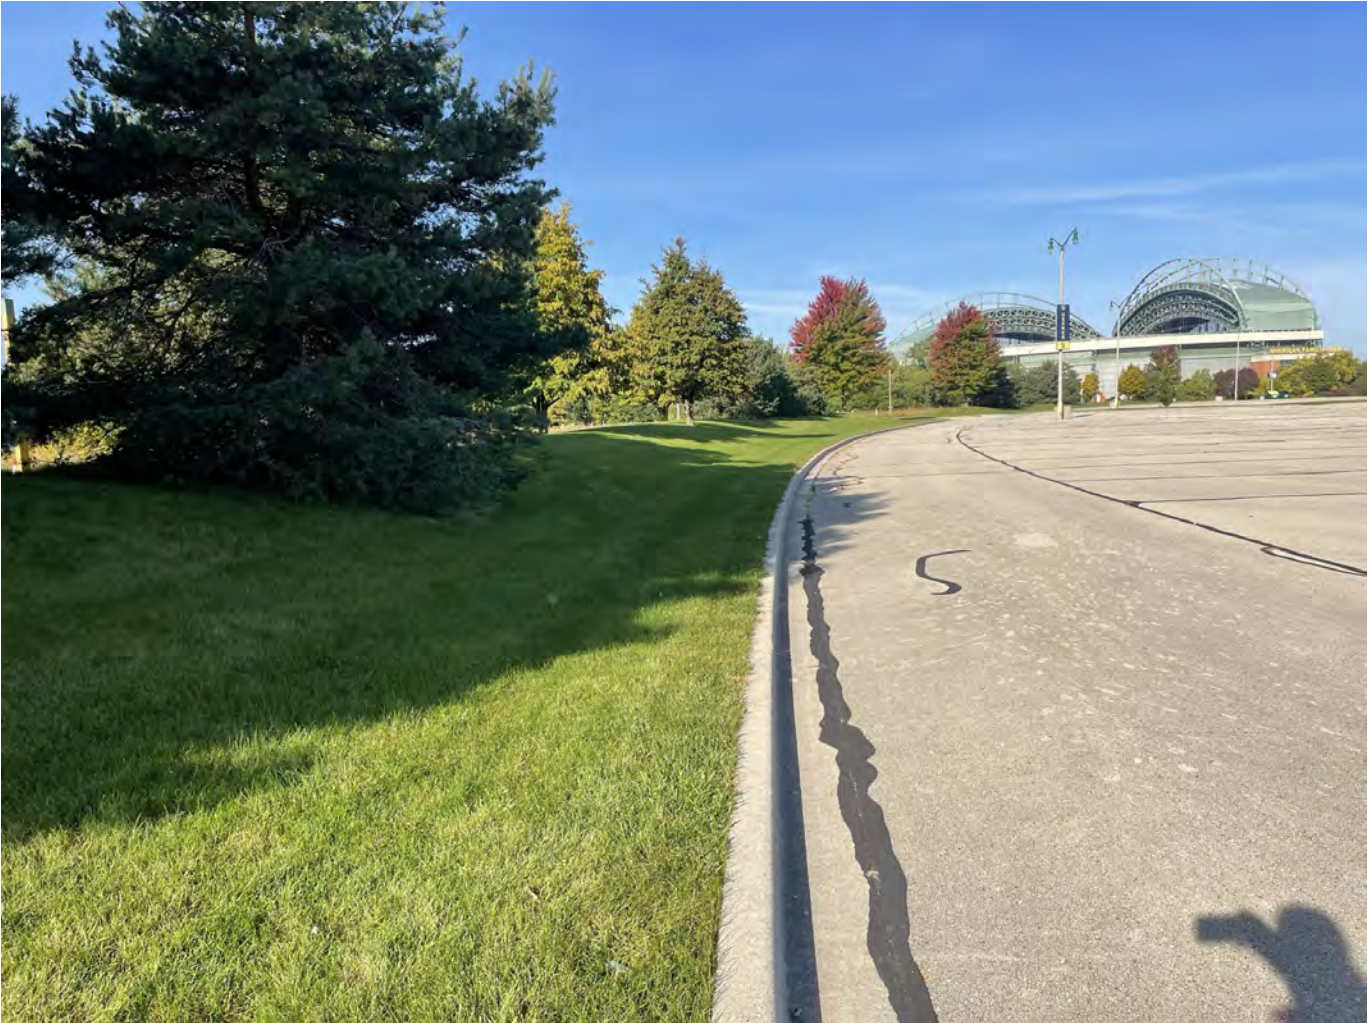
Photo 8: Uecker Lot: Asphalt cap over Uecker Lot (right side of photo): 4-inch asphalt pavement overlying 8-inches of crushed aggregate base course. Greenspace cap over parking lot median along Frederick Miller Way on south side of Uecker Lot: 12-inches of low-permeability non-impacted soil covered with 4-inches of vegetated topsoil. Concrete curb and gutter along median perimeter and edge of asphalt pavement. Photo taken facing west-northwest on October 4, 2022.

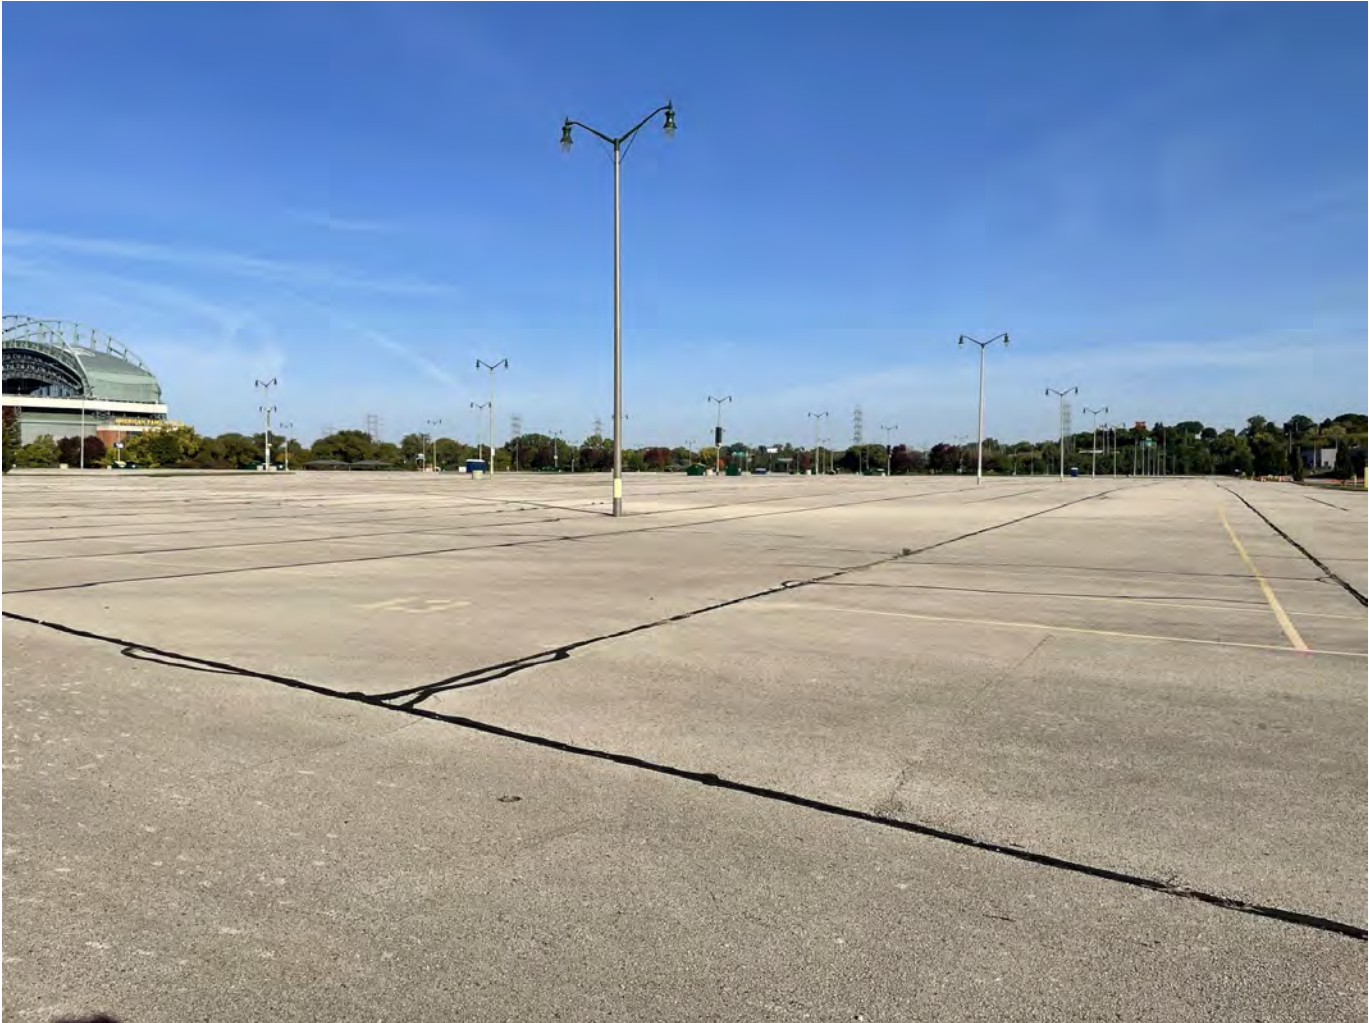
Photo 9: Uecker Lot: Asphalt cap over Uecker Lot: 4-inch asphalt pavement overlying 8-inches of crushed aggregate base course.
Photo taken facing northwest on October 4, 2022.

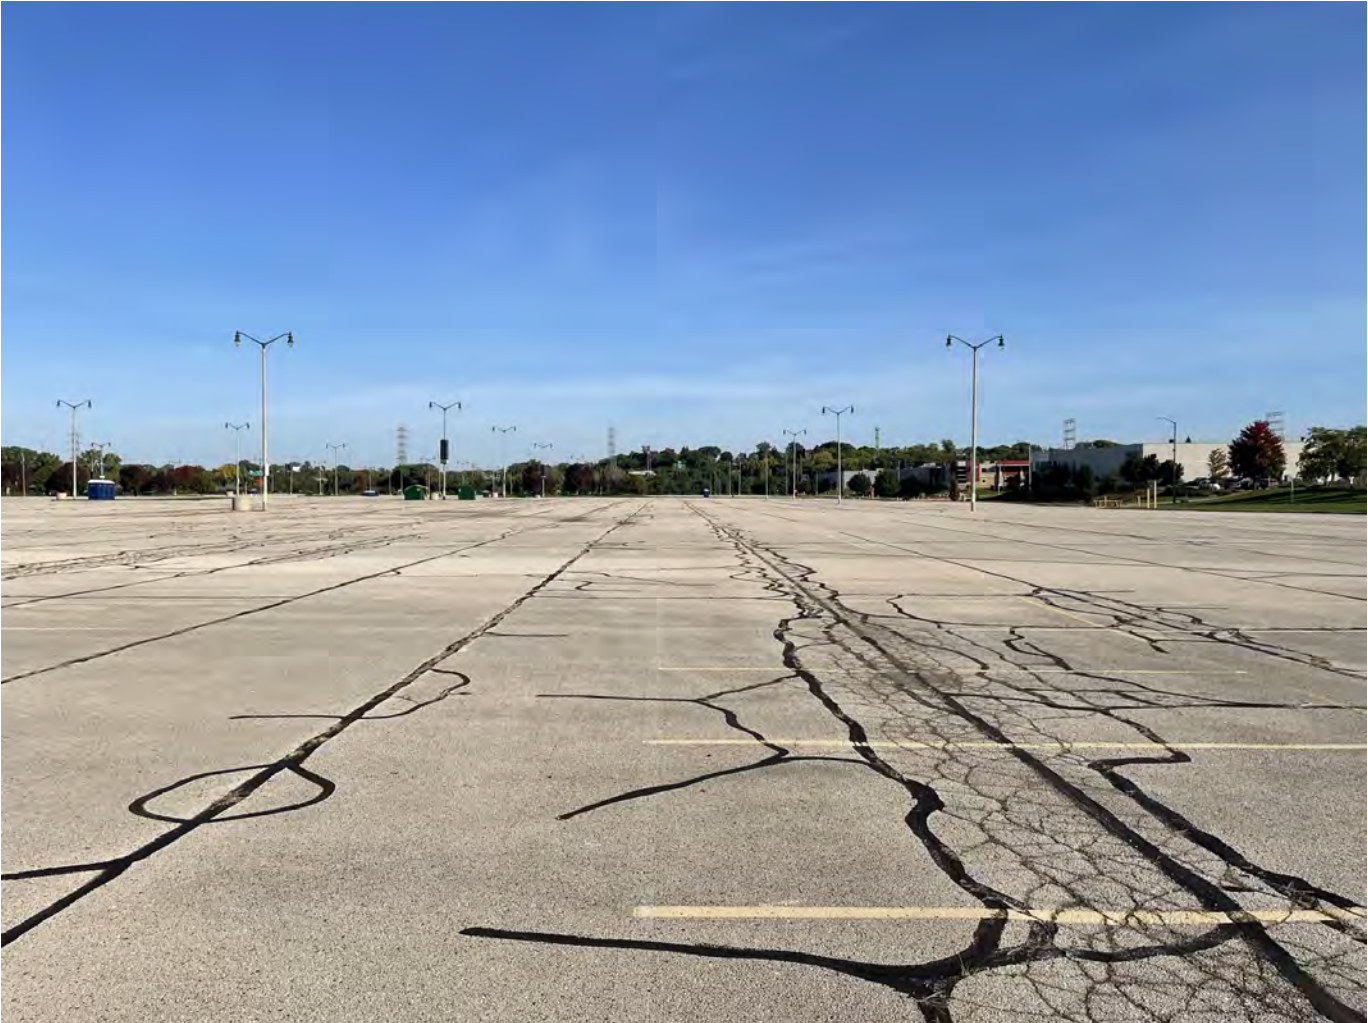
Photo 10: Uecker Lot: Asphalt cap over Uecker Lot: 4-inch asphalt pavement overlying 8-inches of crushed aggregate base course.
Photo taken facing north on October 4, 2022.

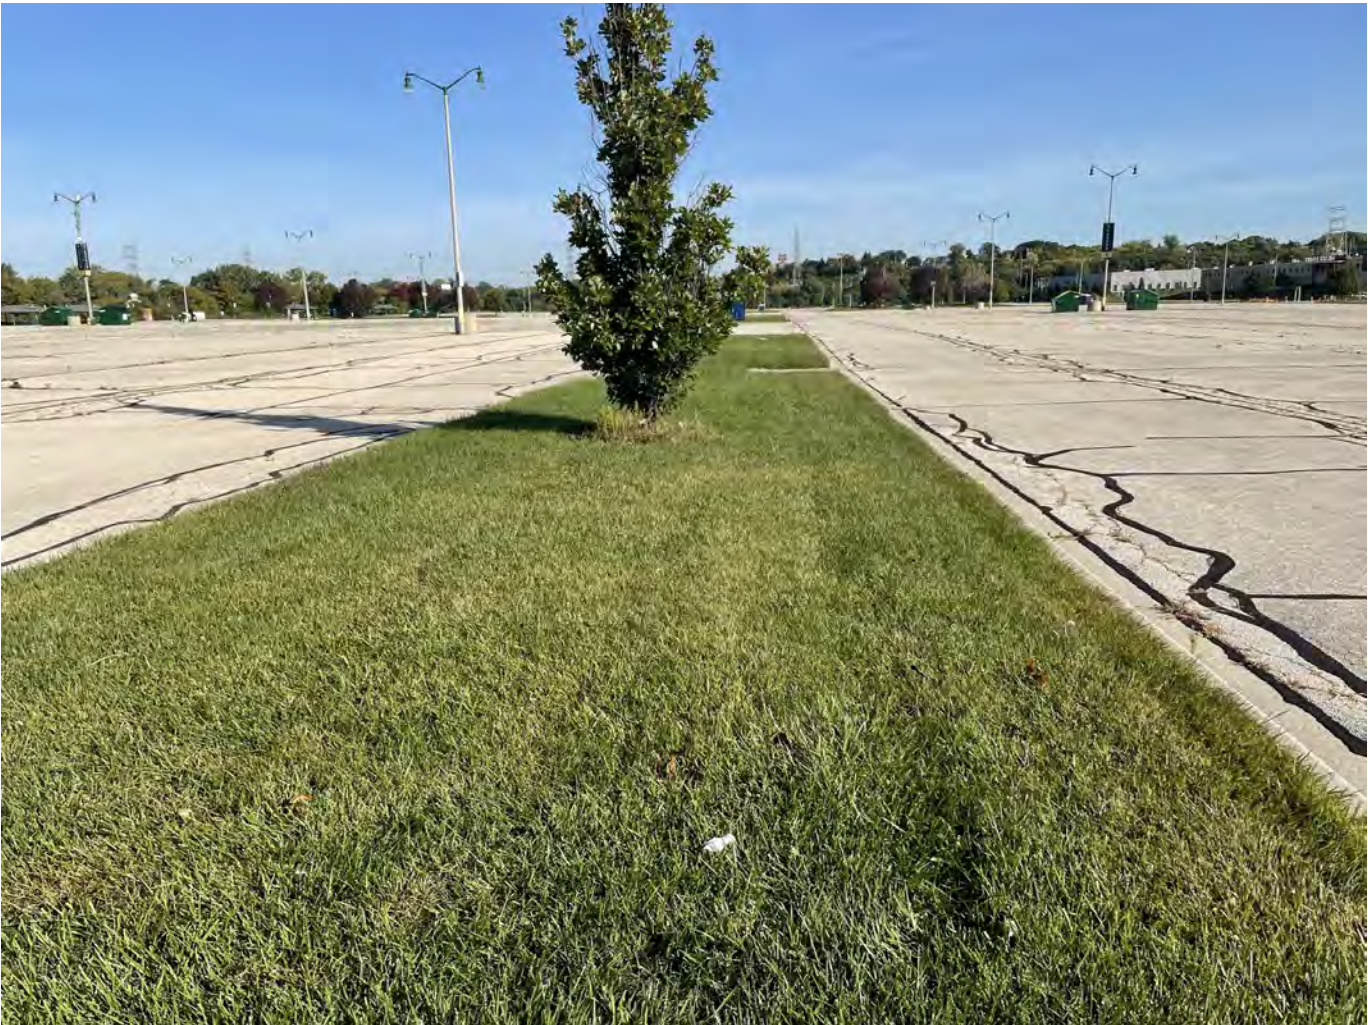
Photo 11: Uecker Lot: Greenspace cap over Uecker Lot island: 12-inches low permeability soil covered with 4-inches of vegetated topsoil.
Photo taken facing north on October 4, 2022.

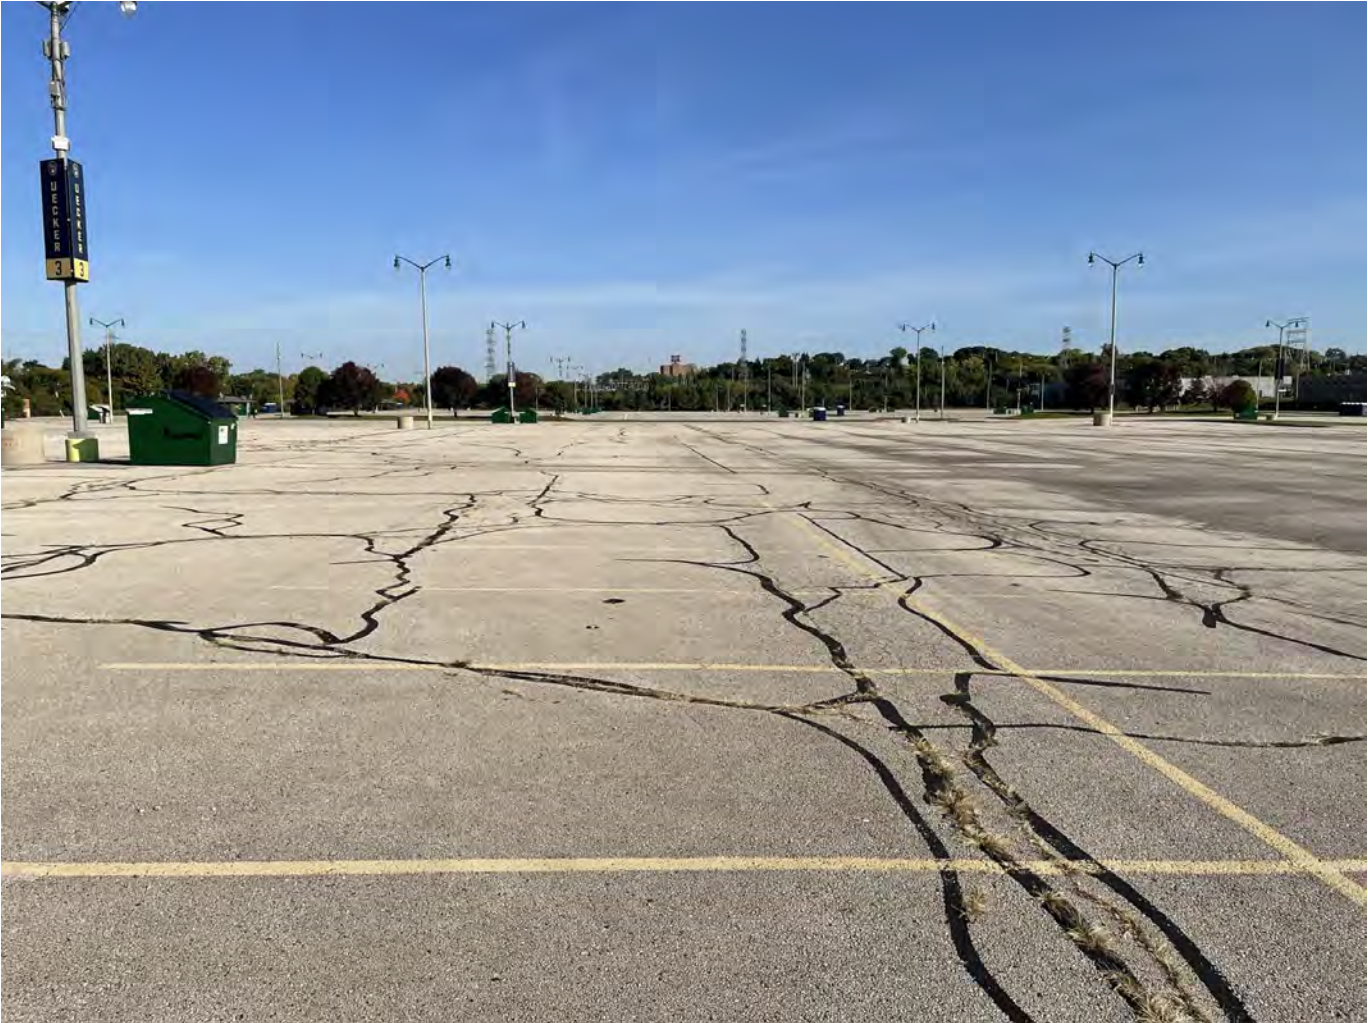
Photo 12: Uecker Lot: Asphalt cap over Uecker Lot: 4-inch asphalt pavement overlying 8-inches of crushed aggregate base course.
Photo taken facing north on October 4, 2022.
