ATTACHMENT D.1.

CAP MAINTENANCE PLAN SOUTHEAST WISCONSIN PROFESSIONAL BASEBALL PARK DISTRICT – RIVER EAST

FEBRUARY 2023

WDNR ACTIVITY NAME: MENOMONEE RIVER STADIUM PROJECT

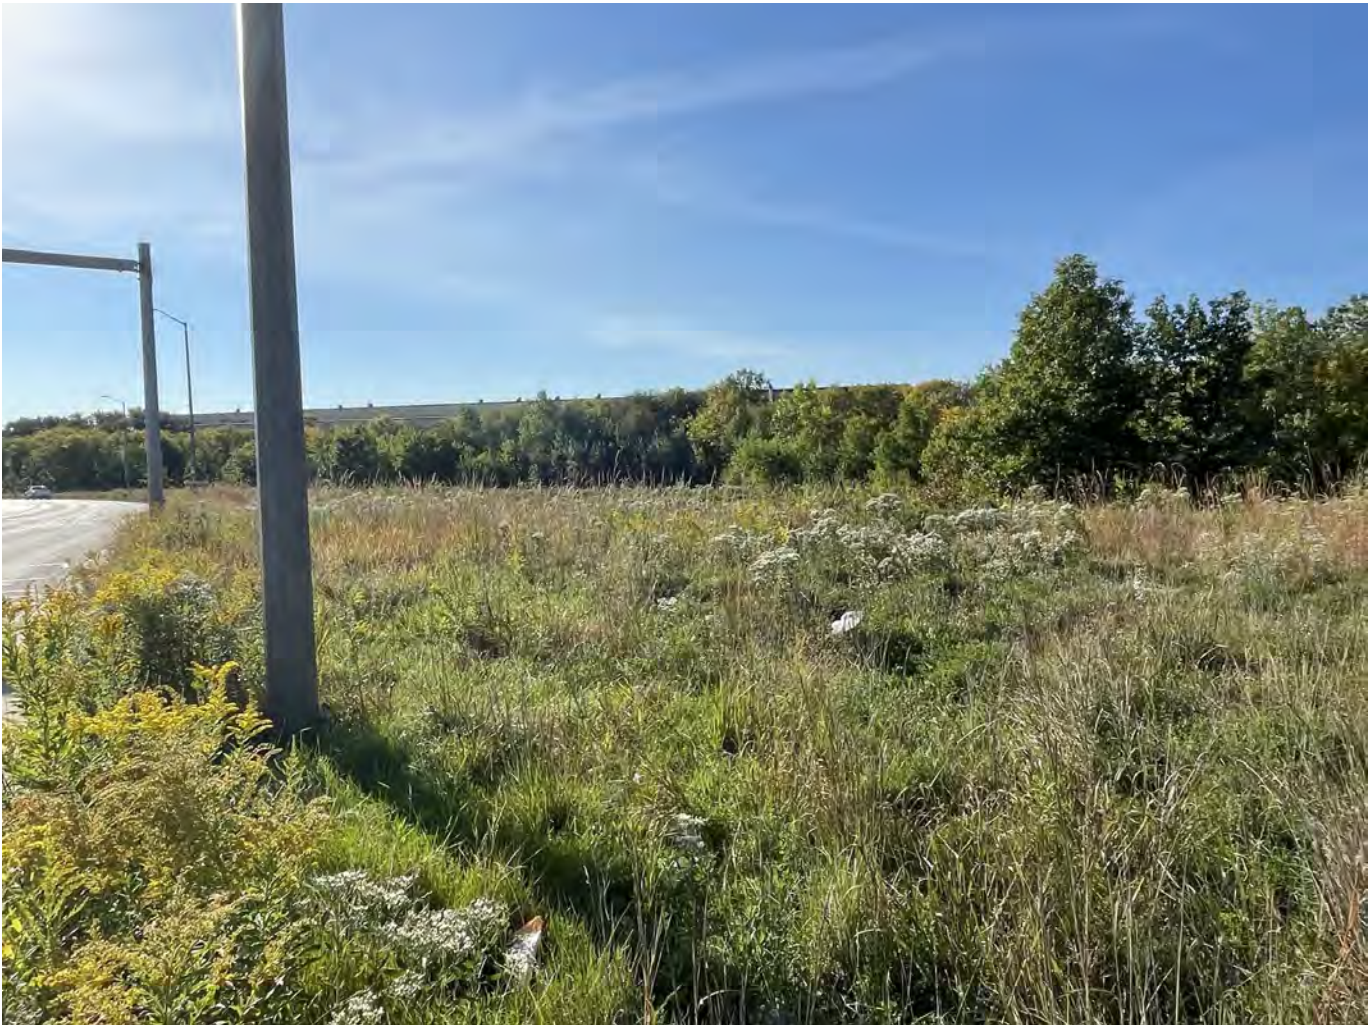
Photo 13: South of Uecker Lot: Greenspace cap and native plantings overgrowth south of Uecker Lot and Frederick Miller Way.
Photo taken facing southeast on October 4, 2022.

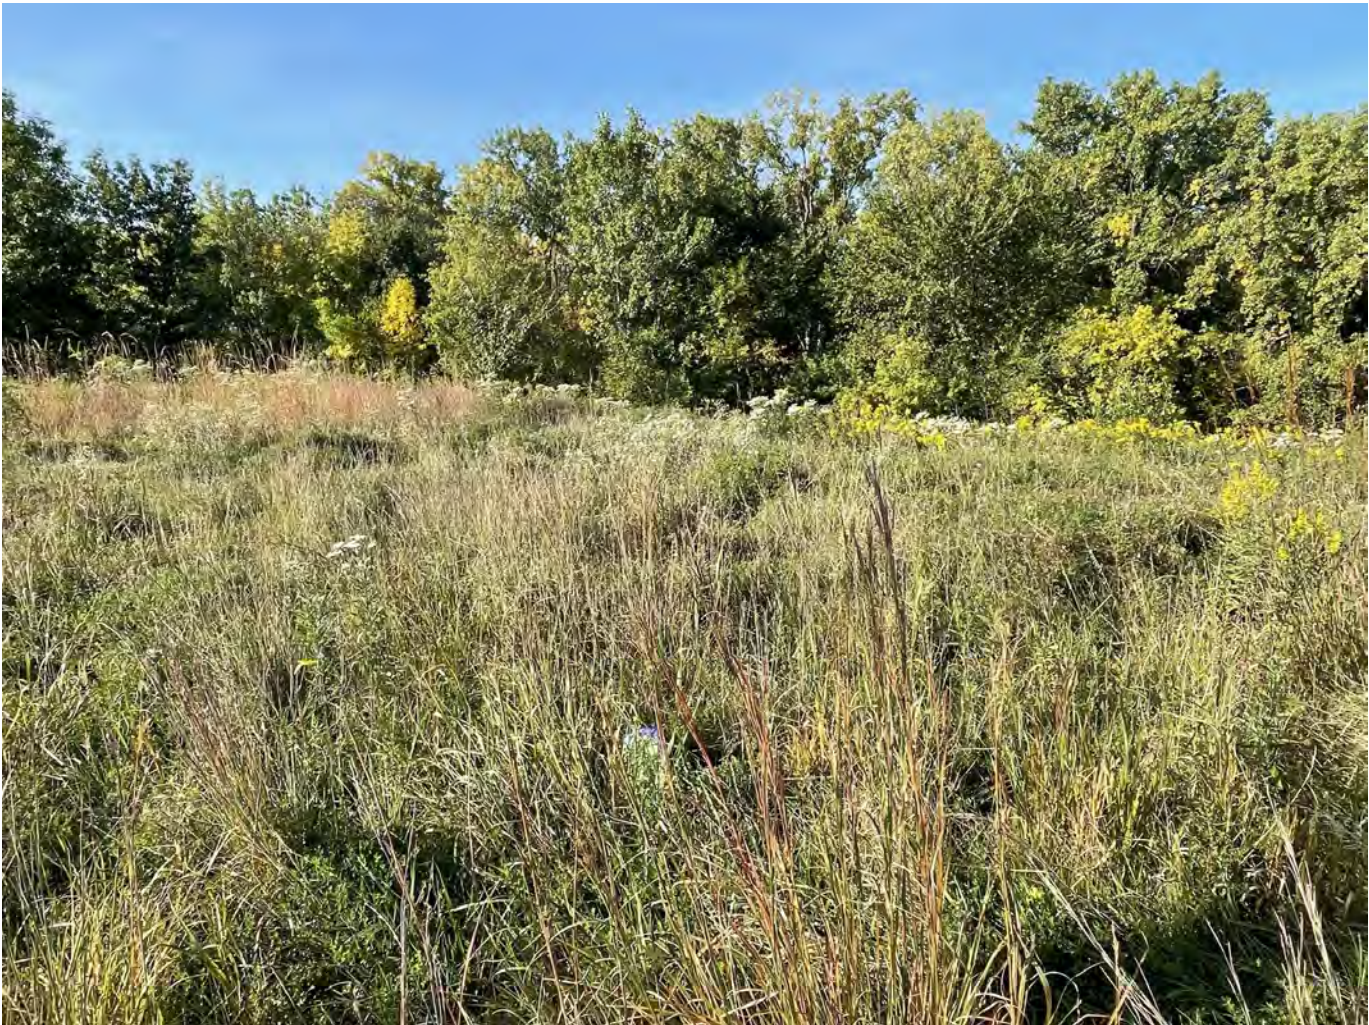
Photo 14: South of Uecker Lot: Greenspace cap and native plantings overgrowth south of Uecker Lot and Frederick Miller Way.
Photo taken facing south on October 4, 2022.

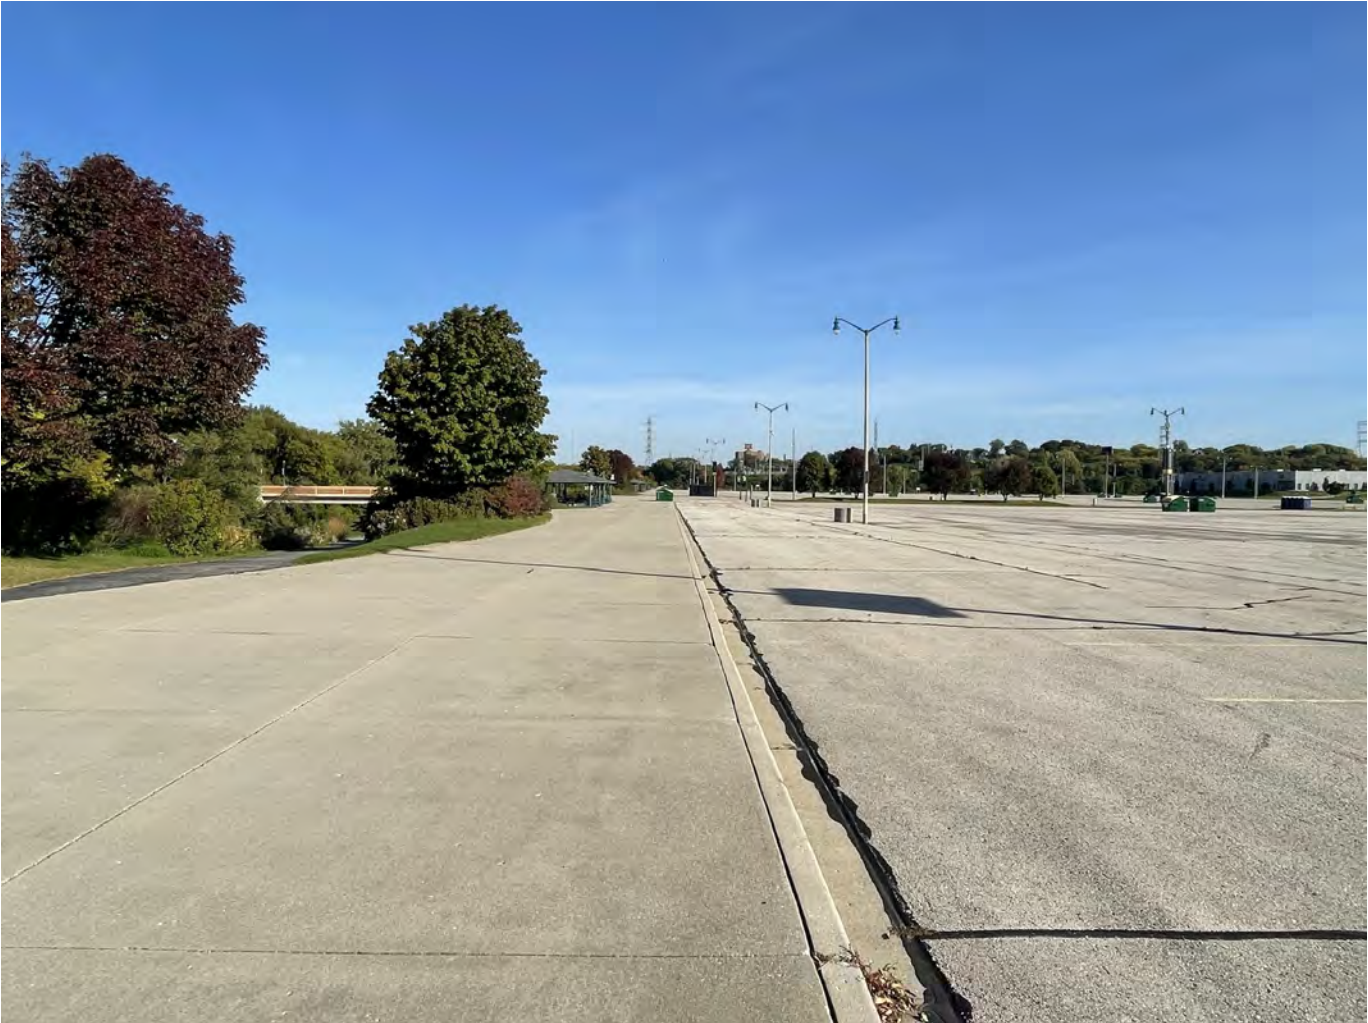
Photo 15: Uecker Lot: Concrete paved plaza and pedestrian path along west side of Uecker Lot (shown on left side of photo): 6-inch concrete pavement overlying 8-inches crushed aggregate. Asphalt paved Uecker Lot (shown on right side of photo): 4-inch asphalt pavement overlying 8-inches crushed aggregate.
Photo taken facing north on October 4, 2022.

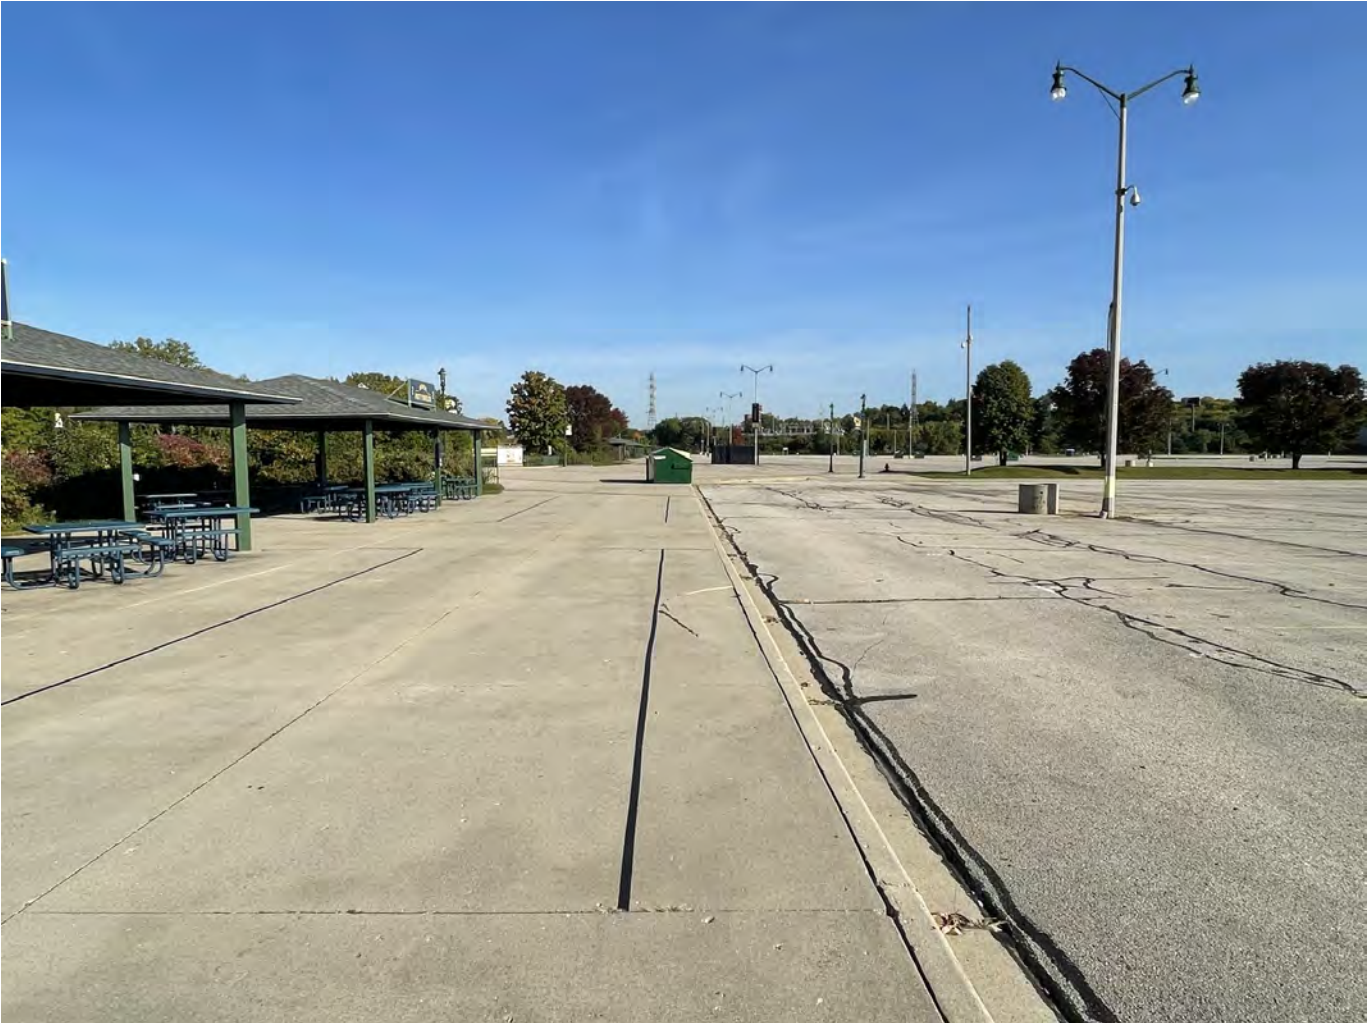
Photo 16: Uecker Lot: Concrete paved plaza and pedestrian path along west side of Uecker Lot (shown on left side of photo): 6-inch concrete pavement overlying 8-inches crushed aggregate. Asphalt paved Uecker Lot (shown on right side of photo): 4-inch asphalt pavement overlying 8-inches crushed aggregate.
Photo taken facing north on October 4, 2022.

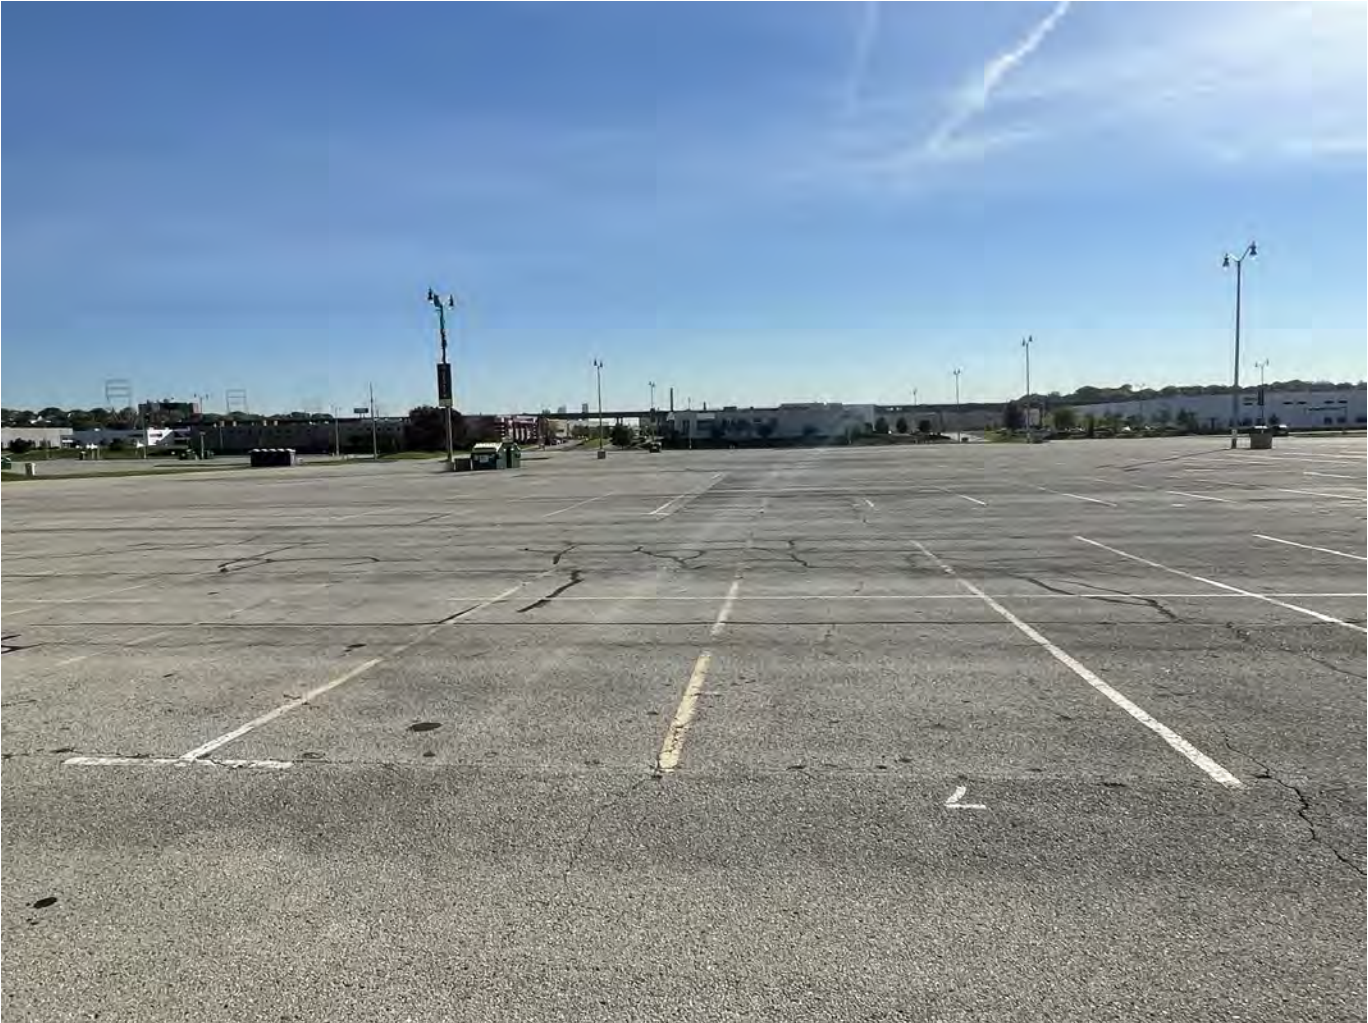
Photo 17: Uecker Lot: Asphalt cap over Uecker Lot: 4-inch asphalt pavement overlying 8-inches of crushed aggregate base course.
Photo taken facing east on October 4, 2022.

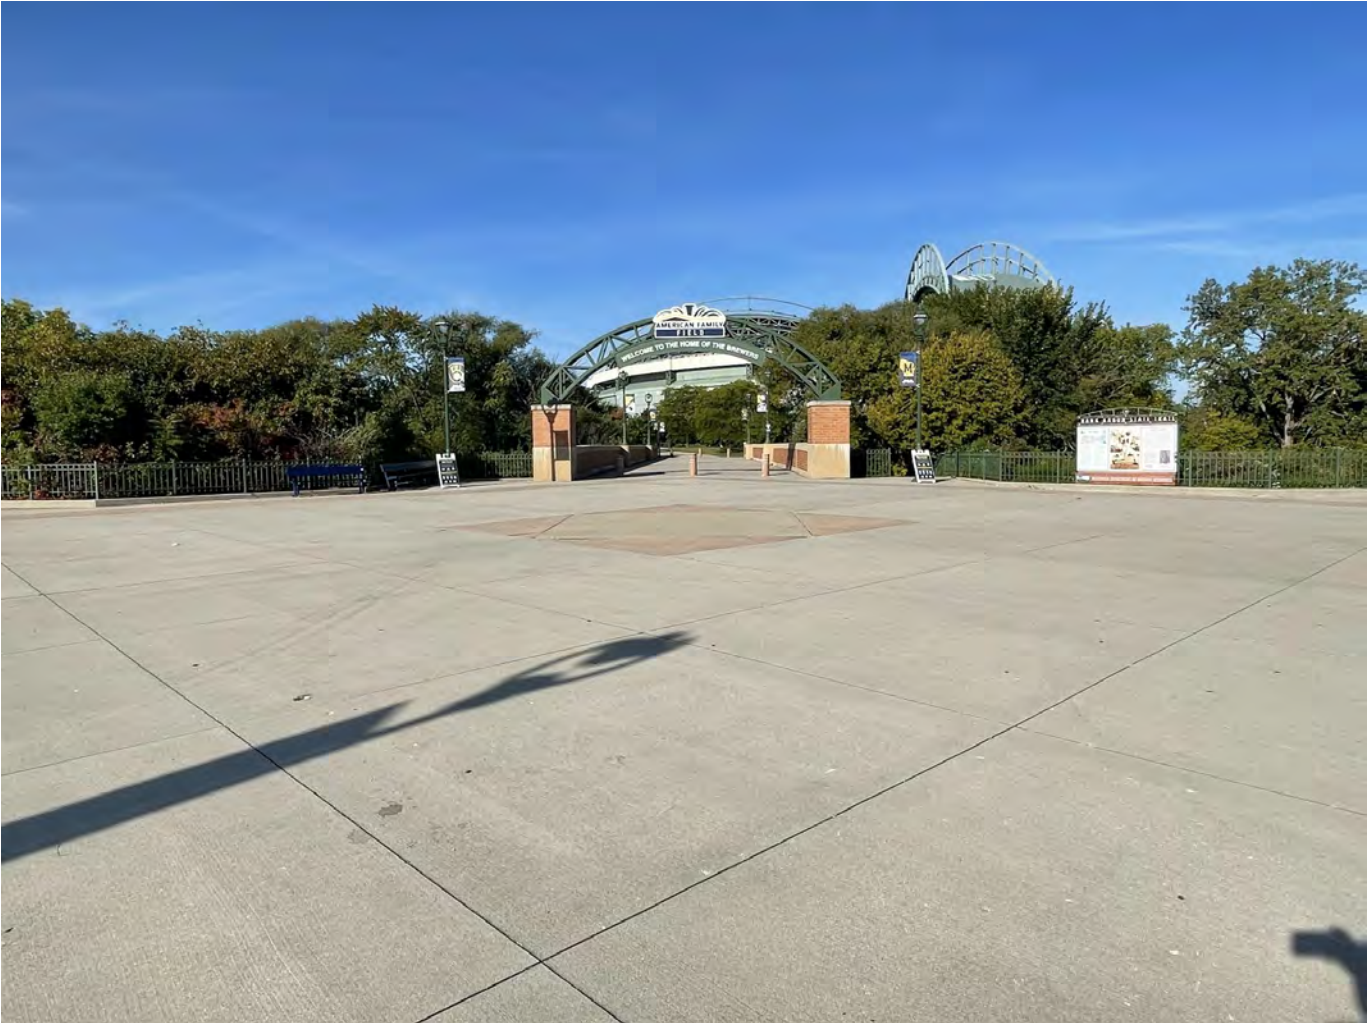
Photo 18: Uecker/Yount Lot: Concrete paved plaza and pedestrian path along west side of Uecker and Yount Lots: 6-inch concrete pavement overlying 8-inches crushed aggregate.
Photo taken facing west on October 4, 2022.

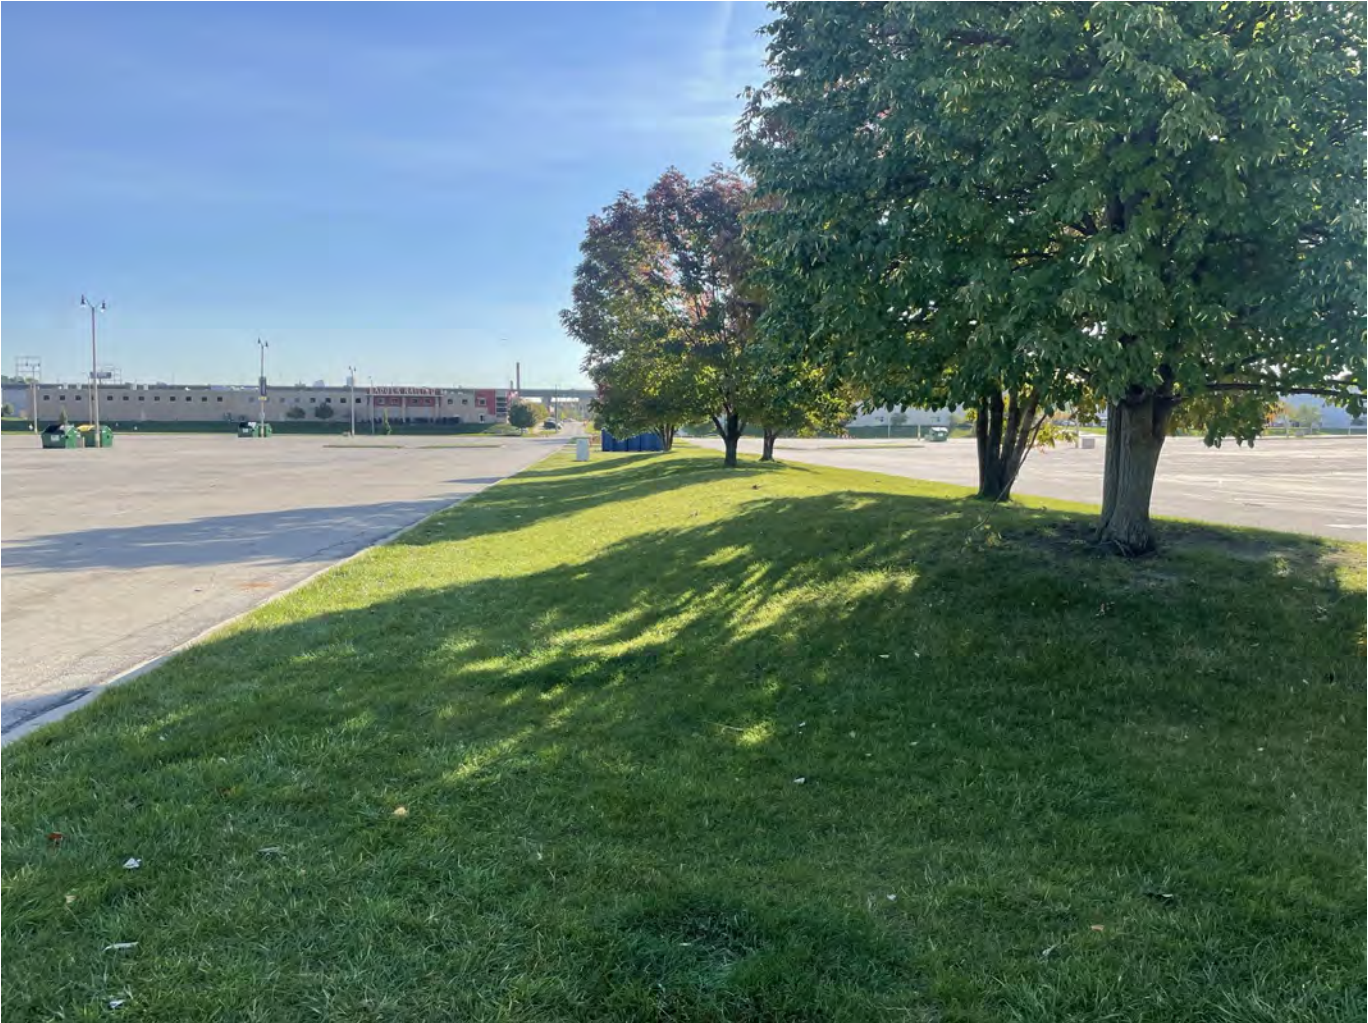
Photo 19: Uecker/Yount Lot: Greenspace cap parking lot island/median between Yount and Uecker Lots on west side of site: 12-inches of low permeability non-impacted soil covered with 4-inches of vegetated topsoil (grass) as well as various landscape plantings.

Photo taken facing east on October 4, 2022.

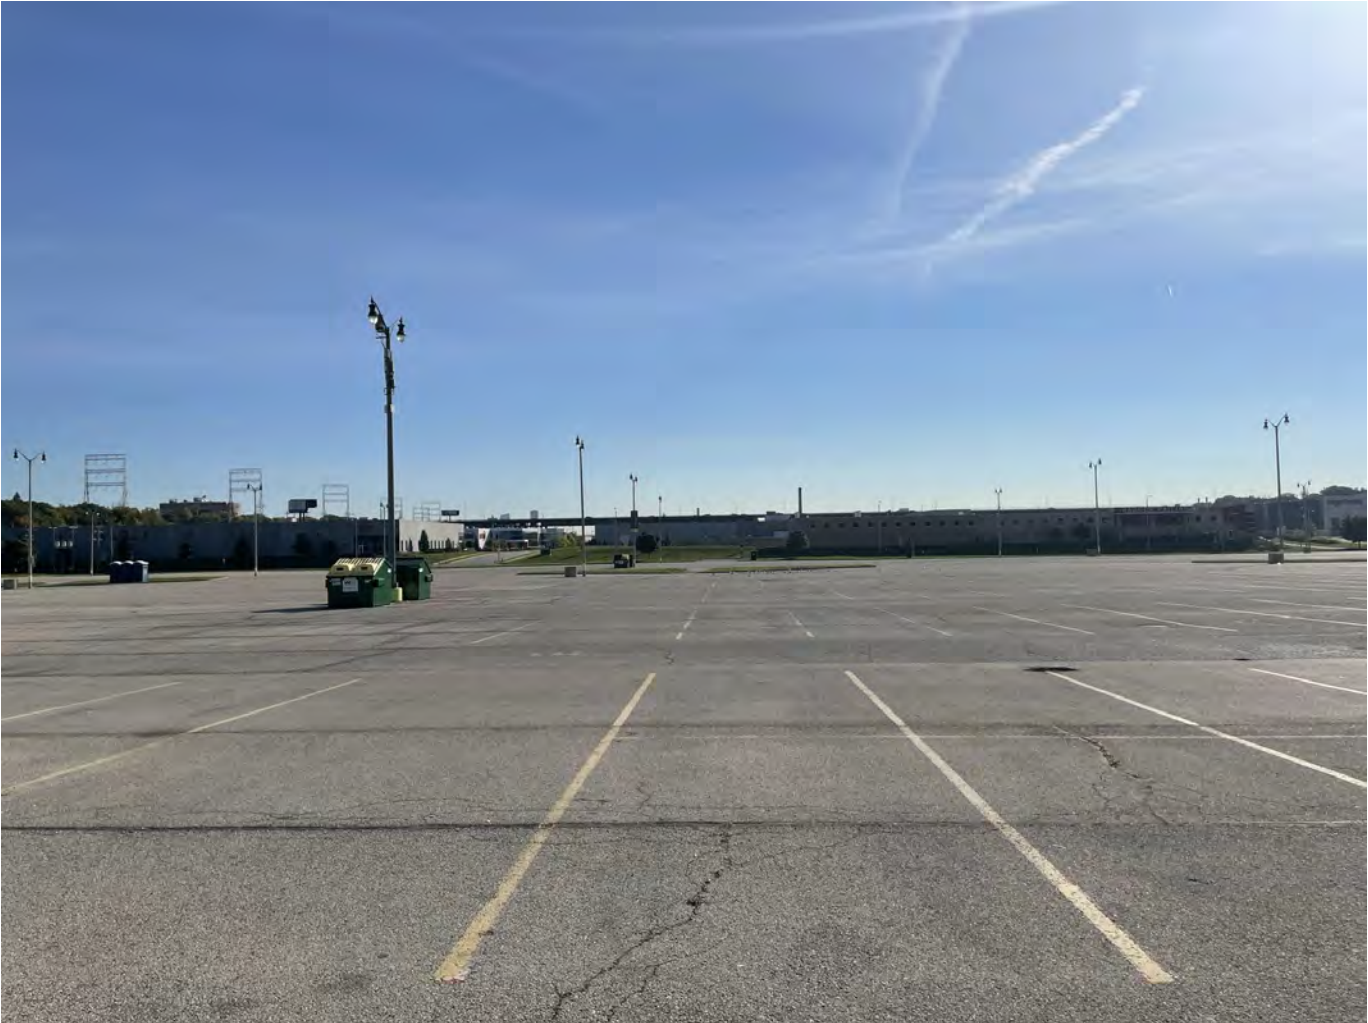
Photo 20: Yount Lot: Asphalt cap over Yount Lot: 4-inch asphalt pavement overlying 8-inches of crushed aggregate base course.
Photo taken facing east on October 4, 2022.

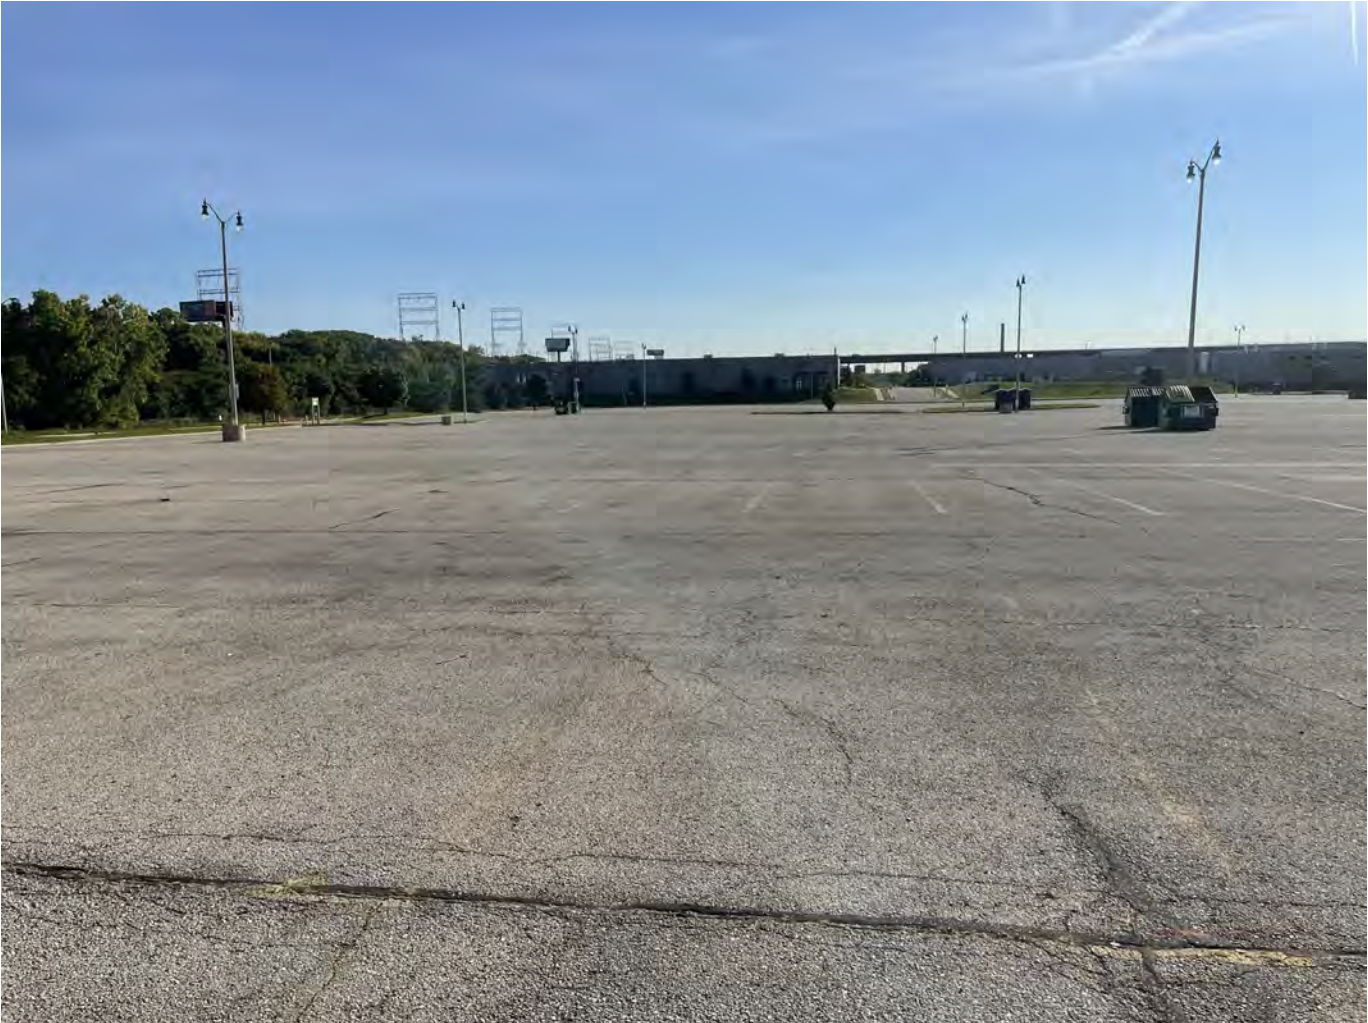
Photo 21: Yount Lot: Asphalt cap over Yount Lot: 4-inch asphalt pavement overlying 8-inches of crushed aggregate base course.
Photo taken facing east on October 4, 2022.

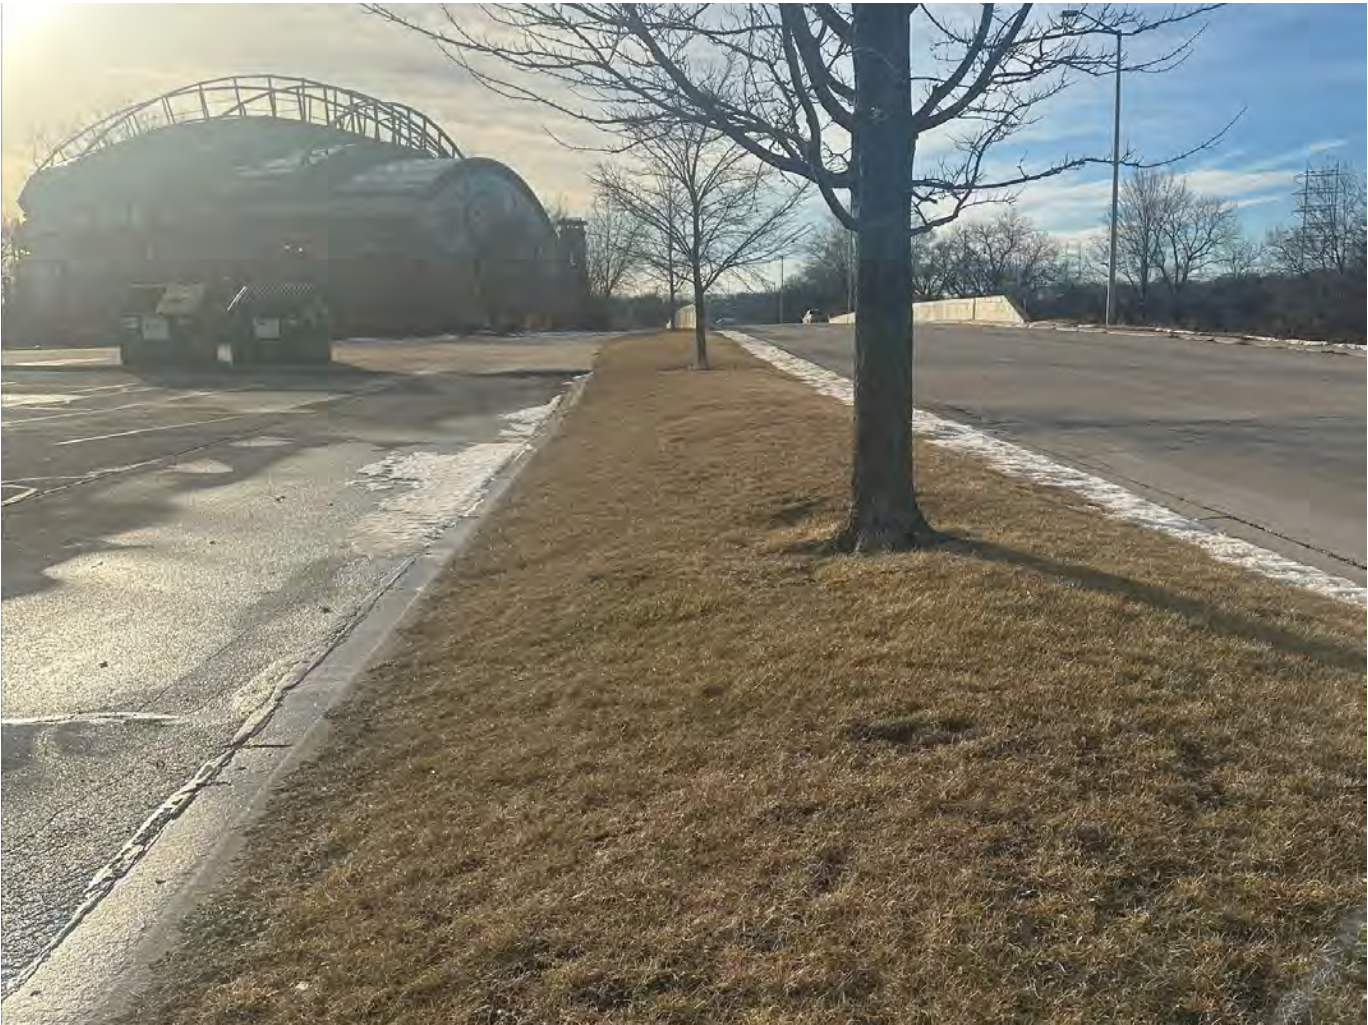
Photo 22: Yount Lot: Greenspace cap over parking lot median on north side of Yount Lot, along the south side of Selig Drive. Photo taken facing west on February 8, 2022.

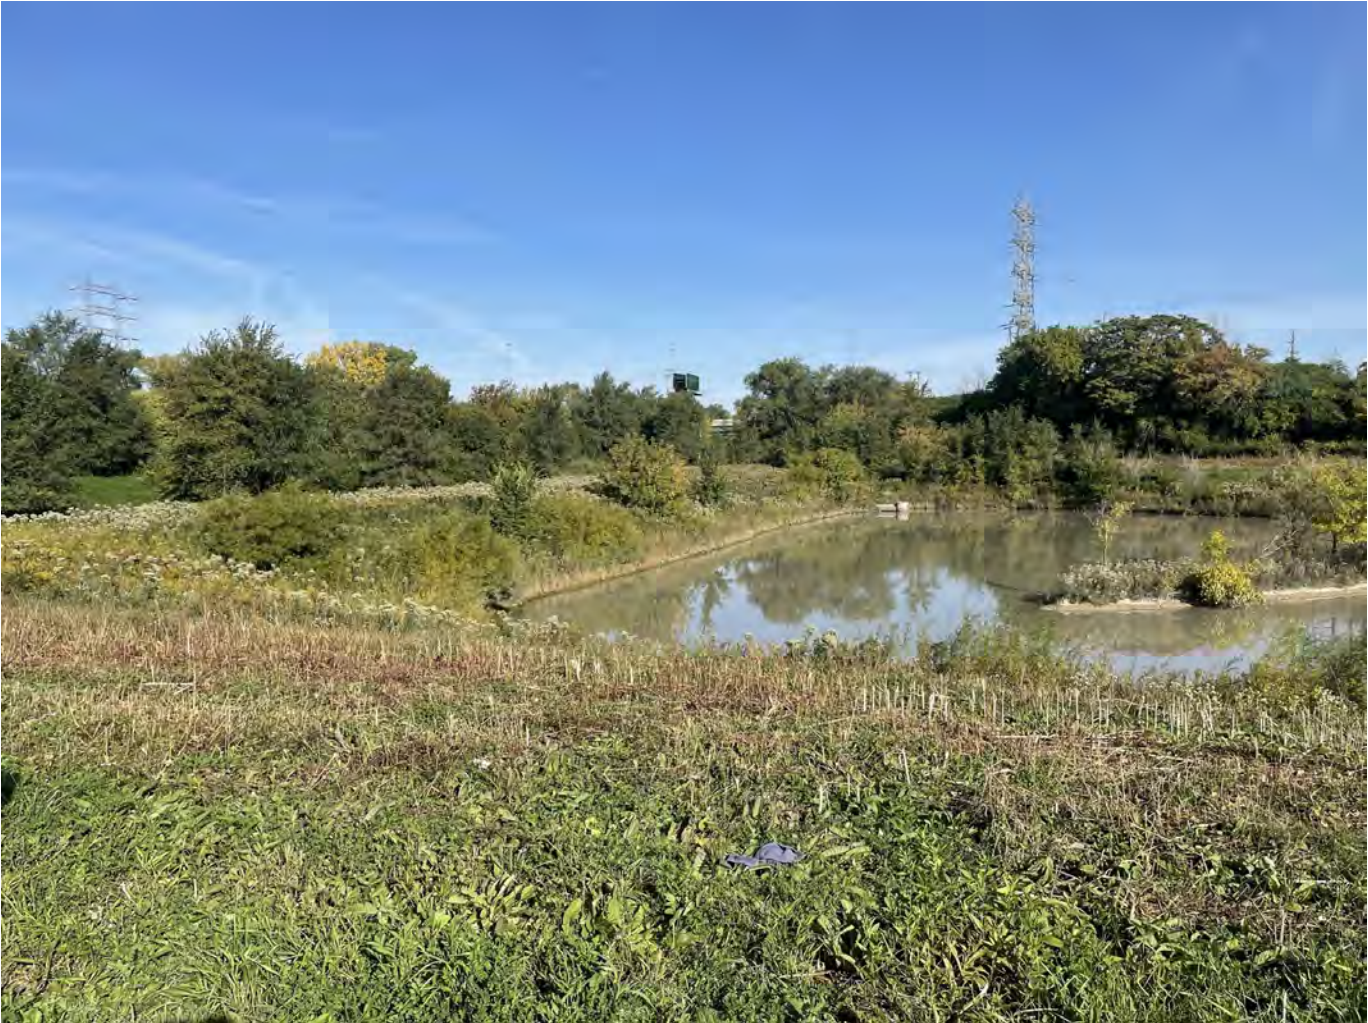
Photo 23: Yount Lot: Storm water pond with clay liner and geomembrane liner, north of Yount Lot and Selig Drive. Landscaping around the pond consists of vegetated topsoil with native plantings. Photo taken facing north on October 4, 2022.

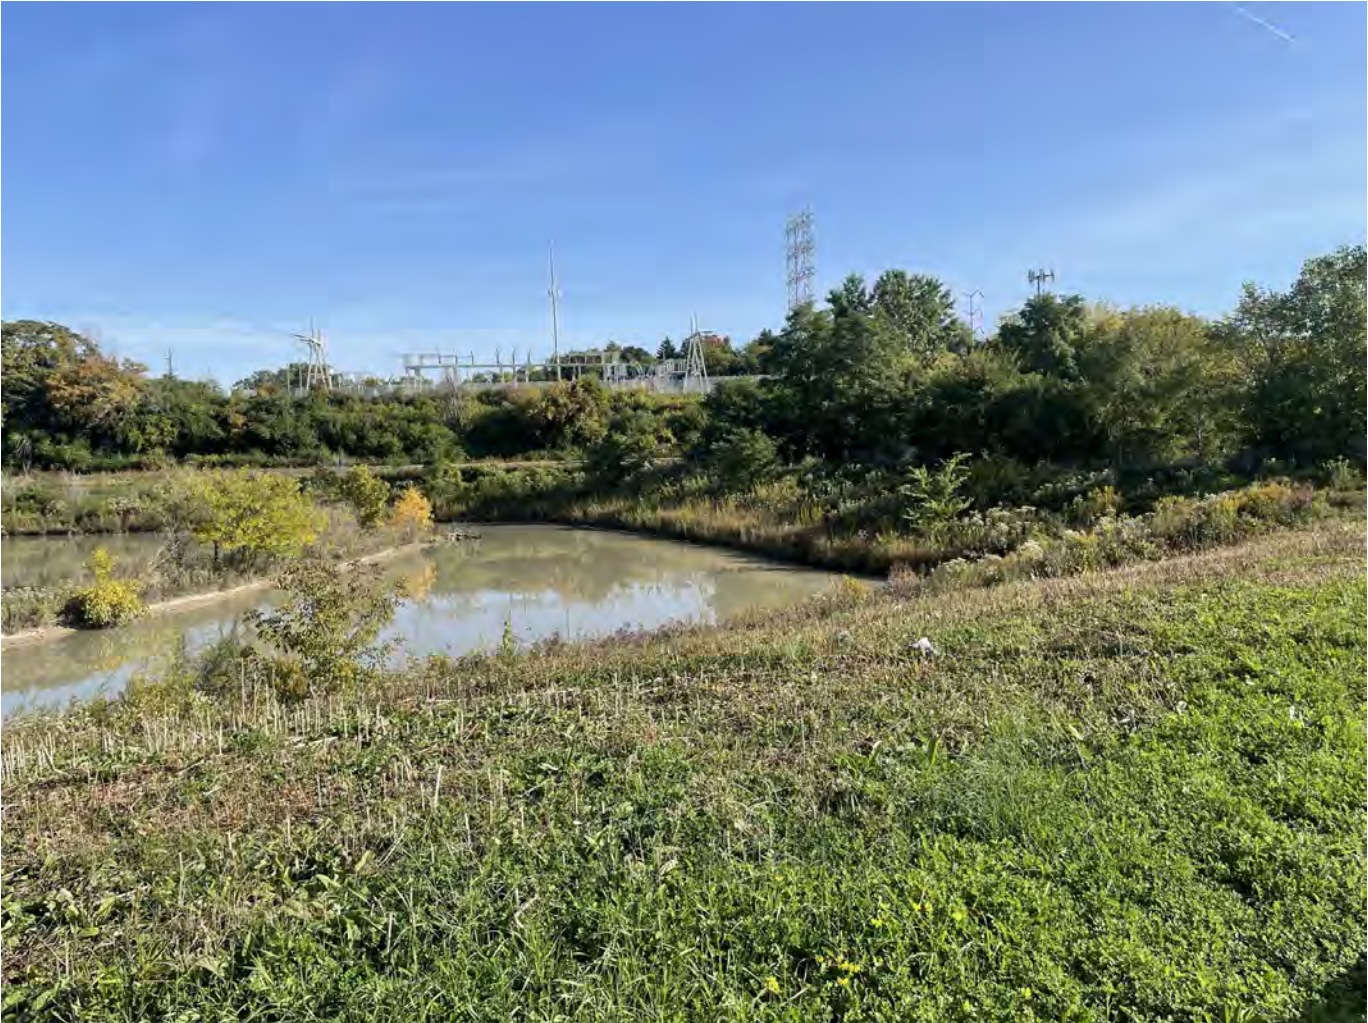
Photo 24: Yount Lot: Storm water pond with clay liner and geomembrane liner, north of Yount Lot and Selig Drive. Landscaping around the pond consists of vegetated topsoil with native plantings. Photo taken facing north on October 4, 2022.

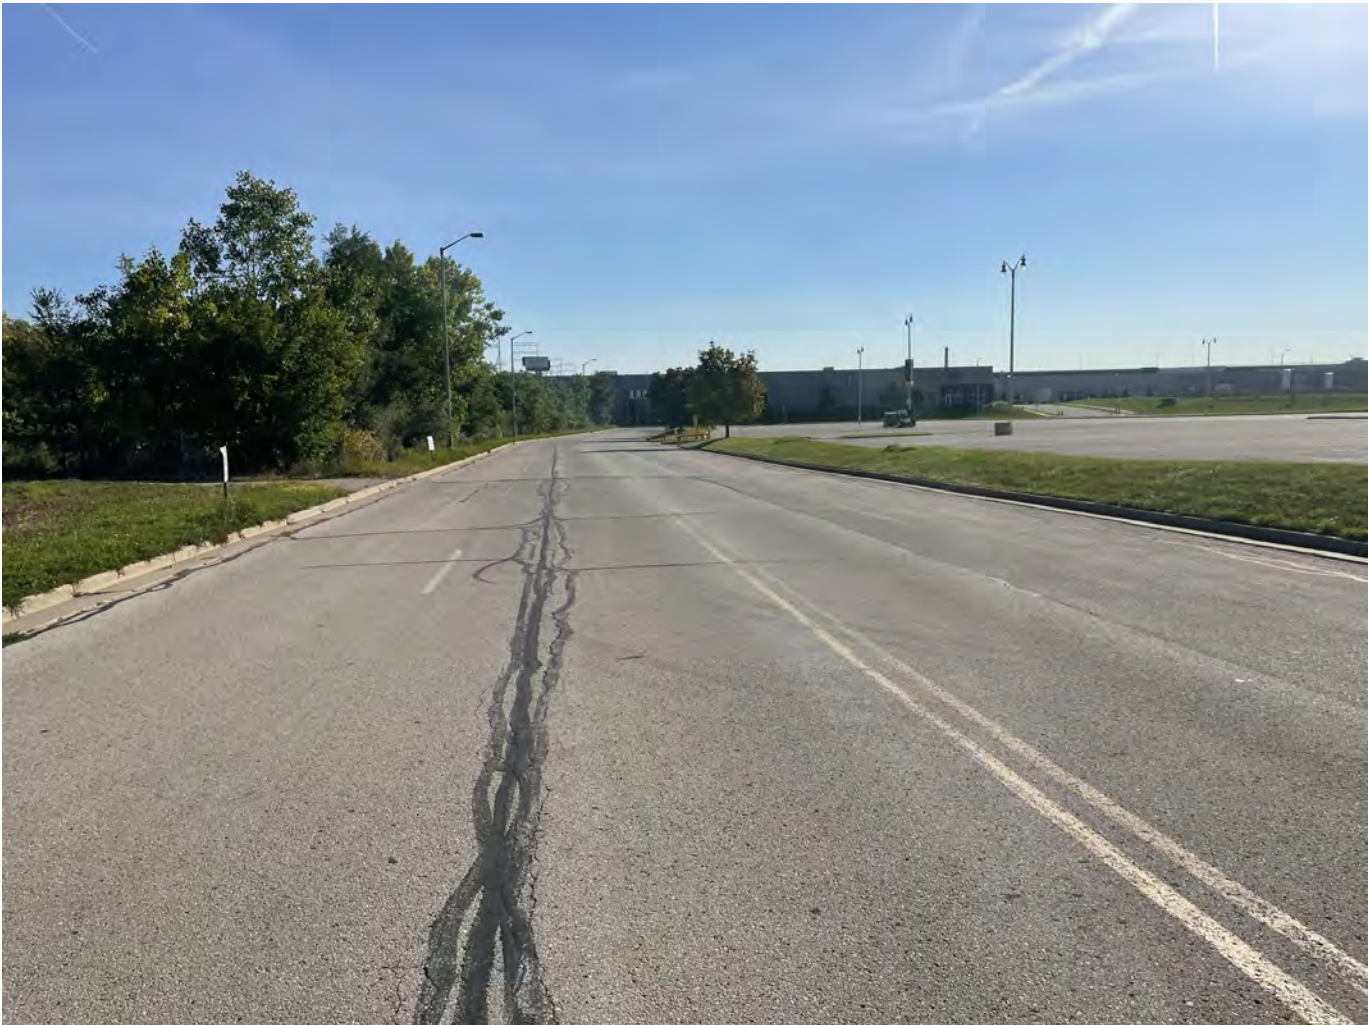
Photo 25: Yount Lot: Asphalt cap over Selig Drive north of Yount Lot: 4-inch asphalt pavement overlying 8-inches of crushed aggregate base course.
Photo taken facing east on October 4, 2022.

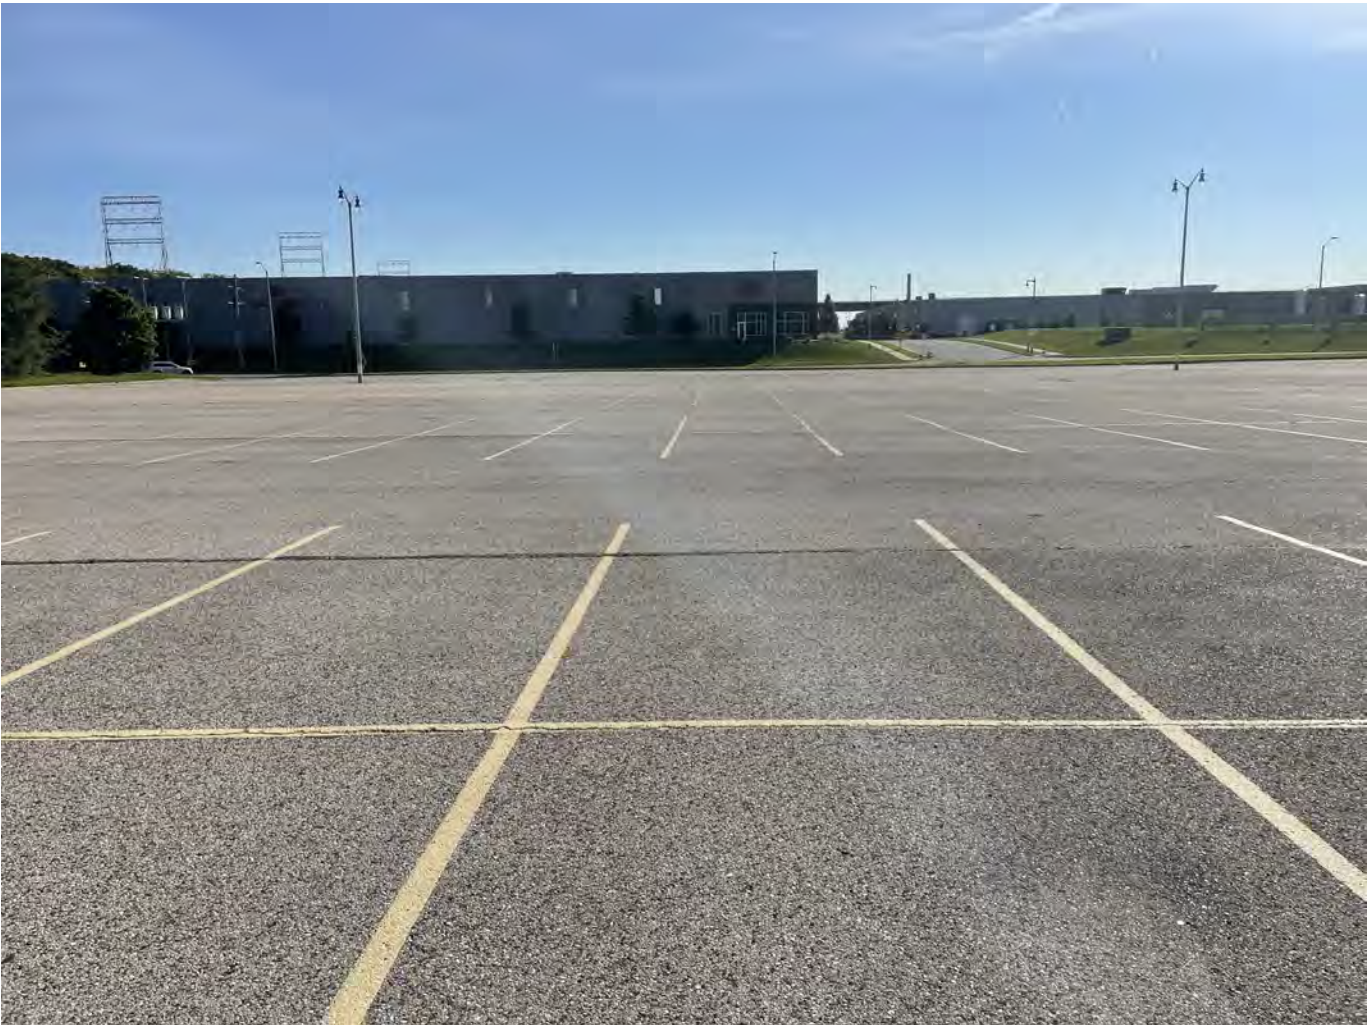
Photo 26: Yount Lot: Asphalt cap over Yount Lot: 4-inch asphalt pavement overlying 8-inches of crushed aggregate base course.
Photo taken facing east on October 4, 2022.

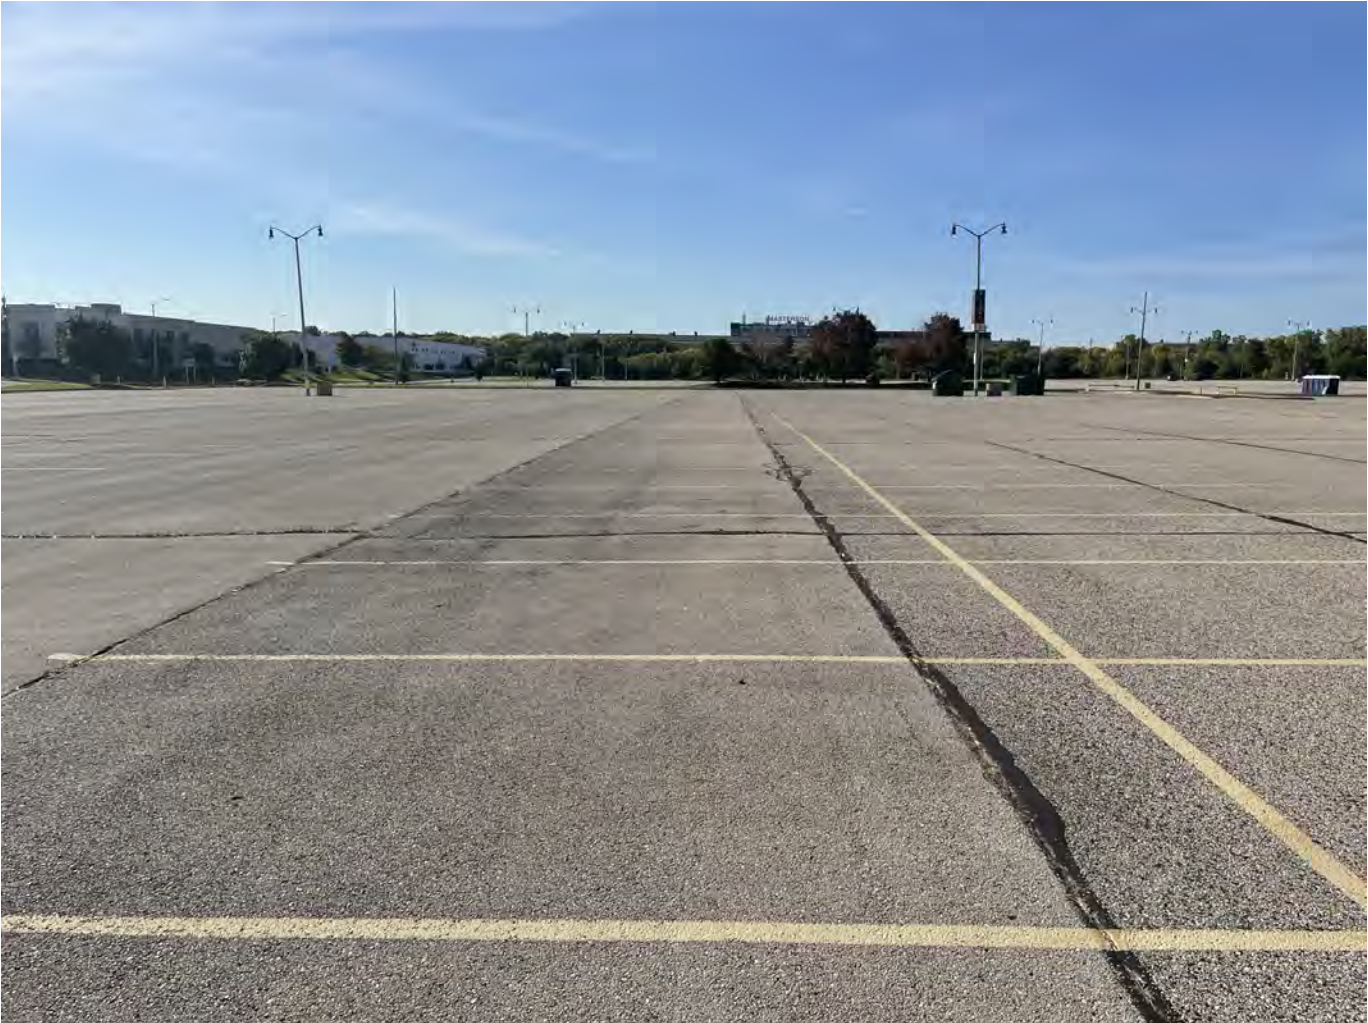
Photo 27: Yount Lot: Asphalt cap over Yount Lot: 4-inch asphalt pavement overlying 8-inches of crushed aggregate base course.
Photo taken facing south on October 4, 2022.
