ATTACHMENT D.1.

CAP MAINTENANCE PLAN SOUTHEAST WISCONSIN PROFESSIONAL BASEBALL PARK DISTRICT – RIVER EAST

FEBRUARY 2023

WDNR ACTIVITY NAME: MENOMONEE RIVER STADIUM PROJECT

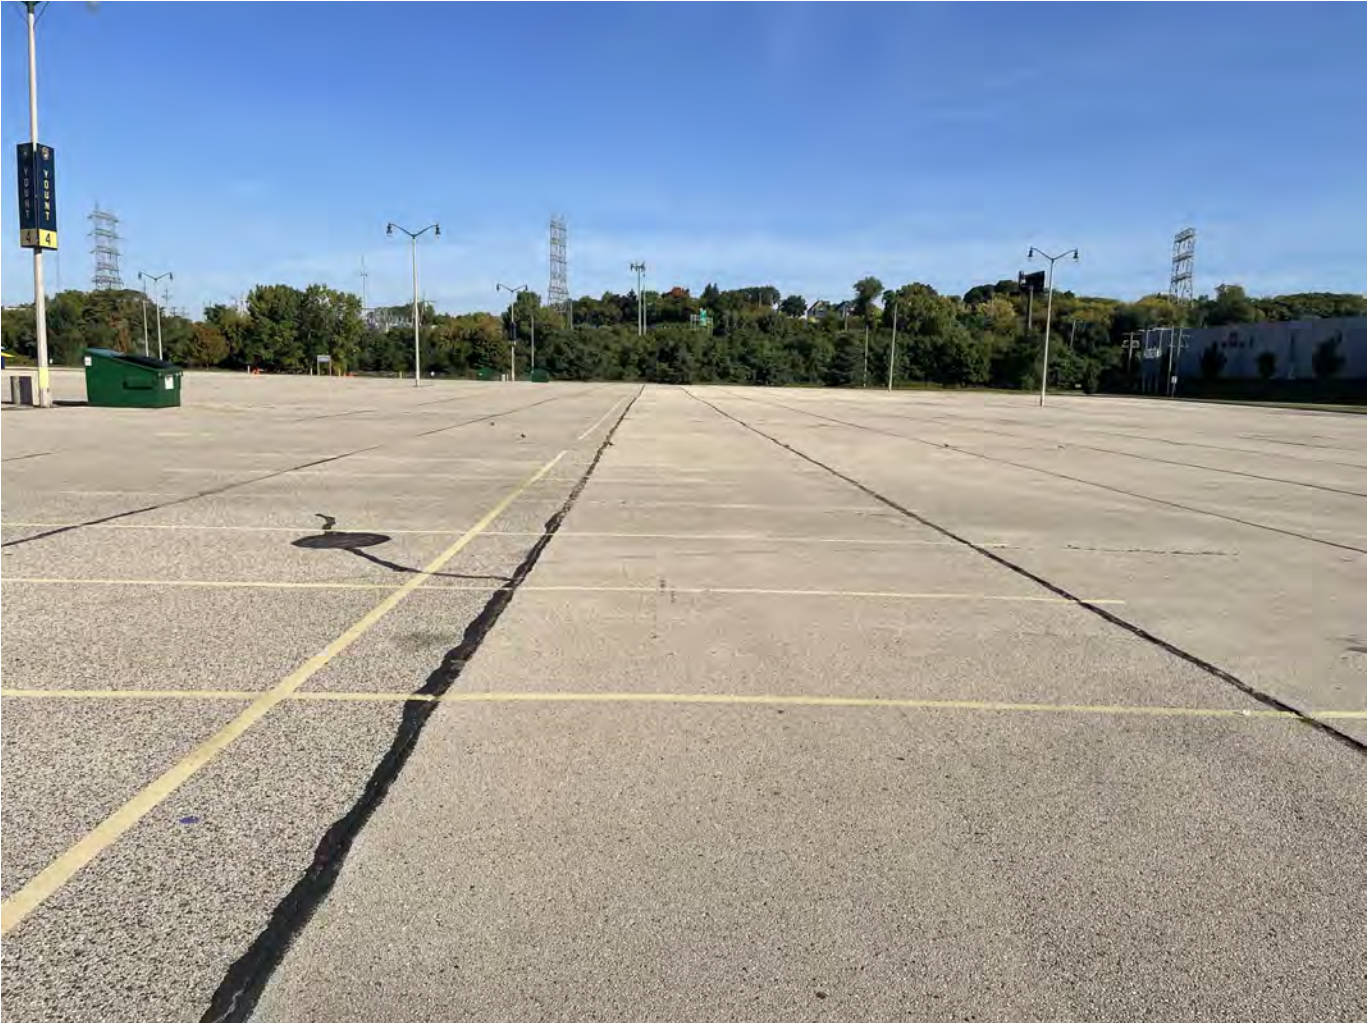
Photo 28: Yount Lot: Asphalt cap over Yount Lot: 4-inch asphalt pavement overlying 8-inches of crushed aggregate base course.
Photo taken facing north on October 4, 2022.
